## **Load Rating and Condition Assessment of the Grand Avenue Overbridge**

Marcia Prelog and Nasir Hossain, Aurecon, Australia

Grand Avenue overbridge at Rosehill is an existing Sydney Trains asset constructed in 1980. The bridge design was based on a T44 truck loading to the NAASRA code (1976).

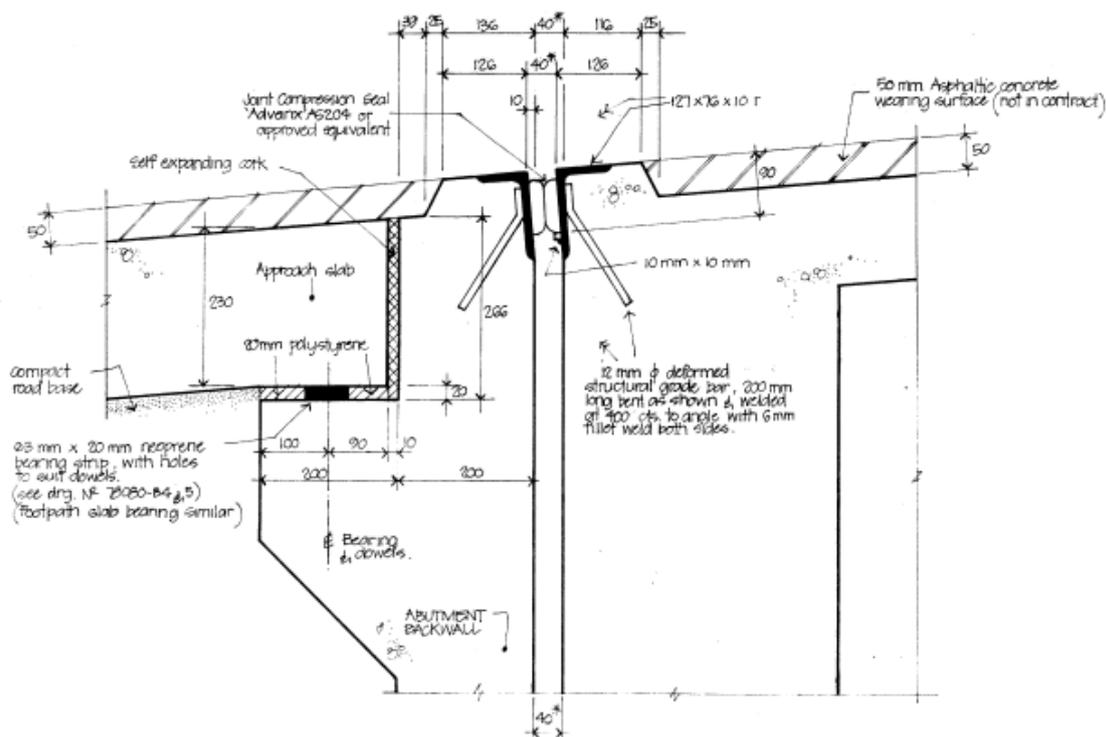
Approach slabs behind each abutment rest on the embankment fill, allowing for expected settlement. However, the slab connection is detailed with no movement joint at the deck surface, despite the slab being free to rotate at the dowelled joint on the abutment. This detailing is subject to degradation as the asphalt will crack over time.

**Figure 4 Deck joint section**

The remedial design proposed a standard RMS small movement joint retrofitted to the approach slabs and removal of existing angle and compression slab for the Granor XJS joint, allowing for ease of construction on one lane at a time whilst maintaining access to the industrial estates at all times.

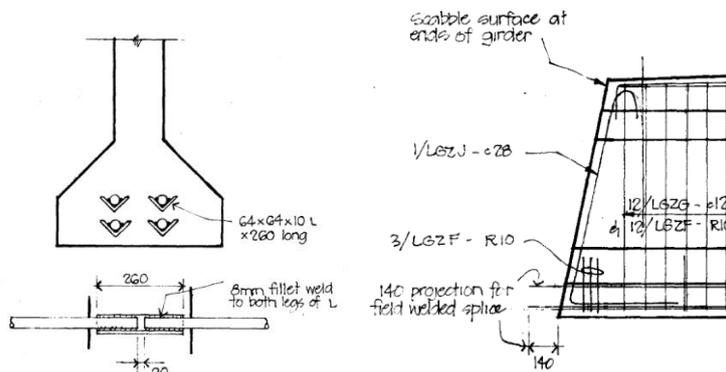
Girders are individually pre-tensioned and have been made continuous over the three spans through stitching of the reinforcement bars at the diaphragms above the piers, prior to placement of the deck slab. High shear and bending effects are concentrated at this location. The welded detail shown in Figure 5 is therefore an area subject to fatigue effects.

**Figure 5 Girder reinforcement welding above piers at diaphragm**

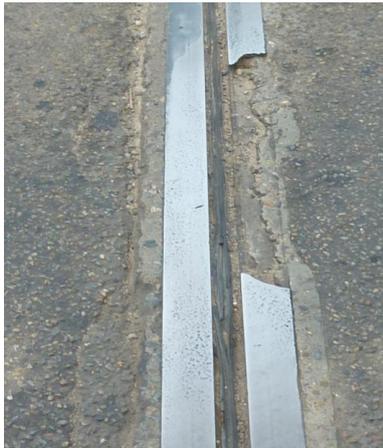
A condition assessment confirmed that the main defect was deterioration of the joint angles and rubber seal with sections of steel missing; in addition, the asphaltic concrete was degrading in the local area and notably across the approach slab

where no provision for movement has been made. These defects are due to the repeated high impact loads from a high proportion of heavy vehicles.

**Figure 7 Deck joint failure**

The deck joint defects were observed on site and correlated well with the expected degradation, due to repeated high load impact and the lack of a joint detail at approach slabs. Overstressing of the pier bearings is an expected effect of disproportionate span lengths and was determined through the staged analysis of this structure for the particular construction method adopted for the deck. Span ratios and continuity of spans can adversely affect bearings and supporting structures. Today, critical design thinking and adherence to standard practice and current guidelines can usually avoid the design flaws exemplified by this bridge.

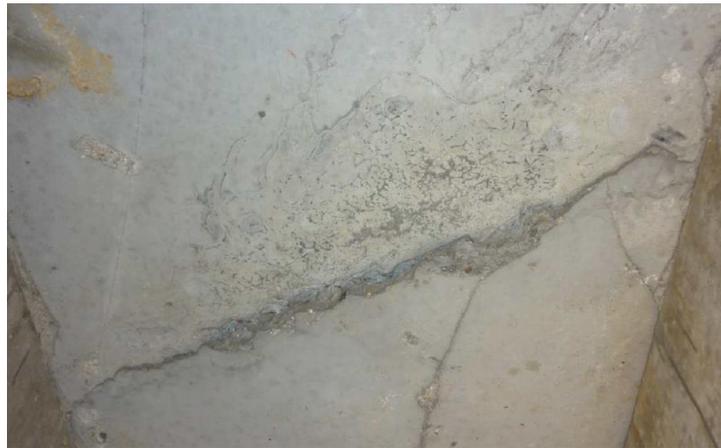
Defects were observed on the deck soffit, which appeared to be cracks on first sight. With a detailed inspection using an elevated platform, these defects were found to be due to the permanent formwork cracking during the original concrete pour and did not affect the structural integrity of the bridge. Overall the bridge was in good condition with no defects noted on the piers.

**Figure 8 Deck soffit construction defect**

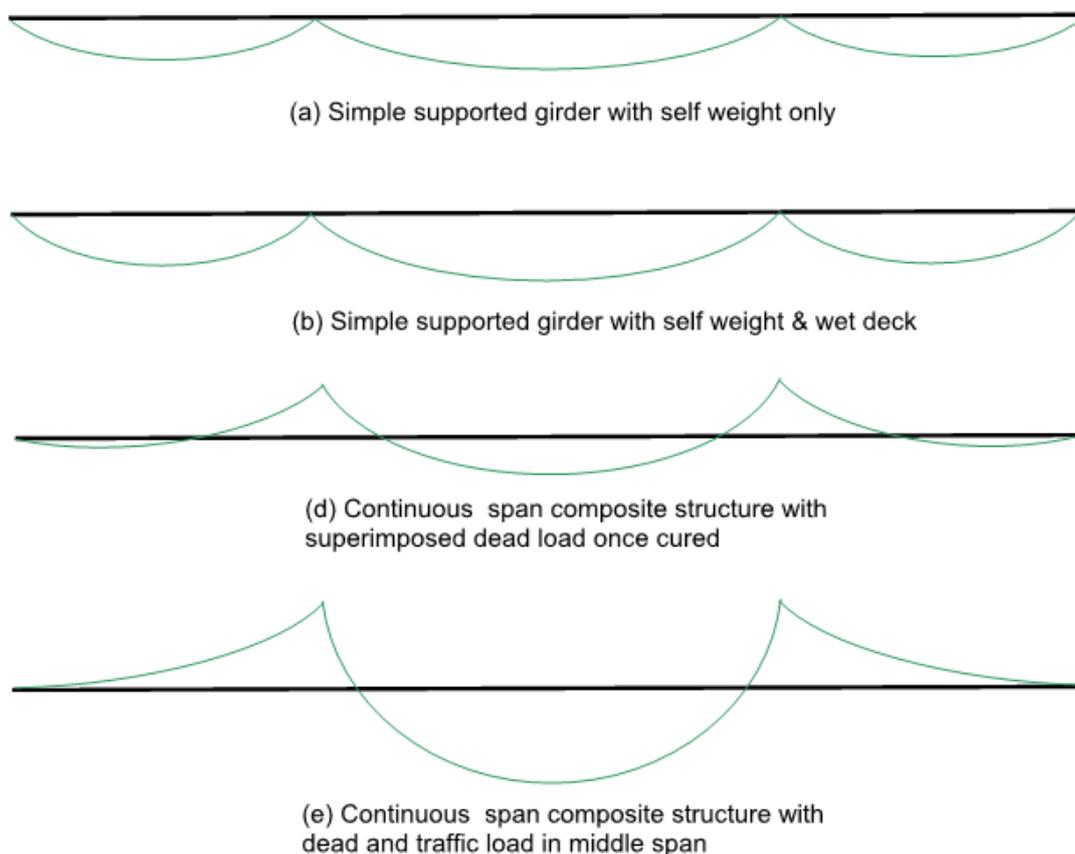
Due to the 0.37 span ratio, there is uplift at the abutments and additional shear and negative bending under the self-weight of the bridge deck and live loads at the piers. This would not have occurred during the placement of the girders at construction stage, but after the three spans were made continuous.

This resulted in lower reactions at the abutment bearings and higher loads being applied to the piers, under the full self-weight of the structure and vehicle loading. This correlated well with the visible signs of overstressed bearings with the slight bulging noted at the piers.

**Figure 9 Indicative bending moment diagram at different stages**

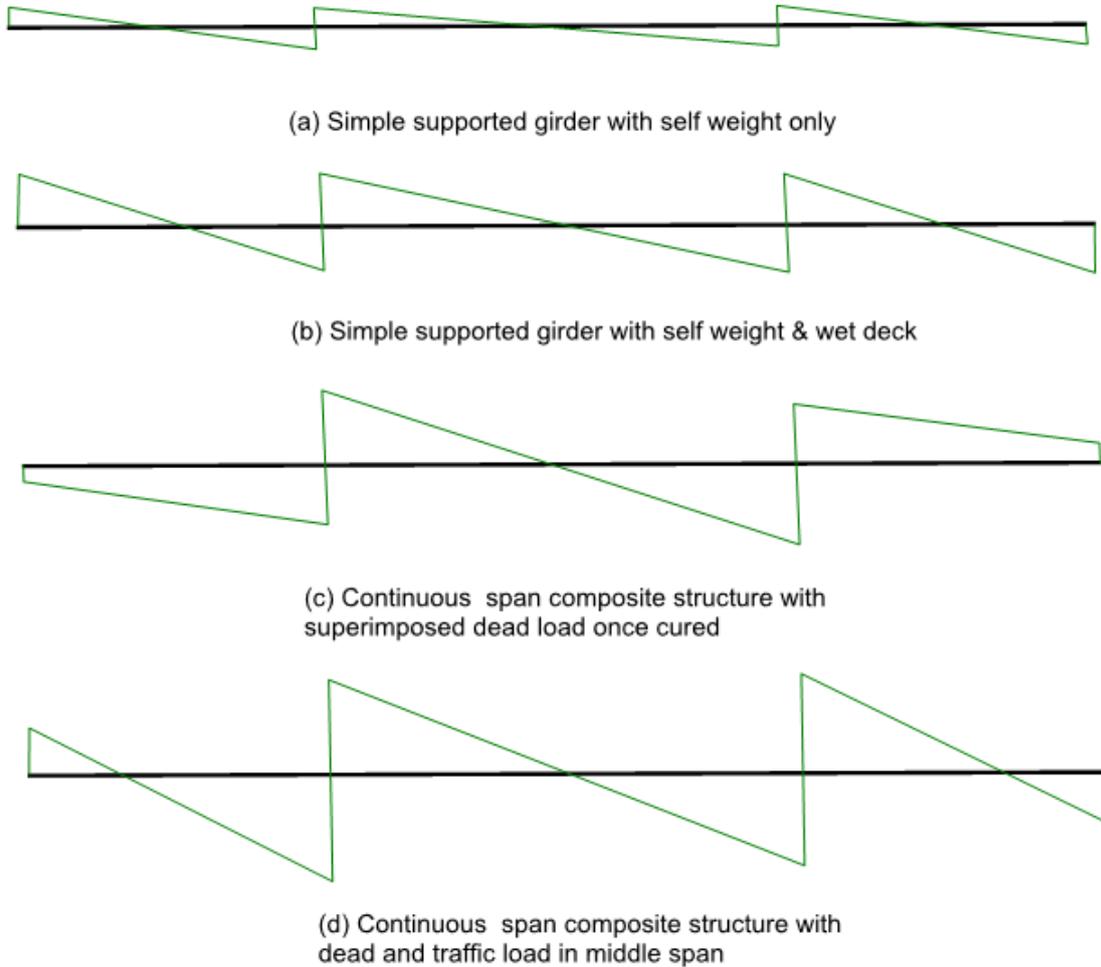
Figure 10 Indicative shear force diagram at different stages

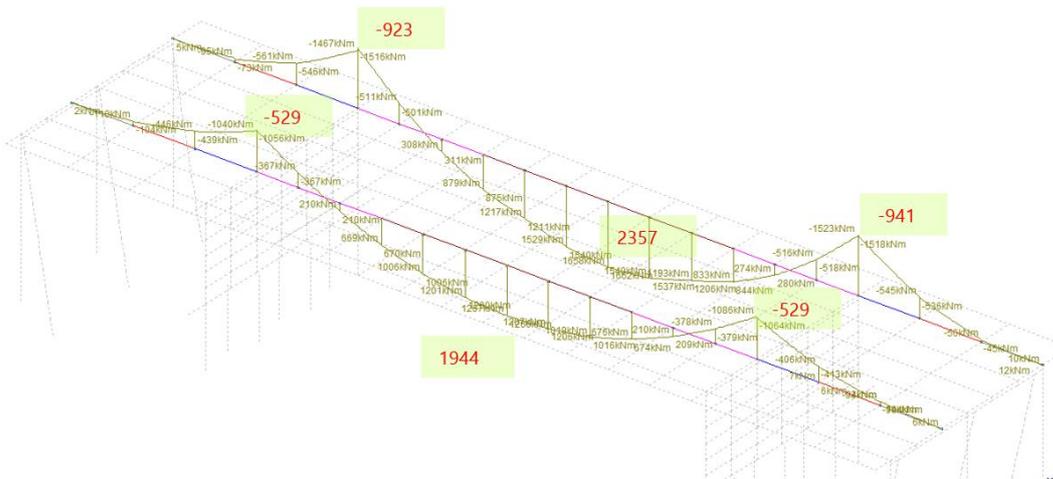
Figure 11 Bending moments under dead load as a continuous span (adjusted bending in red)
