Condition assessment of corrugated steel underpasses including three-dimensional terrestrial laser scanning

Nathan Roberts, Associate, Aurecon

Alan Michie, Bridge Engineer, Aurecon

Lindsay Brown, Regional Bridge Engineer, Hunter Region, Roads and Maritime Services NSW

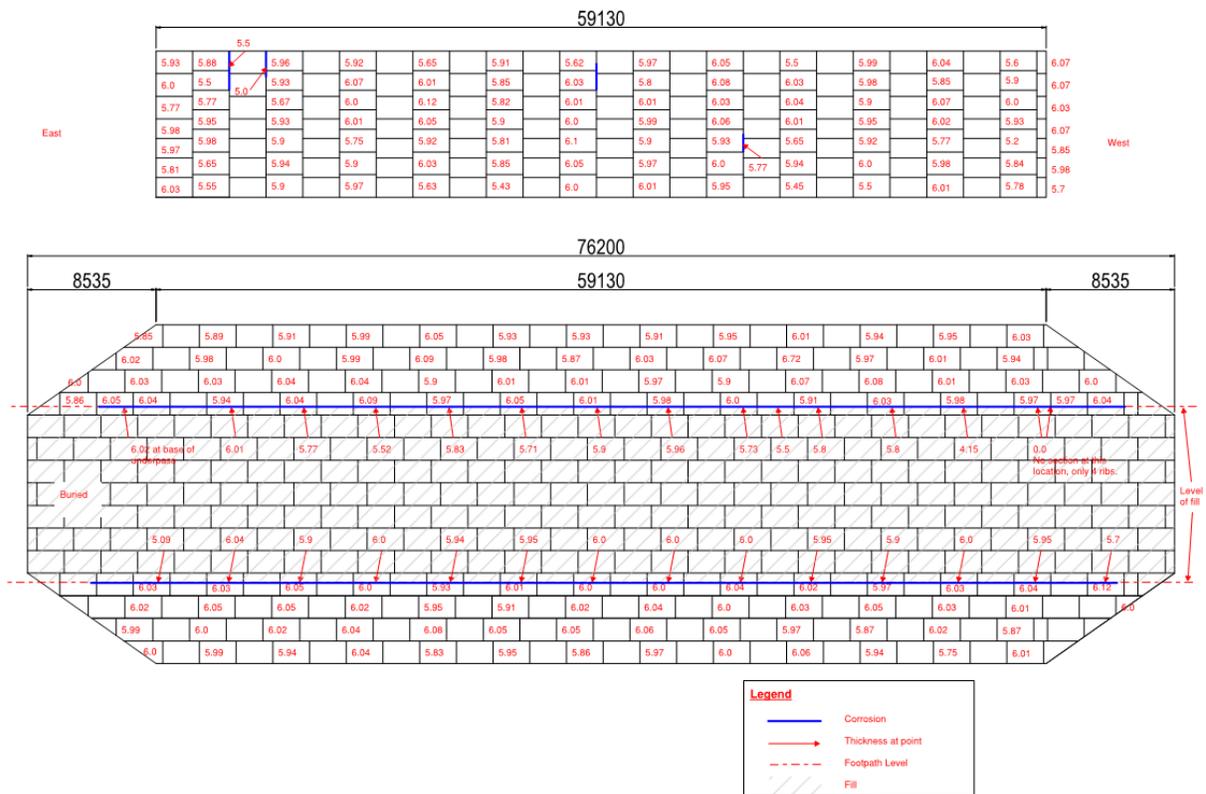
A defect plan was prepared for each structure using a plate layout with measured thickness and visible corrosion and other defects marked. A typical defect plan is shown below in Figure 5.

Figure 5 Defect plan for the structure at Bushells Ridge

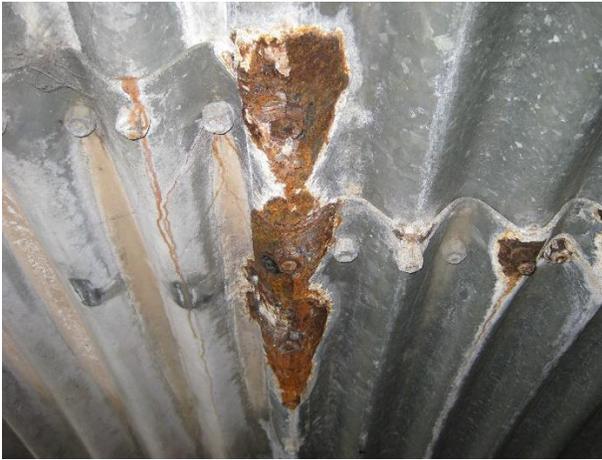
- Surface corrosion was evident at the seams of the plates, this corrosion was more prevalent at the top plates and plates above the horizontal centre line. Water was observed seeping through the plate lap joints.
- Surface corrosion was present for the bottom 100-200 mm of the exposed structure where the bolted plates meet the footpath zone. This was present for structures for which the footpath is not concreted, and earth fill is placed directly against the steel. Negligible corrosion was observed at this interface for the BCMS at Somersby which has concrete footpaths. Where present at this interface, the surface corrosion was more prevalent near the portals.

Figure 6 Typical corrosion at bolted lap.

The mechanism for the observed corrosion is attributed to continued wetting and exposure to oxygen at the lap joints, footing connections, and footpath interface locations (due to the passage of vehicles). The corrosion at the lap joints is typically around the thrust beam location. It is possible that water is trapped on the thrust beam and this contributes to water ingress at these locations.

- Cleaning and painting of corroded areas for several structures.
- Removal of trees and vegetation on the road embankment batters for several structures.

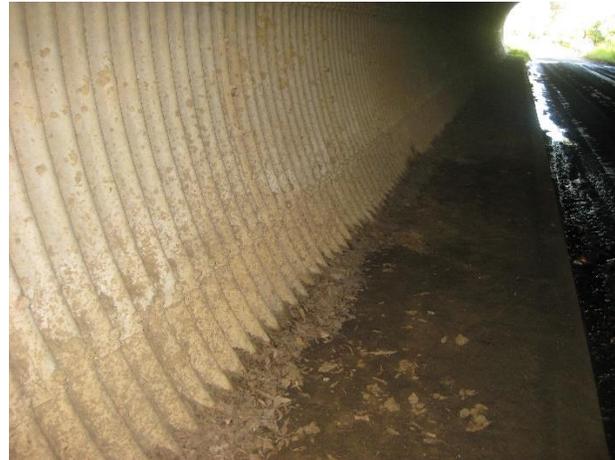
Several inspections were undertaken during wet weather and it was identified that poor road drainage was leading to ponding in the gutter in and near the BCMS portals. This was particularly the case for the BCMS at Kangy Angy and Bushells Ridge. The passage of vehicles (even with traffic control speed restrictions) was causing ponded water to be splashed repeatedly onto the structure. The presence of mud and dirt on the BCMS walls supported this

Figure 7 Path interface showing water ponding in gutter and splashed dirt and mud on steel plate.

- For horizontal ellipses, sealing the road pavement on the approaches (if unsealed) and improving road drainage.
- For horizontal ellipses, completion of small test pits in the unsealed footpath zones to assess if corrosion continued below ground level.
- For arches, cleaning the foundation connection channel at the interface of plates and the footing to remove dirt and debris. Furthermore, improvement of drainage near the plate to footing connection to direct water away from the channel.

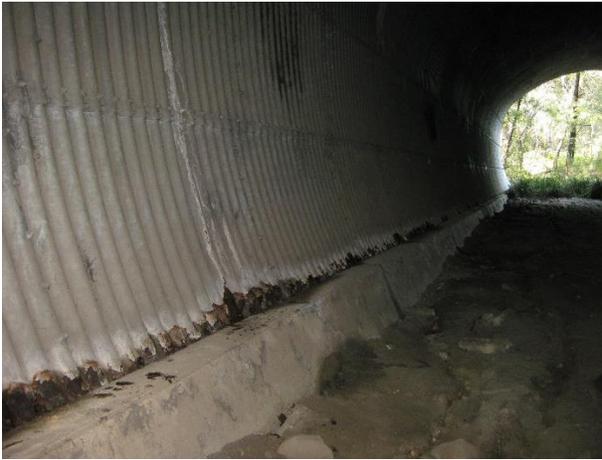
- The most obvious trend for all arches was an increased amount of corrosion at the connection between the steel arch and the reinforced concrete footing. All arches exhibited a zone of approximately 100-150 mm increased corrosion at this interface. At this interface, corrosion was generally significantly more advanced than other locations, generally leading to localised areas with section losses of approximately 40 per cent or greater than general plate locations.
- The footing detail for all arches comprised a steel channel cast into the concrete footing. This channel was consistently observed to be either damp or holding water. Water also appeared to be seeping through the detail from the soil side. Microclimatic conditions caused by this detail are anticipated to have caused the increased corrosion.

Corrosion at this interface was also observed to be worse for arches at Calga and Taree on the uphill side of the section. For both structures, the motorway is on a grade. Greater corrosion was observed on the side of the structure on the uphill side of the cross cross-section. This could potentially be caused by greater groundwater flows in the base of the embankment travelling downhill and being impeded by the underpass, leading to greater moisture levels on the uphill side of the cross cross-section.

Figure 8 Corrosion at footing connection - Calga

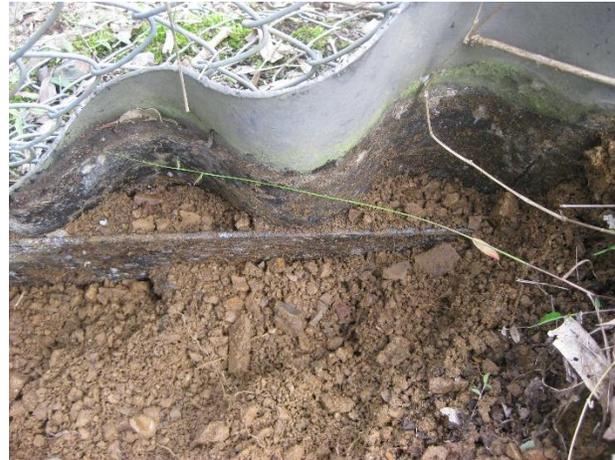
Taree	3.2	3.0 (excluding areas of complete section loss)	1 or less for approximately 18 consecutive ribs at connection with footing.	<p>Extensive corrosion was present on the southern side for the bottom 100-150 mm where the bolted plates meet the footing. The thickness of the plate varied in the locations of corrosion between 0.0–3.0 mm. Approximately 18 ribs had a section thickness of 1.0 mm or less.</p> <p>Aside from the footing connection, minimal corrosion was identified elsewhere.</p>

Figure 9 Arch to footing channel connection detail at end of wing wall - Taree

1. For the smaller structures at Cameron Park and Taree, strengthening the corroded zone at the plate to footing connection was proposed as a remedial option. This would comprise welding shear studs to the corrugated sheets (above the corroded zone) to transfer the load to a cast in-situ concrete plinth which transferred the load to the existing footing.
2. Shotcrete lining was also proposed for all arch structures, with a new shotcrete arch springing from a widening to the existing concrete footing.
3. Use of precast arches or boxes (depending on the structure size) supported on cast in-situ concrete footings were also proposed. If adopted these options would require temporary steel slide beams to

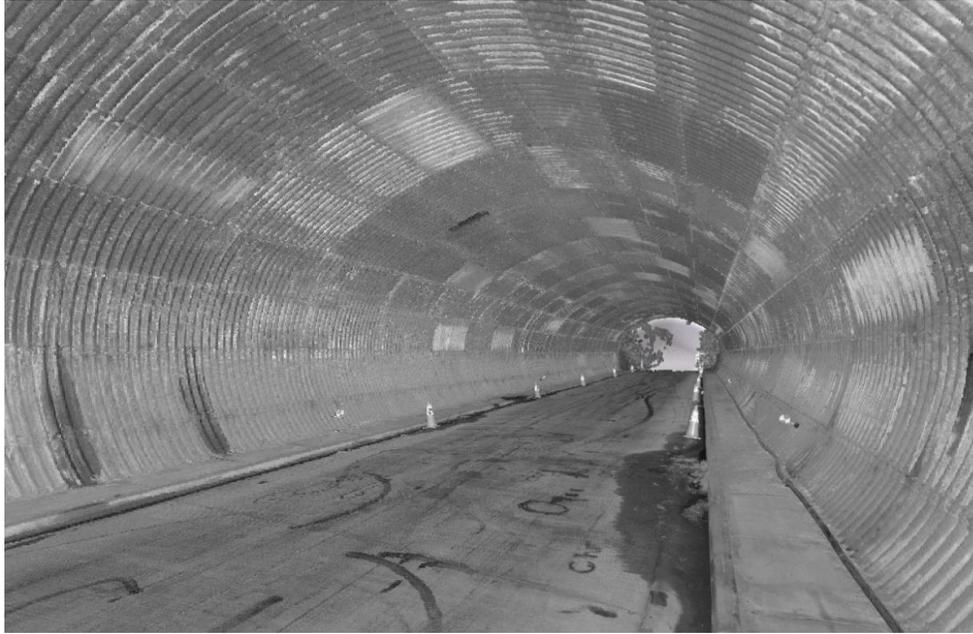
The point cloud data was draped with the photographic imagery captured during the scan to create spatial models of each structure. The spatial models clearly show the extent of corrosion. A lesson learned from this project would be to use temporary lighting to improve the colour return on the photo imagery. An opportunity for future development would be to develop routines that define surface corrosion boundaries to measure the extent of surface corrosion and assess changes between scans done at different times (e.g. growth of surface corrosion extents over a period of years). Figure 13 below shows a screenshot from the rendered spatial model for the BCMS at Somersby.

Figure 13 Screenshot from rendered spatial model at Somersby

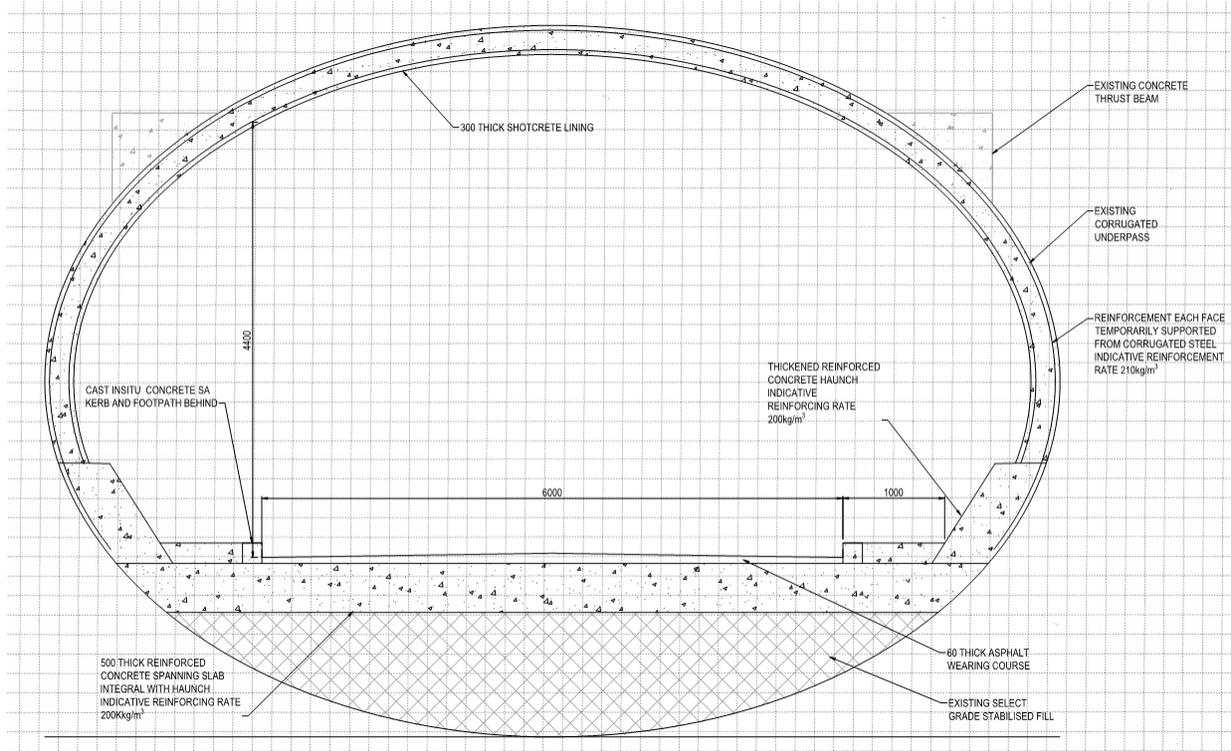
Figure 14 Concept option for shotcrete lining remedial works – Somersby

A multi-criteria assessment of the concept options generally resulted in shotcrete lining being selected as the preferred long term remedial option. Figure 14 below shows a concept sketch for the shotcrete lining option.
