Design, Installation and Management of Remote Pedestrian Structures in Tasmania

Tim Chappell, Senior Engineer, Parks & Wildlife Service, Tasmania, Australia

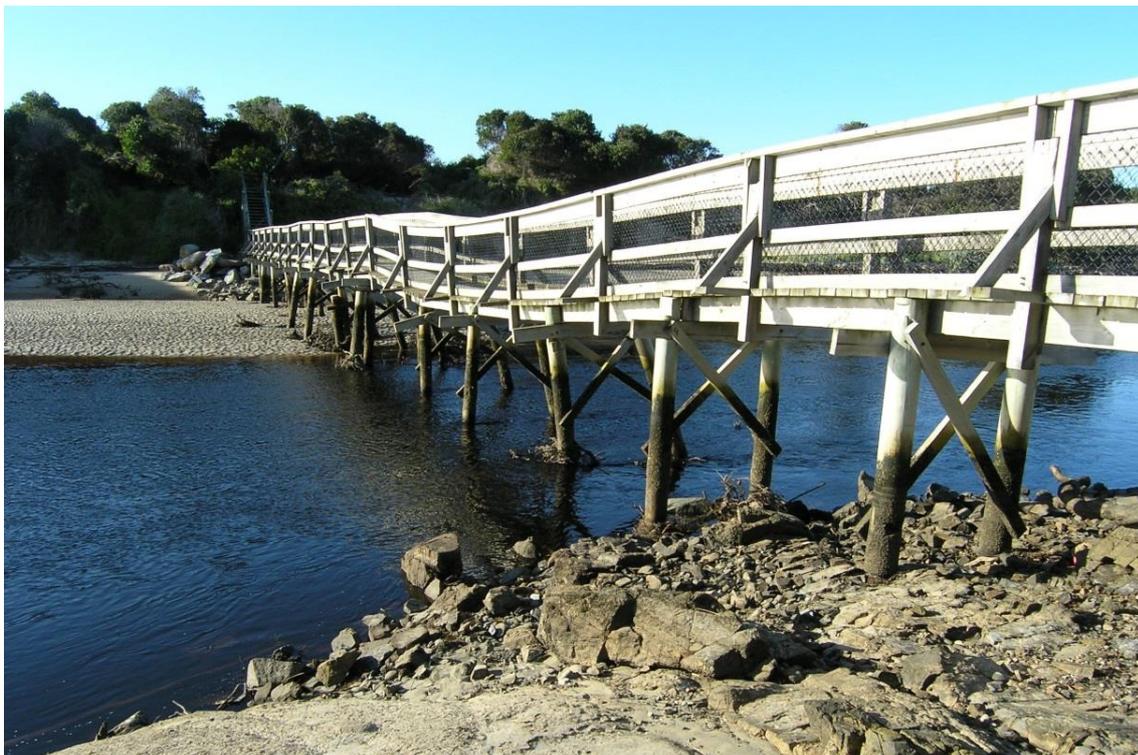
Typically low standard infrastructure dating from the 1980's, predominantly treated pine

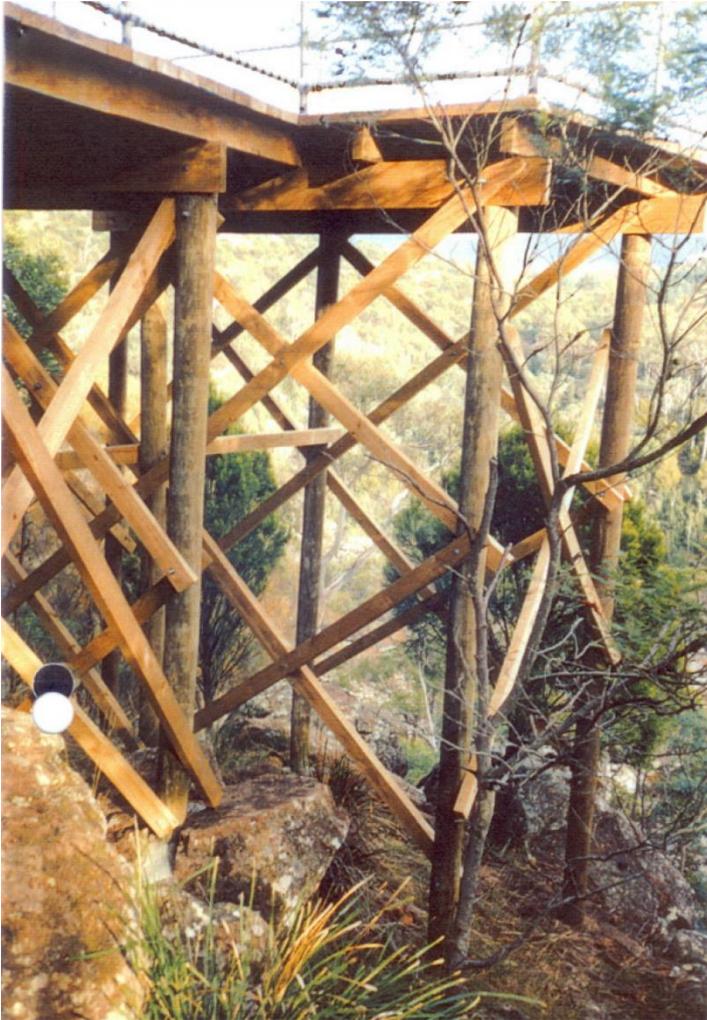
Example of a structure that was closed during the first round of engineer inspections, post 1995

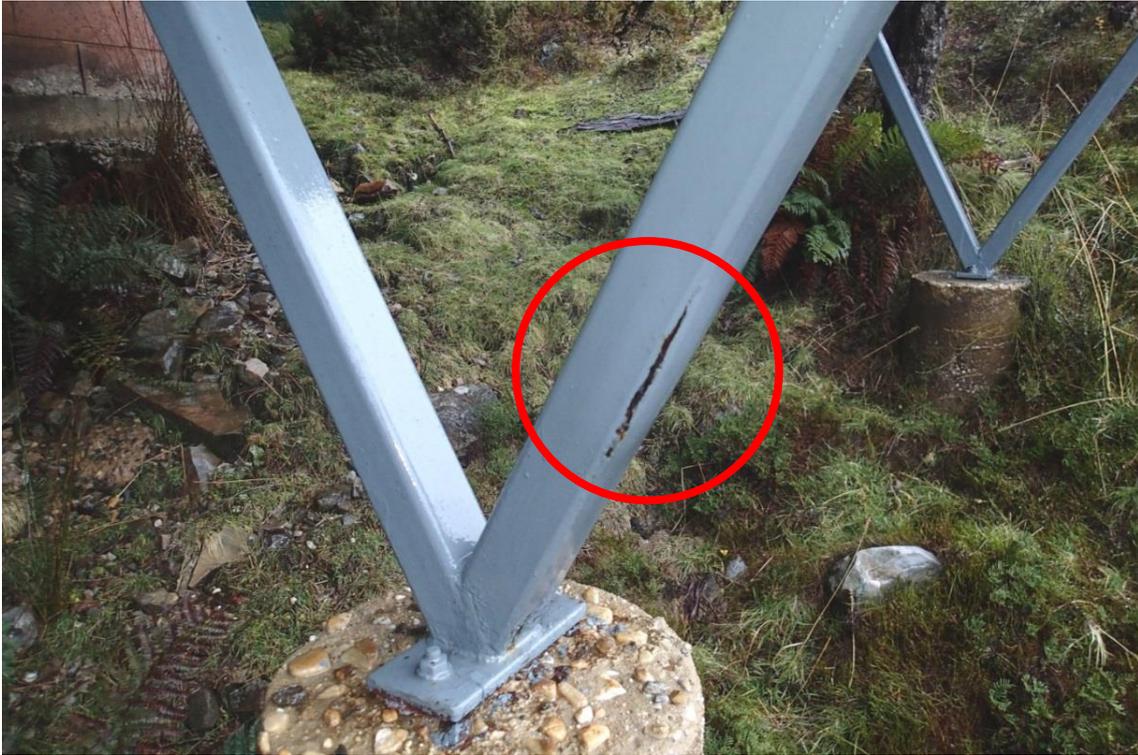
RHS Splitting Example 1

Despite this logic, in practice it has been found that moisture will almost always enter exposed “sealed” hollow sections. A plausible theory is that differential air pressures drive moisture through microscopic flaws and capillaries in the weld material and other defects. This moisture, once inside the member, never escapes and can accumulate over time into a significant volume. Pooling occurs at the lowest part of the member and this will gradually burst or split the section if subjected to repeated freeze-thaw cycles.

It appears that rectangular/square hollow sections with wall thicknesses less than 4mm are the most vulnerable to damage. An early warning sign is bulging of the sides of the section. This is followed by fine crack formation and then splitting, usually at the cold-formed corners.

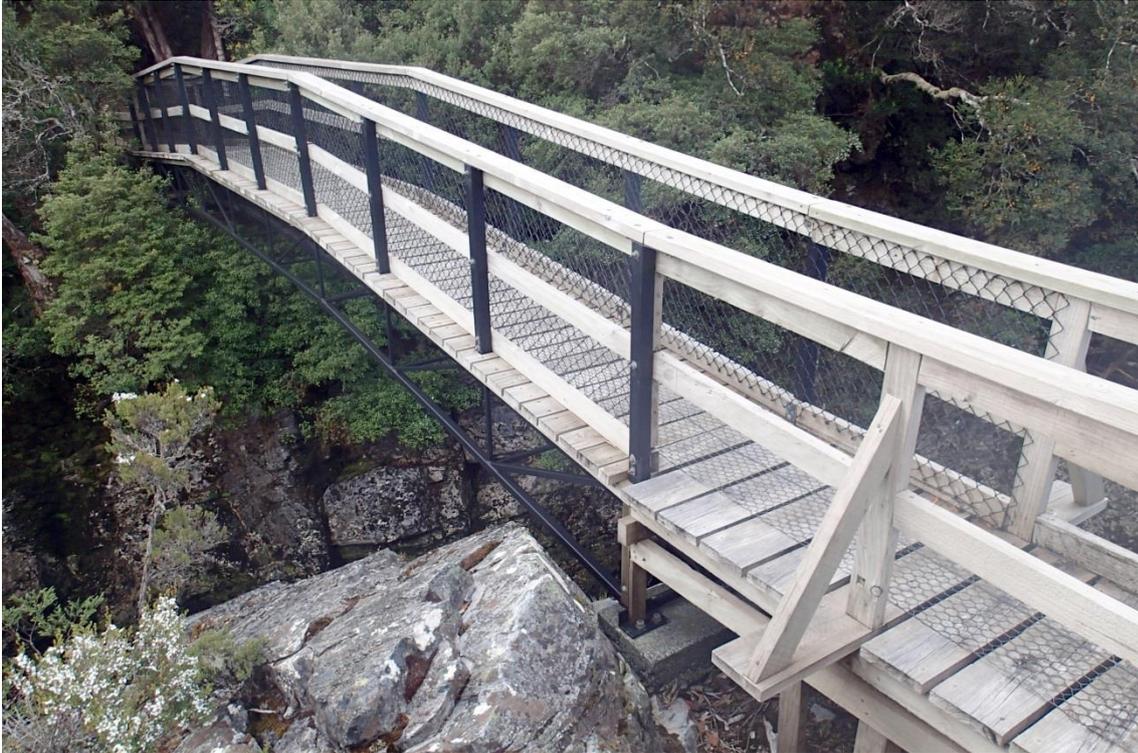
**RHS Splitting Example 3a - Bridge at very cold location with significant fall height
Localised splitting was detected in the lower chord of this structure.**

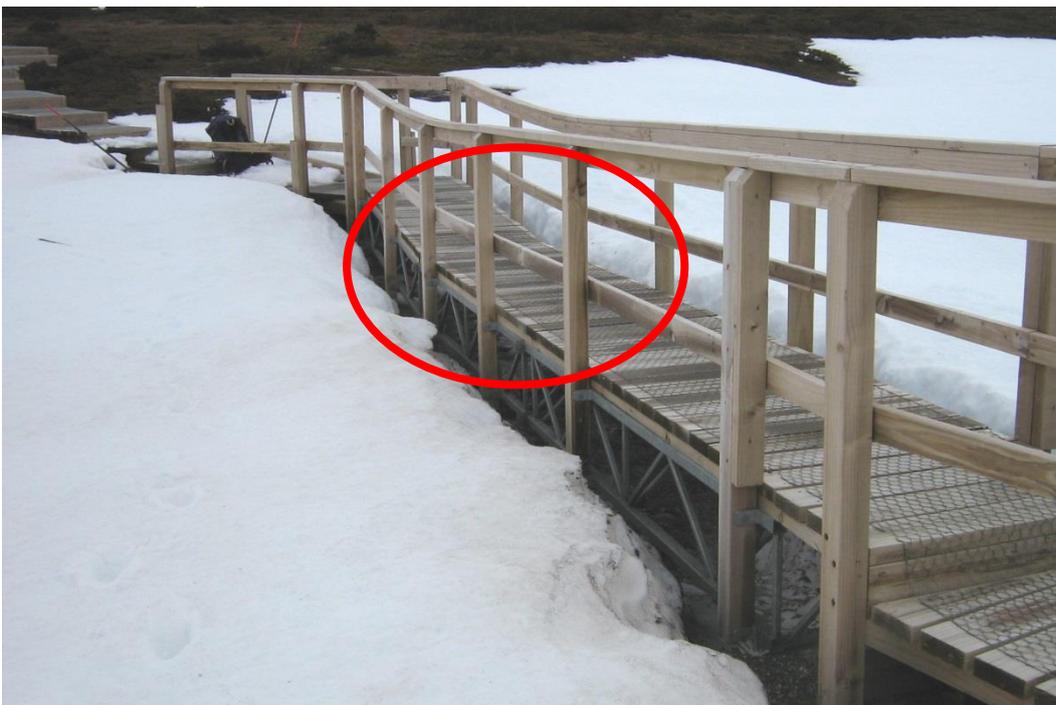
Spring thaw: a problem was revealed

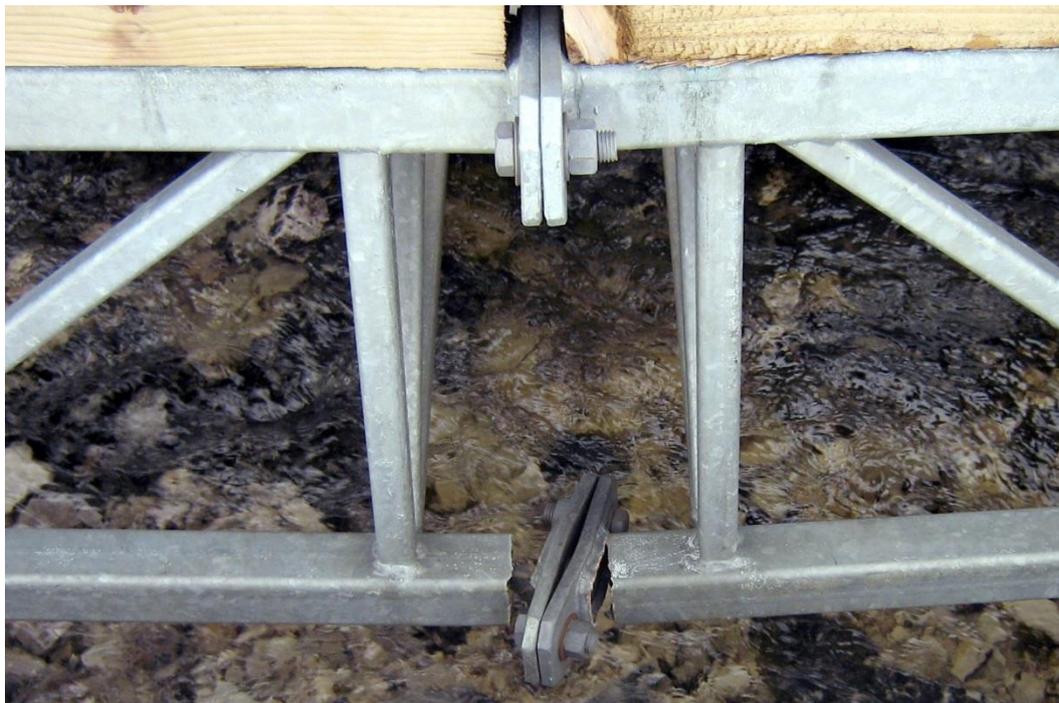
Tension failure of the module connections (upstream side)

It is estimated that the snow load on this structure was about 10kPa, well above the design live load of 4kPa. Irrespective of this, the failure mode was interesting and there were a number of contributing factors:

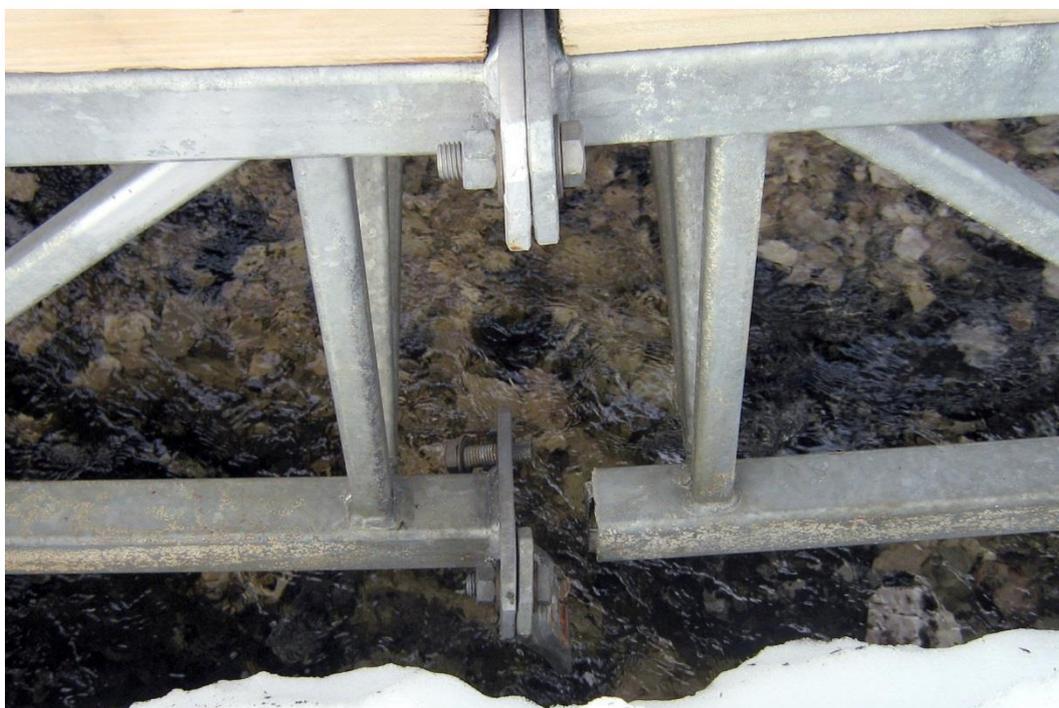
Interestingly, the downstream side failed in a different mode

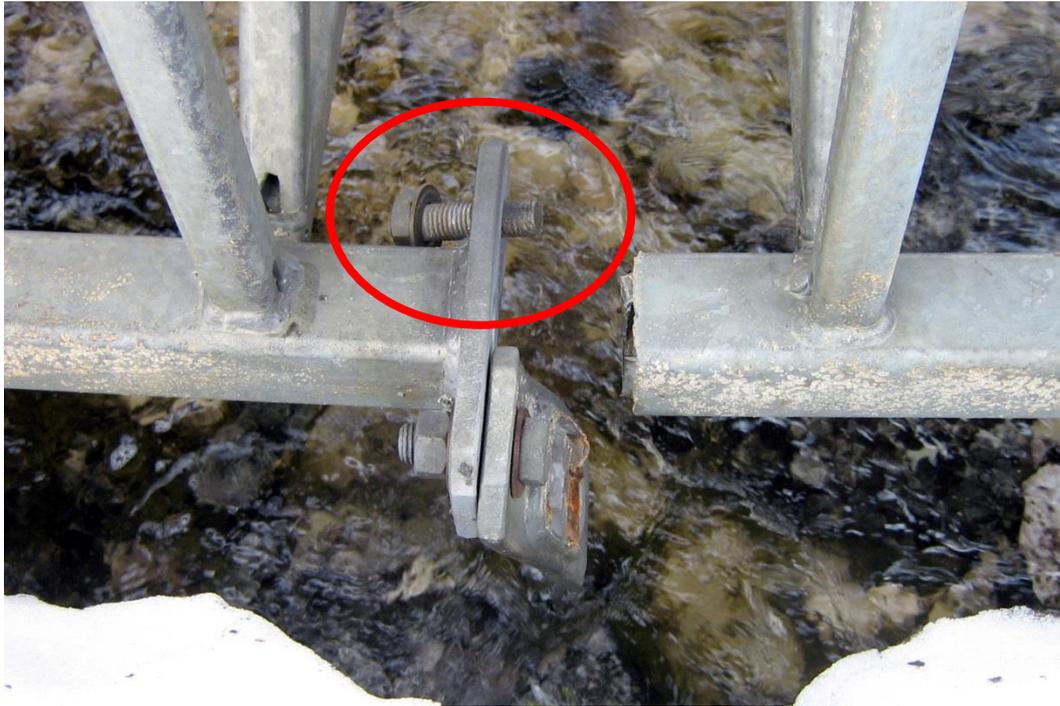
Failure initiated by thread stripping of an M16 bolt

It is thought that the failure was initiated by thread stripping on the inner M16 tension bolt on the downstream side. This resulted in an eccentric load on the connection plate and a “peeling” failure of the corresponding weld. High loads were then transferred to the upstream side of the structure, where the tension connection failed in a more conventional manner, in tension at the connection plate welds.

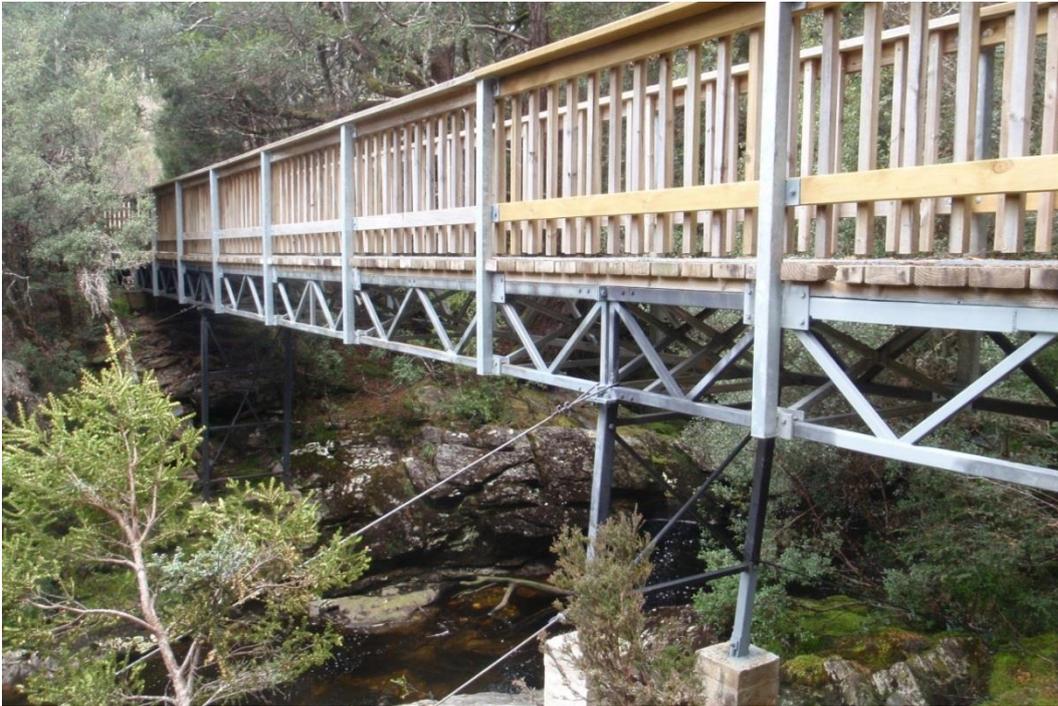
The previous steel and timber bridge was built in 1995 from welded Duragal SHS. Extensive freeze/thaw splitting was discovered in the truss diagonals in 2014 and this issue, combined with a number of other deficiencies, resulted in a recommendation to replace the structure after only 20 years in service. The new structure was an 18m span, walk-through truss, deck width 1.4m. The project was completed for about \$80,000 and the materials from the previous structure were reused or recycled.

Original steel and timber structure, prior to demolition

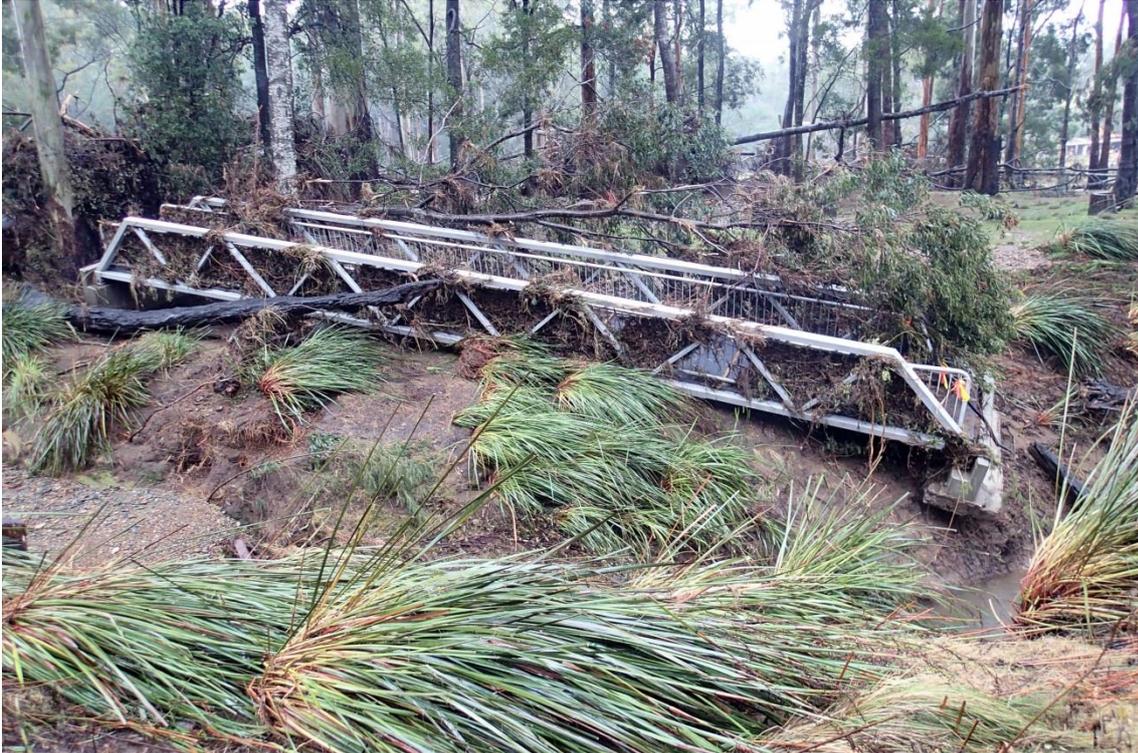
6 June 2016 (5 days later): Northern Tasmania is impacted by a major flood event, with measured rainfall in this catchment indicating at least 100 ARI. The structure was swept about 20m downstream from its original location, still attached to the footings.

Although only spanning a minor channel, this site was located close to the Mersey River, a major catchment system. This site was well known to be flood susceptible and damage to infrastructure in the area had occurred several times over the last 20-30 years, though not to this extent. It was not practical to build flood immune structures for this type of event at the site and it was acknowledged that new parks infrastructure should be considered “sacrificial”, given that it was likely to be damaged in anything above, say a 20 year ARI event. Despite this, no one would have believed the new structure would only survive 5 days!

Footnote: Surprisingly, some months later when the structure was salvaged and examined in a workshop, only superficial damage to the balustrade was found. The structure was repaired and will be installed at a more suitable location. Most of the infrastructure at the original site will not be replaced.

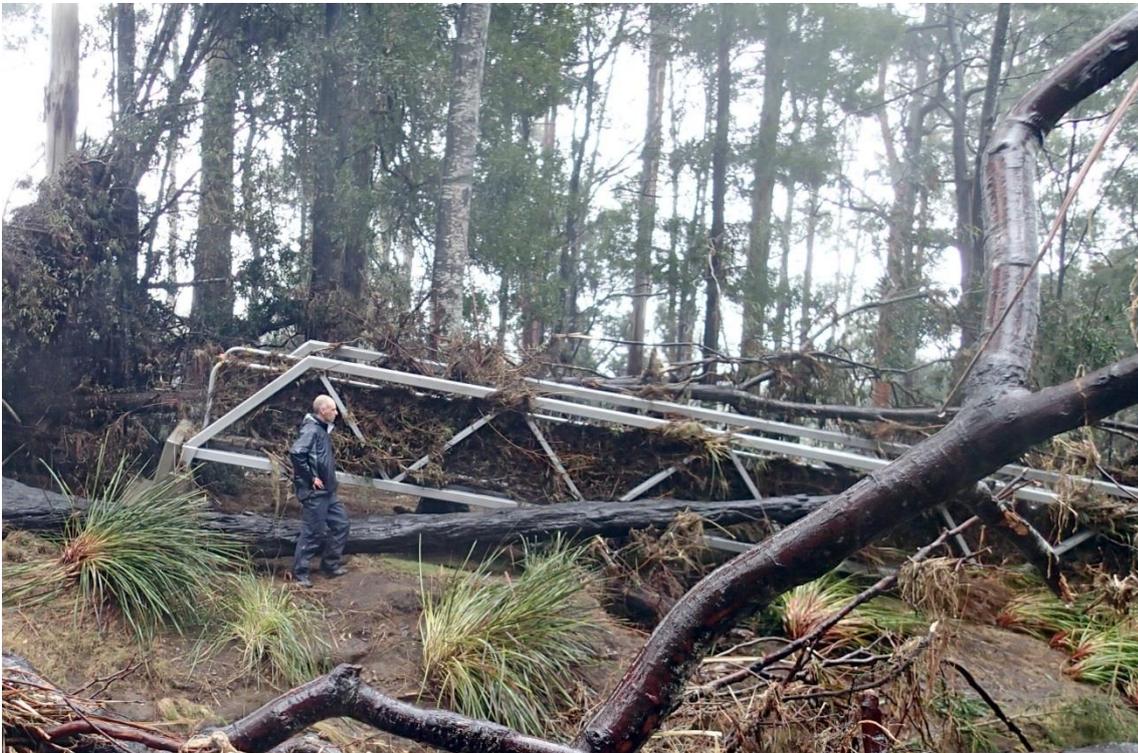
Nearly all infrastructure at the site was destroyed, including the access road. Suburban areas in the nearby town of Latrobe were also inundated.

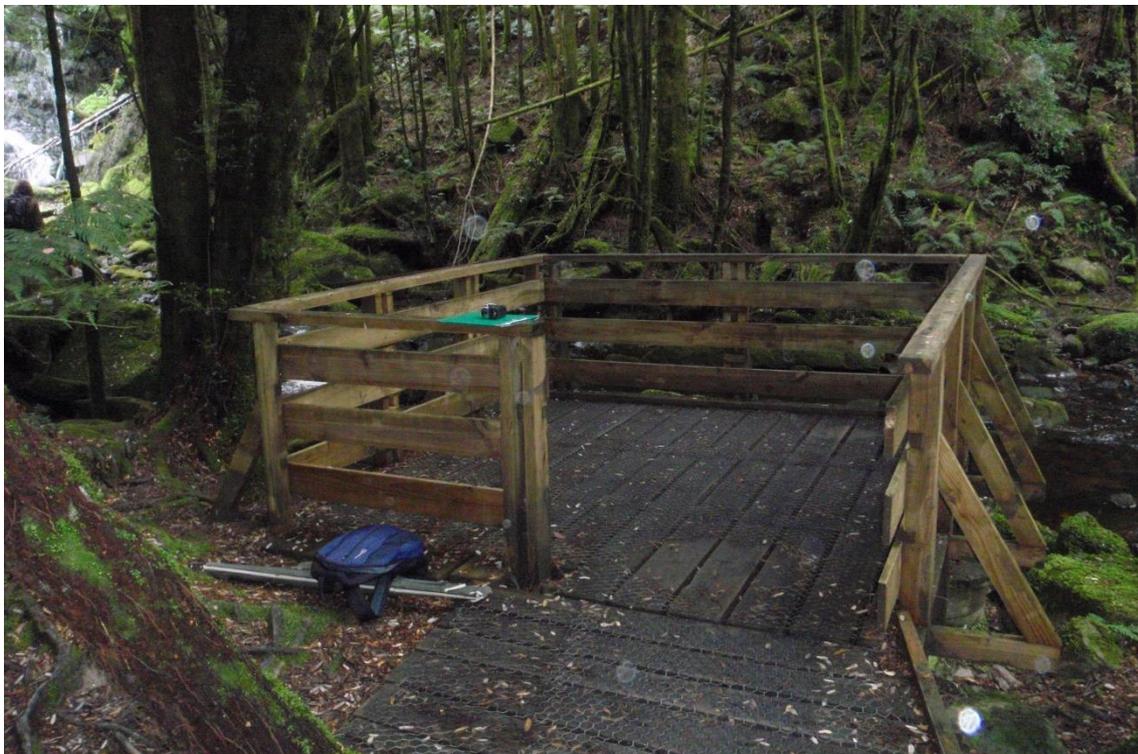
In 2010 it was found during routine inspections that many of the piers were undermined by scour and that there was extensive decay in the substructure. Given that the structure had only survived about 20 years in service, a decision was made to replace the platform with a larger structure, using more durable materials.

The original treated pine structure

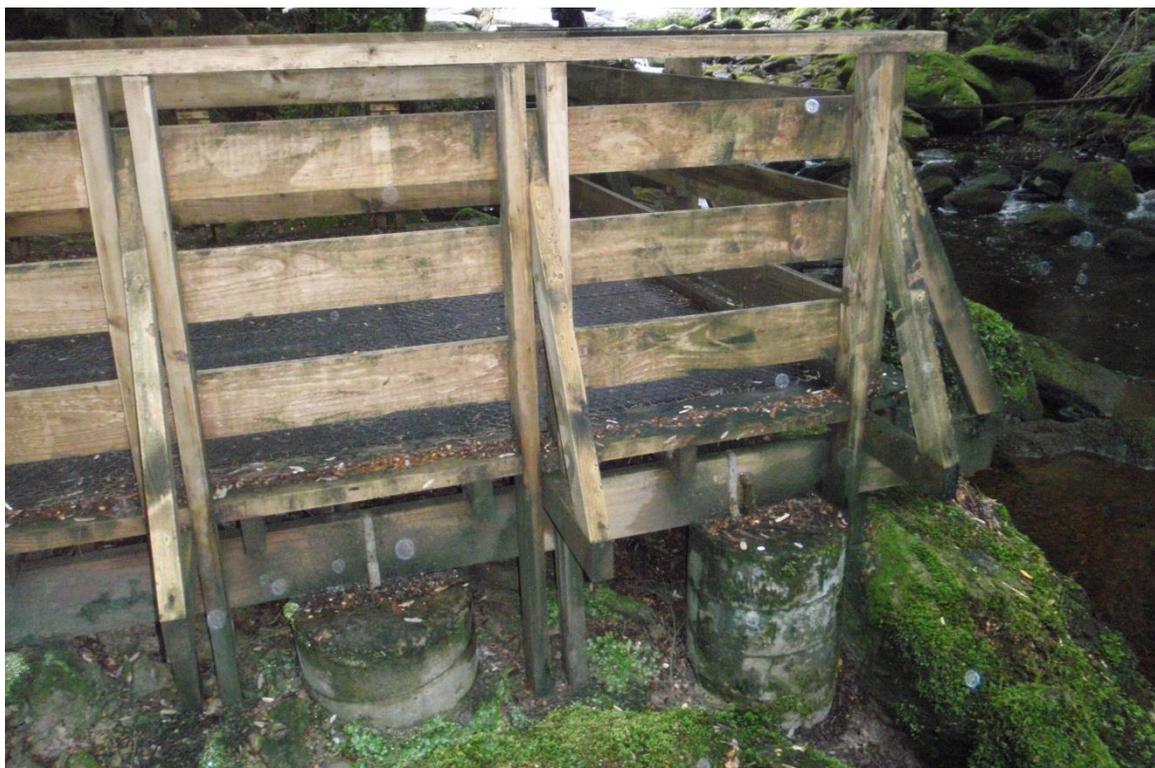
Side view of the original structure, showing low standard construction
