## Demolition of the Angellala Creek Bridges

Shane Crawford, Principal Engineer, RoadTek, Department of Transport and Main Roads

On Friday 5 September 2014 a truck carrying ammonium nitrate rolled and exploded, destroying the road bridge carrying the Mitchell Highway over Angellala Creek, approximately 30 kilometres south of Charleville. The adjacent railway bridge also sustained significant damage in the blast.

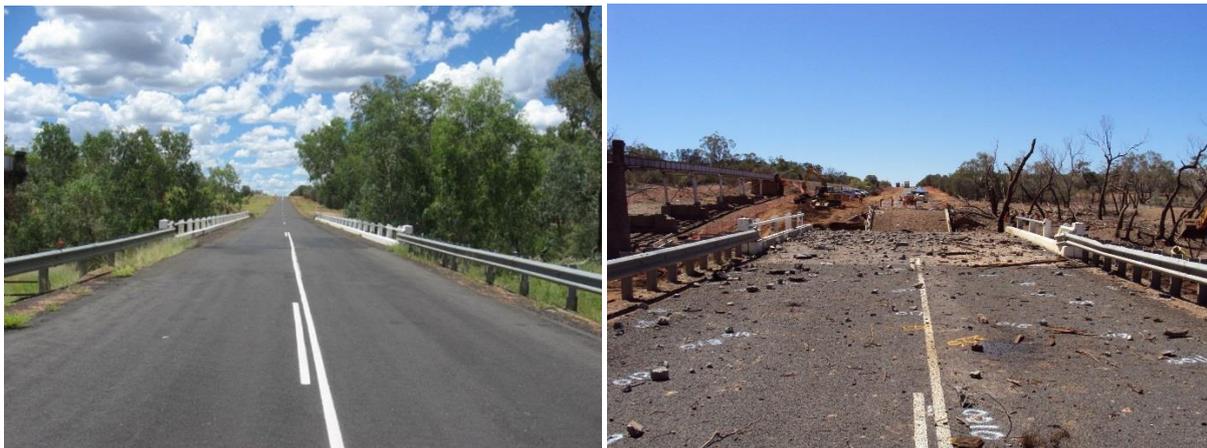
Early reports indicated that the road bridge was completely destroyed and that the adjacent railway bridge had sustained considerable damage to the steel spans. The site was immediately closed, and a 500 metre exclusion zone was put in place by the Queensland Police Service and representatives from the Explosives Inspectorate division of the Department of Natural Resources and Mines (DNRM), due to the possibility of residual ammonium nitrate being present at the site.

**Figure 2 – Angellala Creek Crossing – January 2012 (left) and September 2014 (right)**

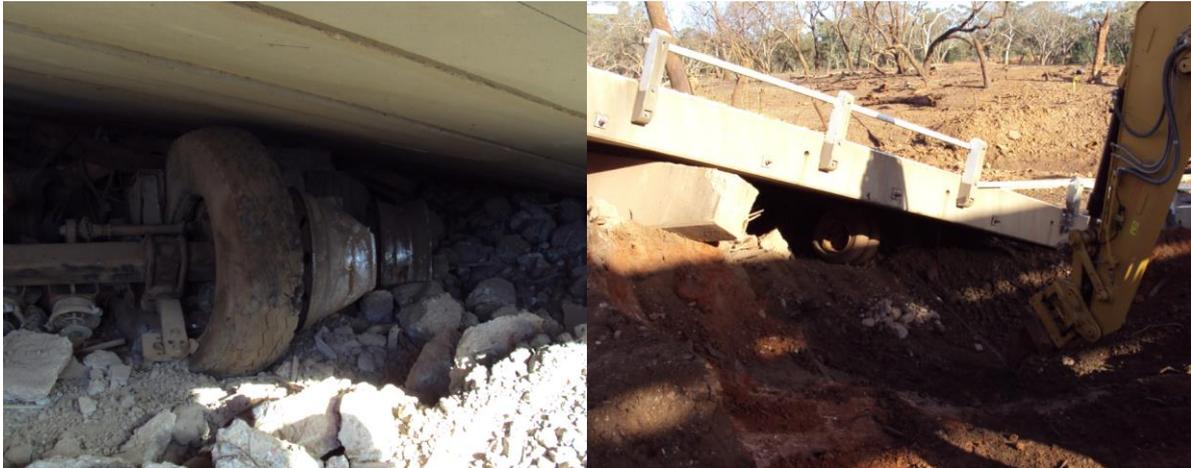
**Figures 3 and 4 – The attempted recovery of trailer components that were pinned under the road bridge**

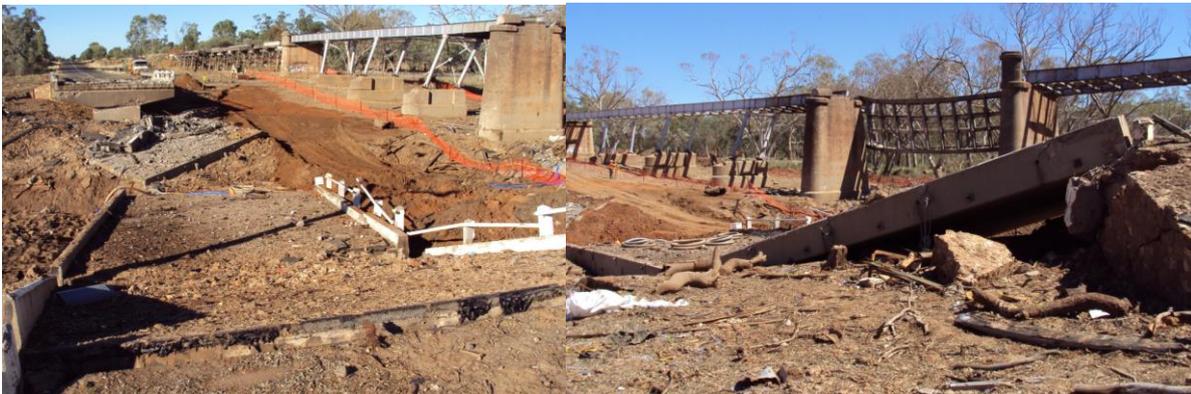
The engineering assessment of the structures concluded that the remaining components of the road bridge should be demolished and the site cleared of debris, to facilitate the construction of a new structure on the same alignment of the existing bridge. It was also noted that the steel spans and cast iron columns of the rail bridge were dangerously unstable. To continue the remainder of the inspection safely, it was suggested that these components be brought down to ground level, to determine appropriate management actions.

**Figures 5 and 6 – Extent of the damage to the road and rail bridge structures**

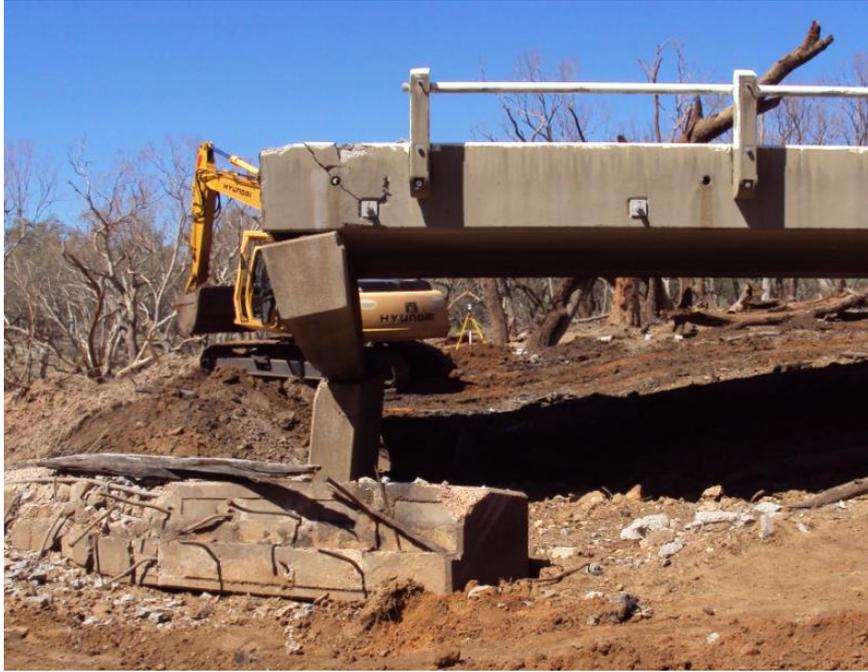
1. The potential for residual amounts of ammonium nitrate to be present on site at locations inaccessible during the initial investigation by the Explosives Inspectorate officers, due to the position of the partially-fallen bridge decks at spans 2 and 5. While relatively stable in its solid form, concern was raised that inadvertent exposure to flame may potentially result in the ignition of any residual ammonium nitrate.
2. Spans 1 and 5 of the structure were partially supported by the remains of the bridge substructure. Span 1 in particular was supported at the northern end by a pier which had been significantly damaged in the blast (Figure 8), rendering the span highly unstable.

**Figure 8 – Damaged pier supporting Span 1**

- Once the site had been declared clear of residual ammonium nitrate, the exclusion zone would be relaxed and the remainder of the suspended concrete components would be brought to the ground in a similar fashion to the processes described above. The damaged pier supporting Span 1 had the headstock pulled over by two excavators (Figures 9 and 10), and the concrete blade column broken back with the excavator-mounted hammer until the northern end of Span 1 had been lowered to ground level.

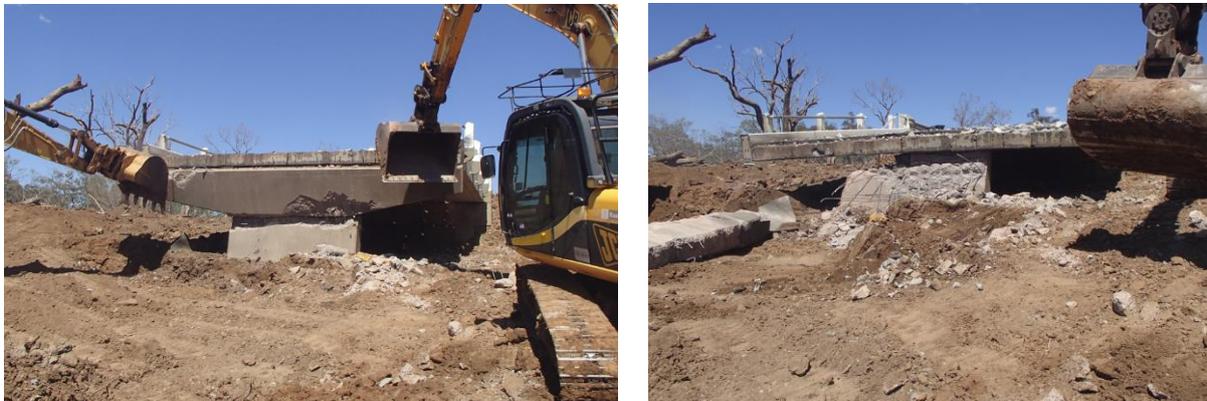
**Figures 9 and 10 – Damaged pier being removed from under Span 1**

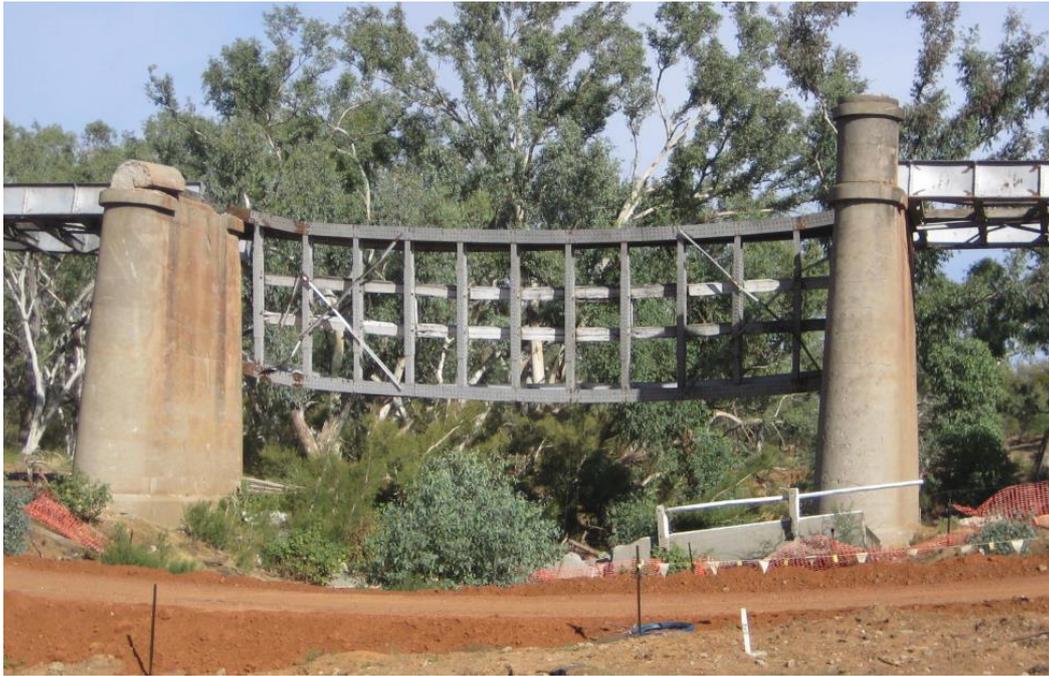
- The northern portion of the bridge comprised of 11 steel ‘half-through’ girder spans, with the main span seated on large concrete pier walls. The remaining spans were supported by cast iron columns seated on concrete plinths. The main span of the bridge had been completely pushed off the concrete piers, and was hanging suspended from the western side of the bridge. The adjacent steel spans and cast iron columns either side of the main span had been pushed sideways to varying degrees based on their proximity to the main span. The spans immediately adjacent to the main span appeared to have moved sideways approximately 2-3 metres, while the spans most distant from the main span showed little or no signs of transverse movement (Figures 12 and 13). The deck spans and cast iron columns were to be brought down to ground level and relocated out of the waterway so as not to obstruct the flow of the creek.

**Figure 12 – View of the main steel span - Angellala Creek Rail Bridge**

1. The main span was suspended from the top of the concrete piers on the downstream side of the bridge at a height of approximately 10 metres. The ends of the span appeared to be caught against the steel rail; however, it was difficult

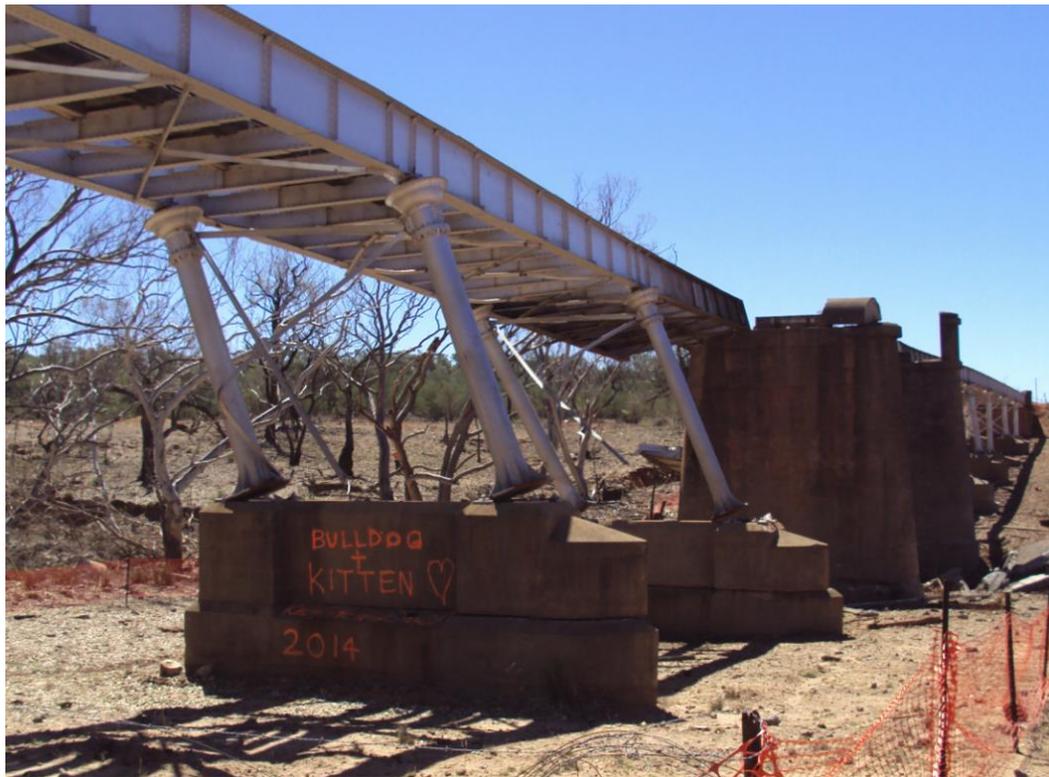
**Figure 13 – View of the displaced approach spans - Angellala Creek Rail Bridge**

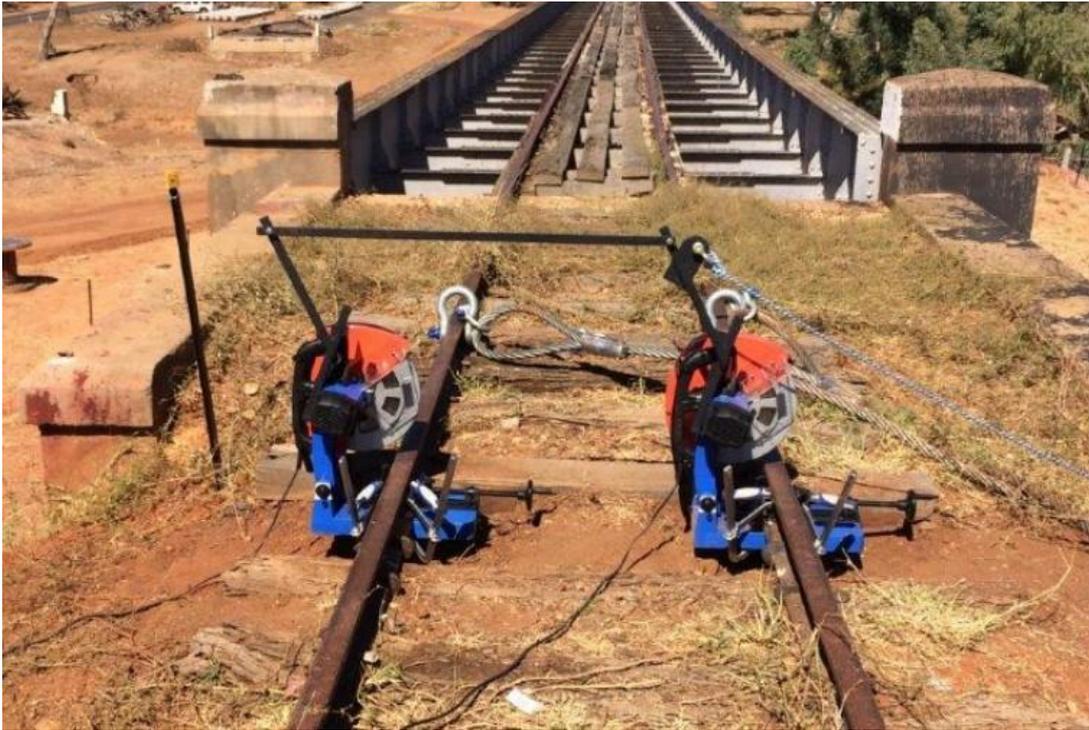
**Figure 14 – The modified drop saws used to sever the rails at the bridge abutment**

The solution, developed by the RoadTek demolition supervisor in conjunction with the local RoadTek workshop in Roma, was to purchase and modify two drop saws to allow them to be operated from a safe distance with levers and a thin steel cable (Figure 14). The concept was tested in the workshop and successfully used on site to separate the rails at the bridge abutments to allow for removal of the rails from the bridge deck.

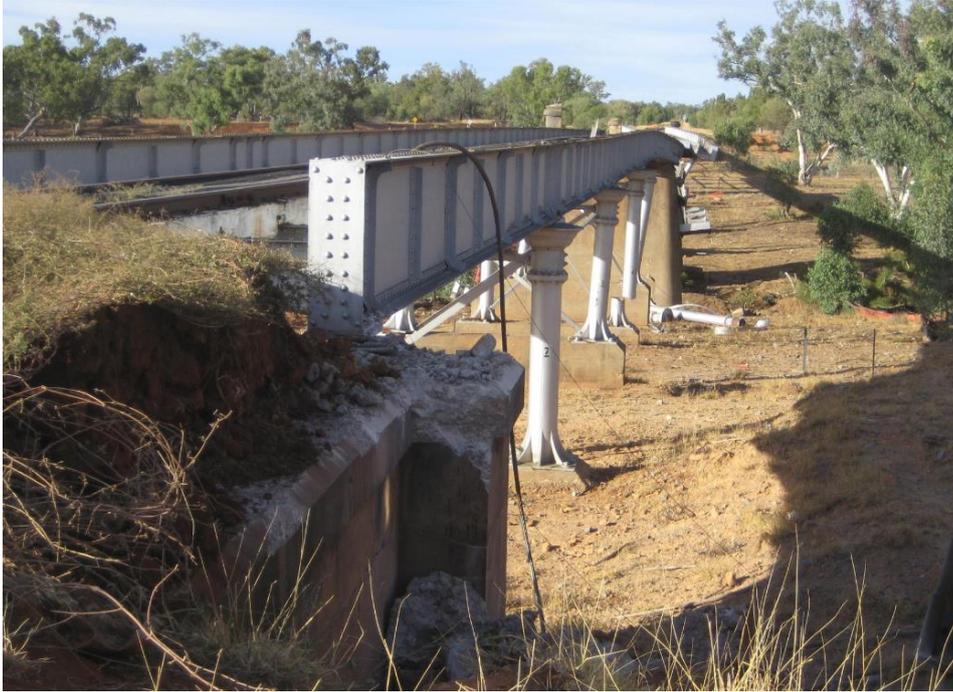
**Figure 15 – Removal of the abutment keeper wall**

- Once this was completed, the concrete keeper walls on the piers and abutments were pulled down with an excavator, to ensure that they would not act as a barrier to prevent the movement of the deck spans (Figure 15).

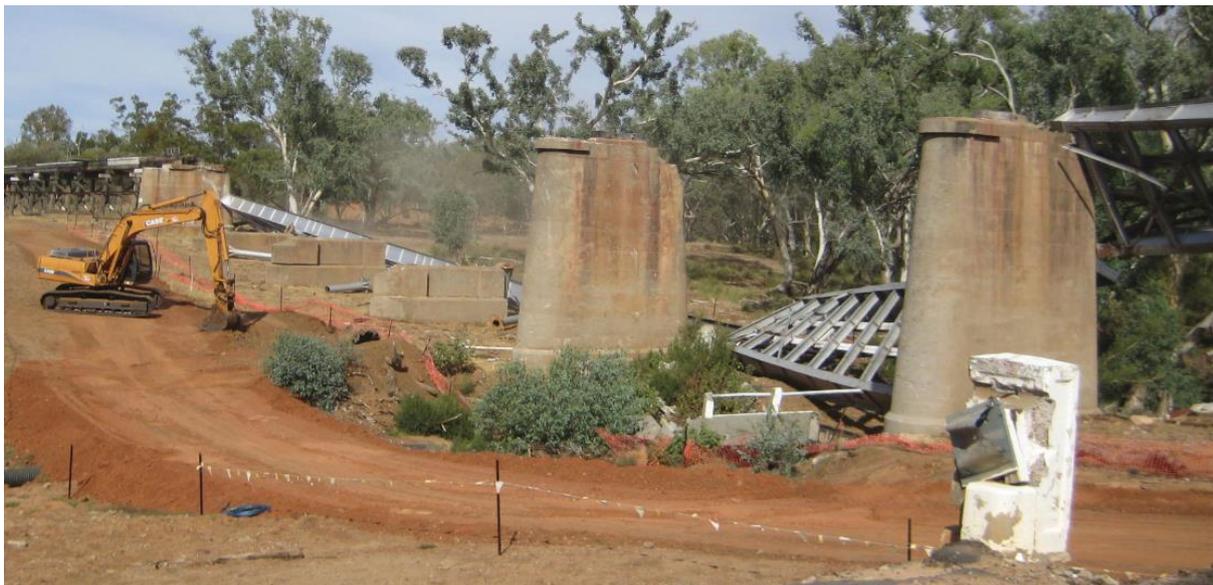
**Figure 16 – Demolition of the southern approach spans**

Ultimately, the excavator did successfully dislodge the deck spans and the steel cables were not required (Figure 16). Once dislodged, the spans were pulled sideways by the dozer until they were fully resting on the ground. They were then cut into smaller segments using oxy-acetylene torches and towed out of the waterway using the dozer and the Kevlar recovery lines. The cast iron columns were brought down with the excavator, a number of which were later used in a memorial erected at the site of the new structure (Figure 17)
