## SMALL BRIDGES CONFERENCE 2015

### TOPIC TITLE: Repair/Strengthening of a Six Span Timber Rail Bridge

Anstice, D.J., GHD, 145 Ann Street, Brisbane, QLD 4000, e: [daniel.anstice@ghd.com](mailto:daniel.anstice@ghd.com)

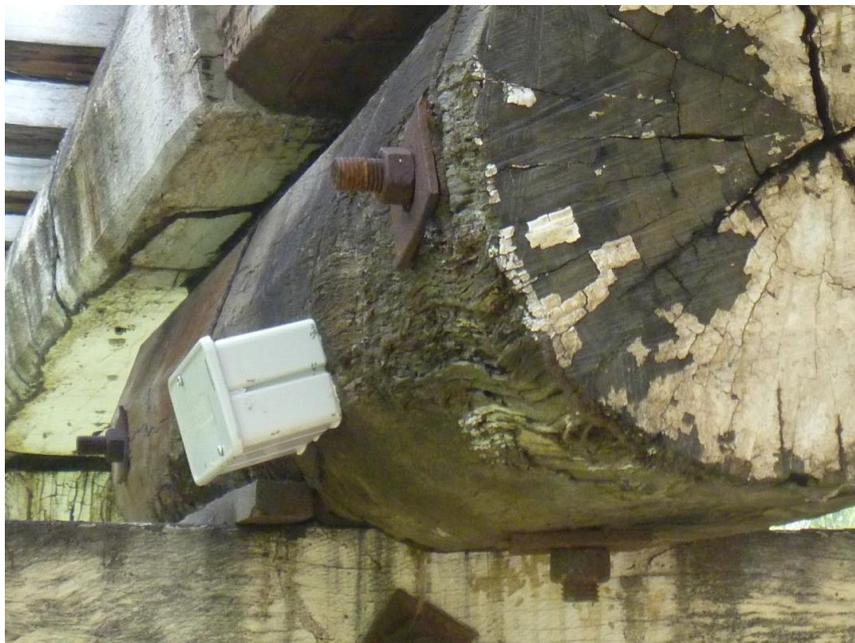
A subterranean termite visual inspection and management report<sup>11</sup>, carried out by Rentokil in September 2013, stated that termite damage was present at the sleepers, piers and loose timbers at the bridge. A potential nest was also located near to the bridge. The activity was believed to be due to subterranean termites, *Nasutitermes Walkeri*. Such termite activity was considered low threat as *Nasutitermes Walkeri* are considered to usually cause only slight damage and thus normally not structural damage. The activity had reportedly been treated with a baiting system (Figure 6) and the potential nest eradicated, with quarterly monitoring recommended. The timber baiting and monitoring system maintenance service report carried out in January 2014<sup>12</sup> noted that there was nil activity at the bridge at the time of the maintenance inspection.

Figure 6 – Termite Bait Box

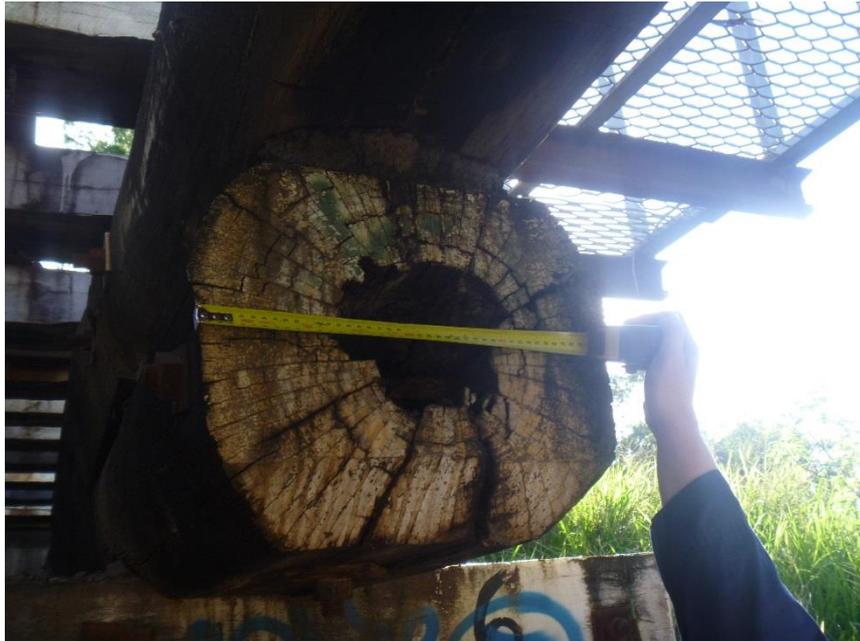
GHD carried out a visual inspection with limited timber drillings and trial pits in February 2014. GHD reported<sup>13</sup> that the bridge overall is in a poor condition due to defects affecting its durability. The most significant issues were the piping of several corbels (Figure 7) and girders and the necking and splitting of some of the piles (Figure 8).

**Figure 7 – Piped Corbel**

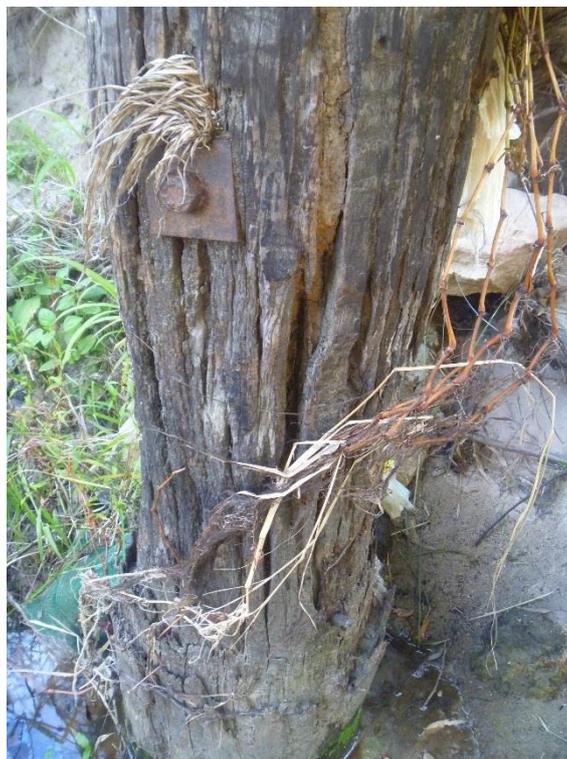
**Figure 8 – Deteriorated Pile**

A total of 57 timber drillings were conducted on accessible locations and these discovered several pipes and soft areas within elements. Trial pit excavation was undertaken using hand tools at two piles and these concluded that there was no noticeable difference in the degree of deterioration below the ground surface at these pile locations.

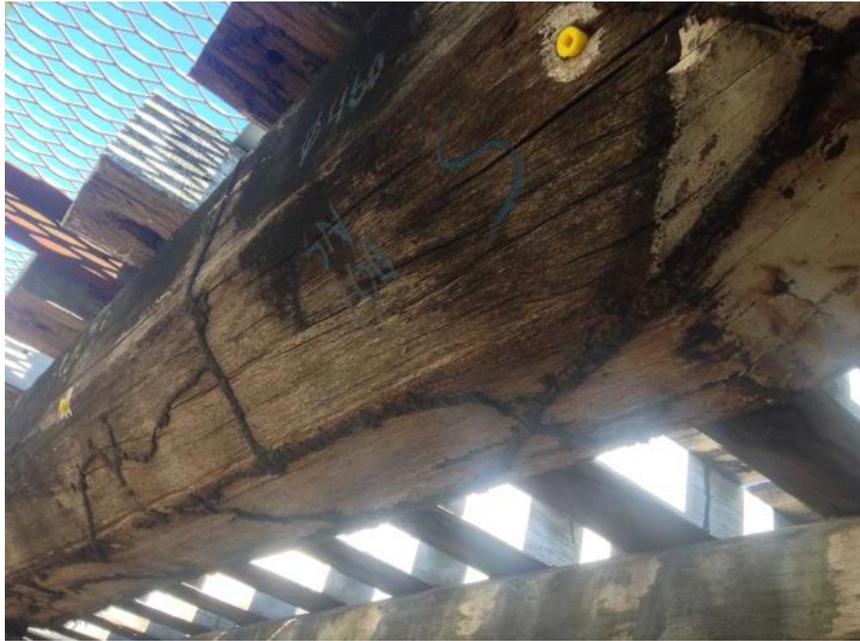
There was evidence of subterranean termite activity throughout (Figure 10), causing severe structural damage to the majority of timber components. Although previous inspections indicated a termite genus of *Nasutitermes*, the findings of this inspection indicated that the termites are more likely *Coptotermes Acinaciformis*, which are arguably considered to be the most destructive termites in Australia. It was therefore highly recommended that invasive termite treatment be undertaken to eliminate further termite damage to the structure. It was recommended that the termite activity should then be monitored after treatment, with chemical injection re-applied if necessary.

**Figure 10 - Termite Tunnelling and Mudding at Girder**

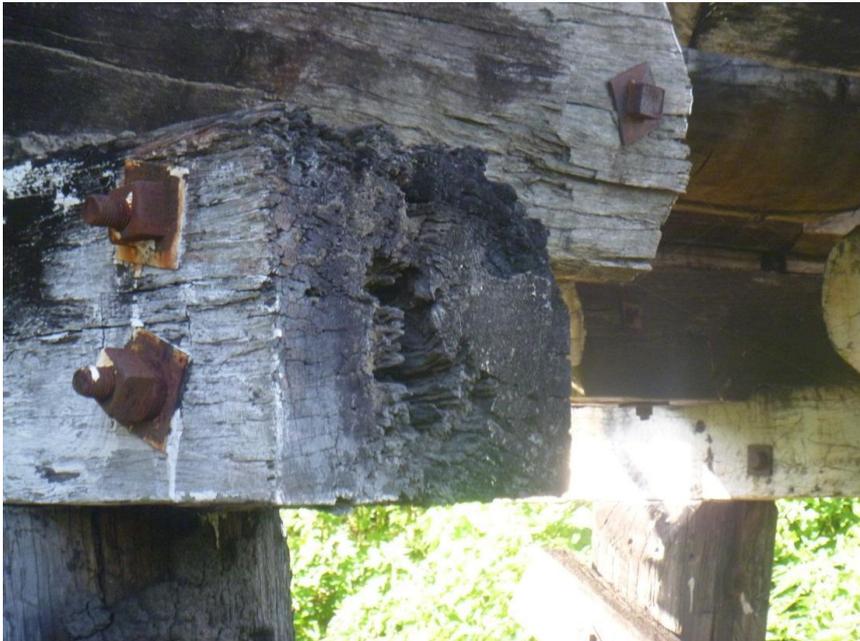
It was reported that there was severe fungal decay throughout the majority of the bridge elements, evidenced by the surface of the girders, corbels, headstocks and piles being white and fibrous (a characteristic of White Rot, Figure 11). White Rot significantly reduces the mechanical strength properties of the timber. It was recommended that all timber components be treated with an anti-rot product to prevent further fungal attack.

**Figure 11 – Piping and White Rot at End of Headstock**

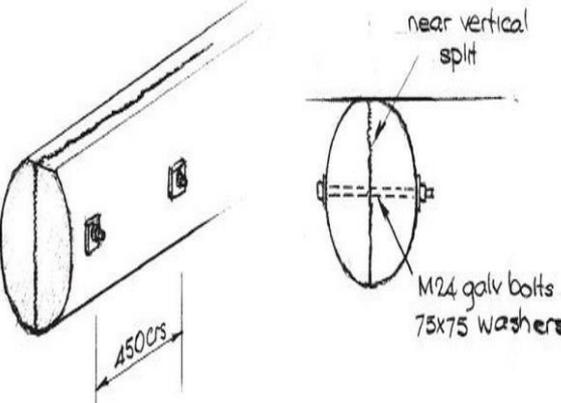
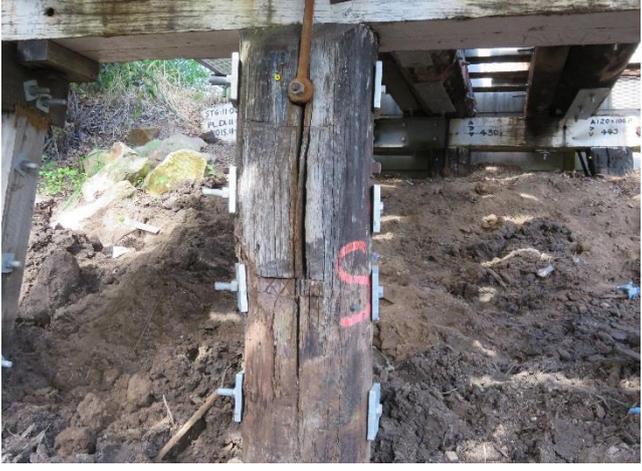
<p>near vertical split</p> <p>M24 galv bolts 75x75 washers</p> <p>4500s</p>

3 no. piles, 2 no. corbels had anti-splitting bolts applied (22T1)

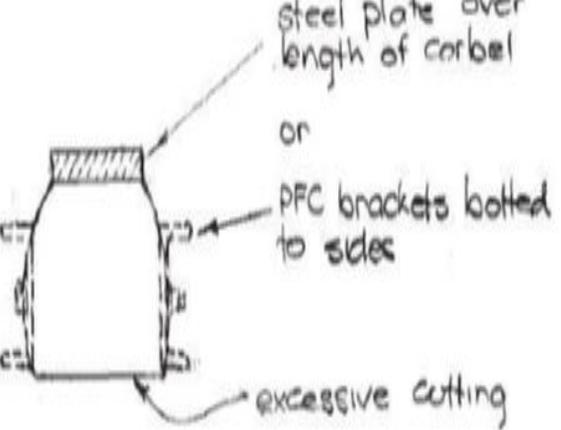
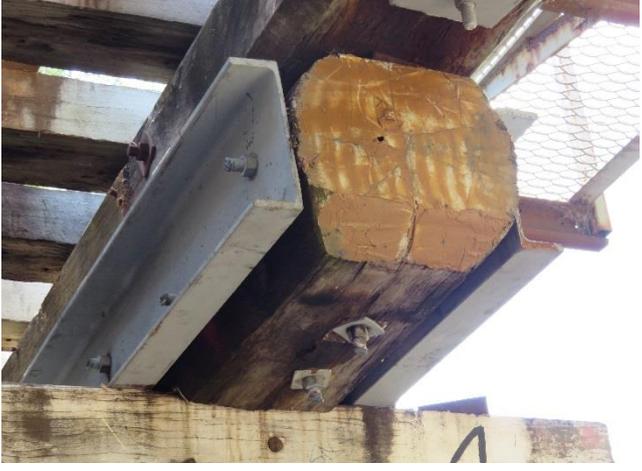
<p>steel plate over length of corbel</p> <p>or PFC brackets bolted to sides</p> <p>excessive cutting</p>

2 no. over-sniped and piped corbels strengthened (27T1)
