Extending the life of a coastal bridge affected by chlorides and ASR

Alan Bird⁽¹⁾ and Christopher M Dowding⁽²⁾

(1) Marine & Civil Maintenance Pty Ltd, NSW Australia

(2) TOD Consulting Pty Ltd, QLD, Australia,

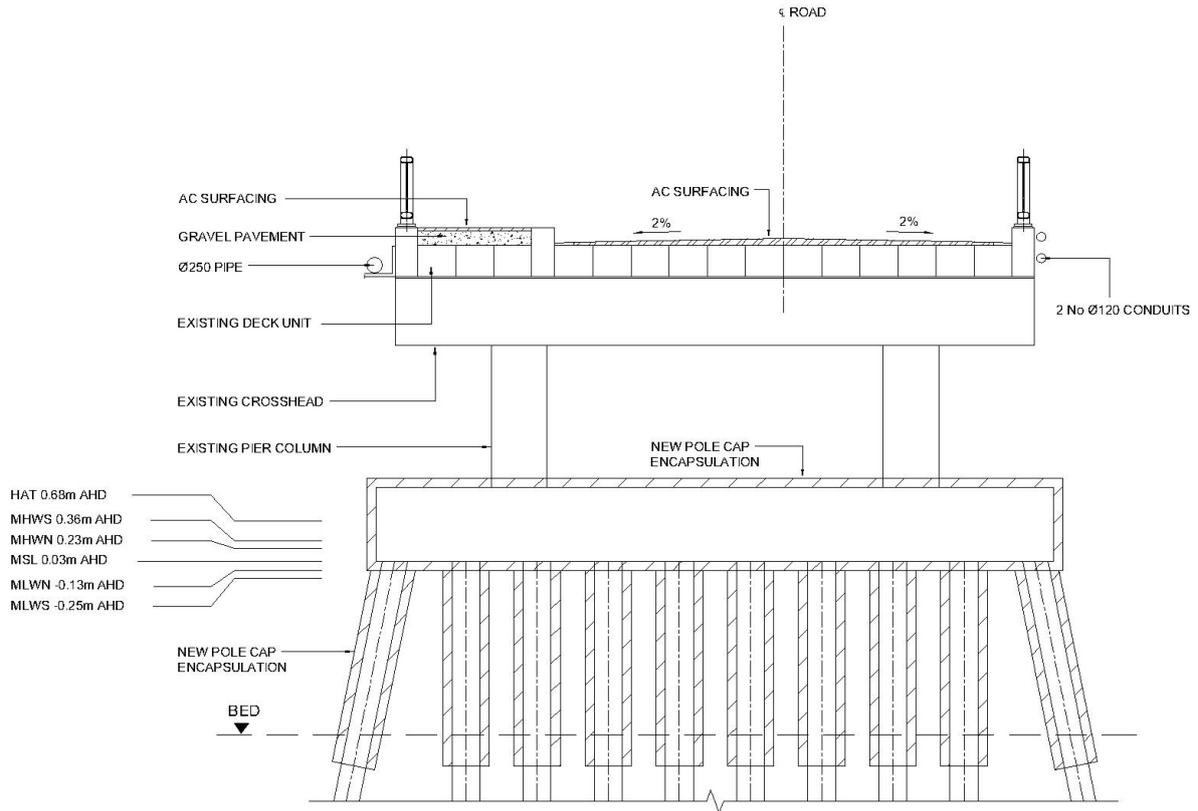
FIGURE 1 - TYPICAL PIER CROSS SECTION

The investigations concluded that ASR has affected the concrete piles underwater, with many cracks but no corrosion damage evident in the reinforcing steel when exposed. It was also considered that ASR would significantly affect the pile caps through the design life.

Corrosion activity was found to be predominantly in the pile caps, the surfaces of which were delaminated significantly in the sides and ends. The columns, headstocks and precast deck units were found to be in adequate condition generally, although some isolated delaminations were noted and the transverse stress-bar tie rod anchor plates were severely corroded.

- Install a reinforced concrete encasement around all pile caps, in order to resist the effects of ASR and repair any spalling and delamination that was present
- Install a reinforced concrete jacket around all piles from pile cap down to below bed level, in order to contain the effects of ASR

Impressed-current cathodic protection (ICCP), consisting of ribbon anodes cast into the new concrete encasement, was proposed for the tops and sides of all pile caps, with the potential for extension into the columns if required.

These concept designs are shown in Figures 1 and 2.

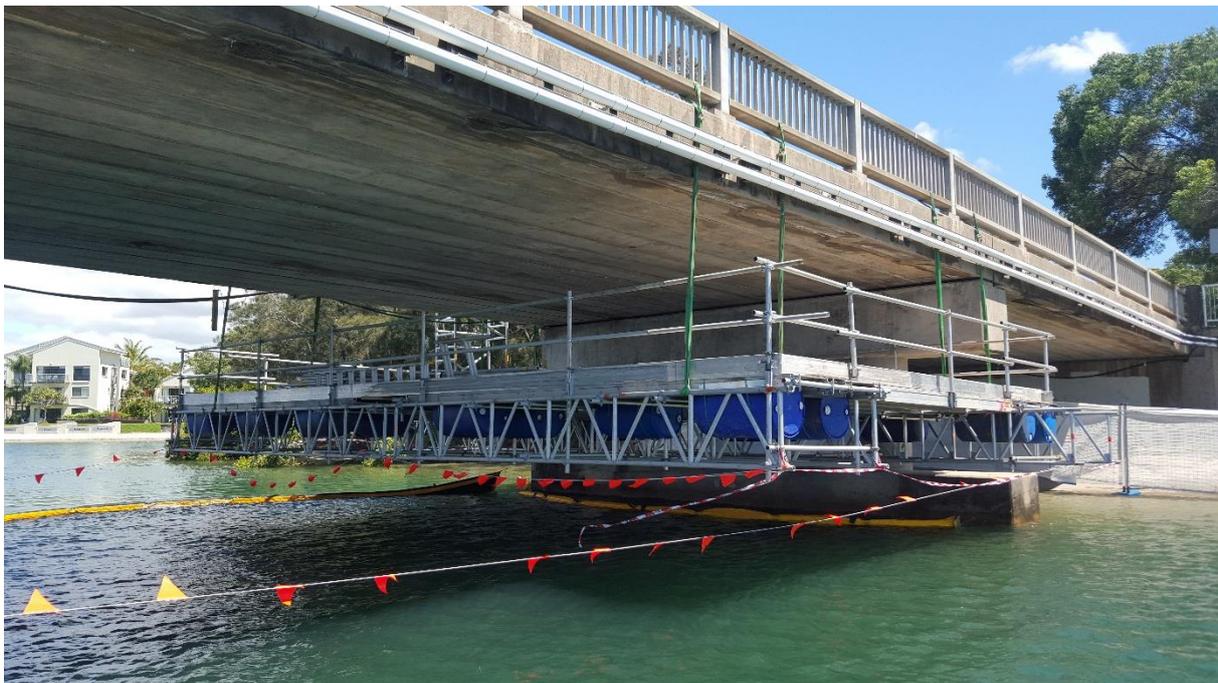
Photograph 1: Floating Access to Deck Soffits

Access to the span soffits for repairs and coating was provided by a floating platform which could be raised and lowered via webbing slings attached to the bridge crash barriers. This gave access to the full width of the bridge over half a span, and included an upstand section to provide access to the sides of the bridge. Moving the platform in the water from one end of a span to the other was done with the aid of a punt.

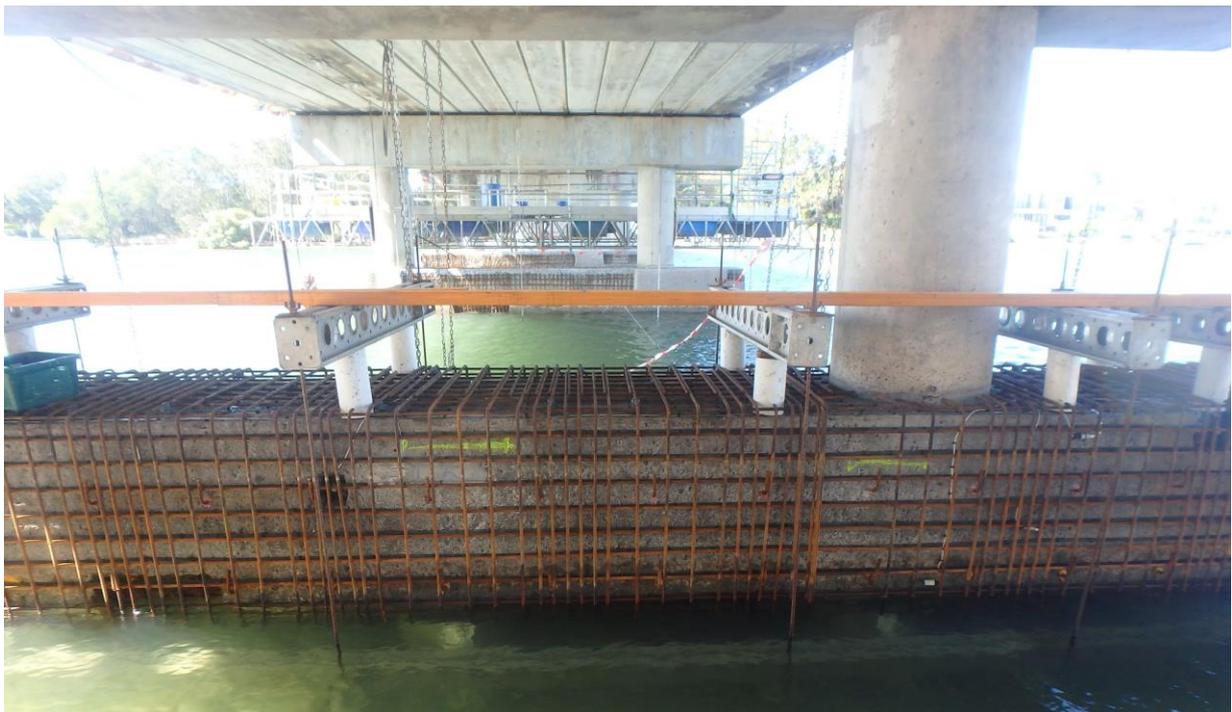
Detailed investigation showed that the pile caps were quite significantly damaged by corrosion of the reinforcement, though few bars required replacement. In all, some 88m² of concrete was found to be delaminated. The piers nearest the banks were the least damaged, while the middle two piers were delaminated over 49% and 58% of their top, side and end surfaces.

Photograph 2: Pile Cap Encapsulation under Construction

The pile caps were fully encapsulated in a 150mm thick reinforced concrete of 40MPa minimum strength. Because the bottom of the forms was always submerged, the same concrete mix used for the pile jackets was also used for the pile caps.

After removal of the damaged concrete by hydrodemolition, all bars with corrosion losses greater than the minimum acceptable were augmented with new reinforcement. As this generally applied only to the stirrups, new bars were either welded to the existing steel or were epoxied into holes drilled into the substrate.

New reinforcing steel was required in both directions and all around each pile cap. As the pile caps were rarely out of the water completely, the soffit bars had to be fixed underwater, which was further complicated by the ten raking piles on each soffit. The new steel was fixed after the ICCP anodes were fixed as described below, and immediately before the formwork.

For maximum efficiency, each pile cap was concreted in one pour, including backfilling of all defective concrete removed earlier. The forms were built from ply and timber, including the soffits. The side and soffit forms were supported by steel bars from transverse steel beams propped off the top surface of the existing concrete. The props were encased in pvc sleeves which were removed and grouted after completion of the pour.

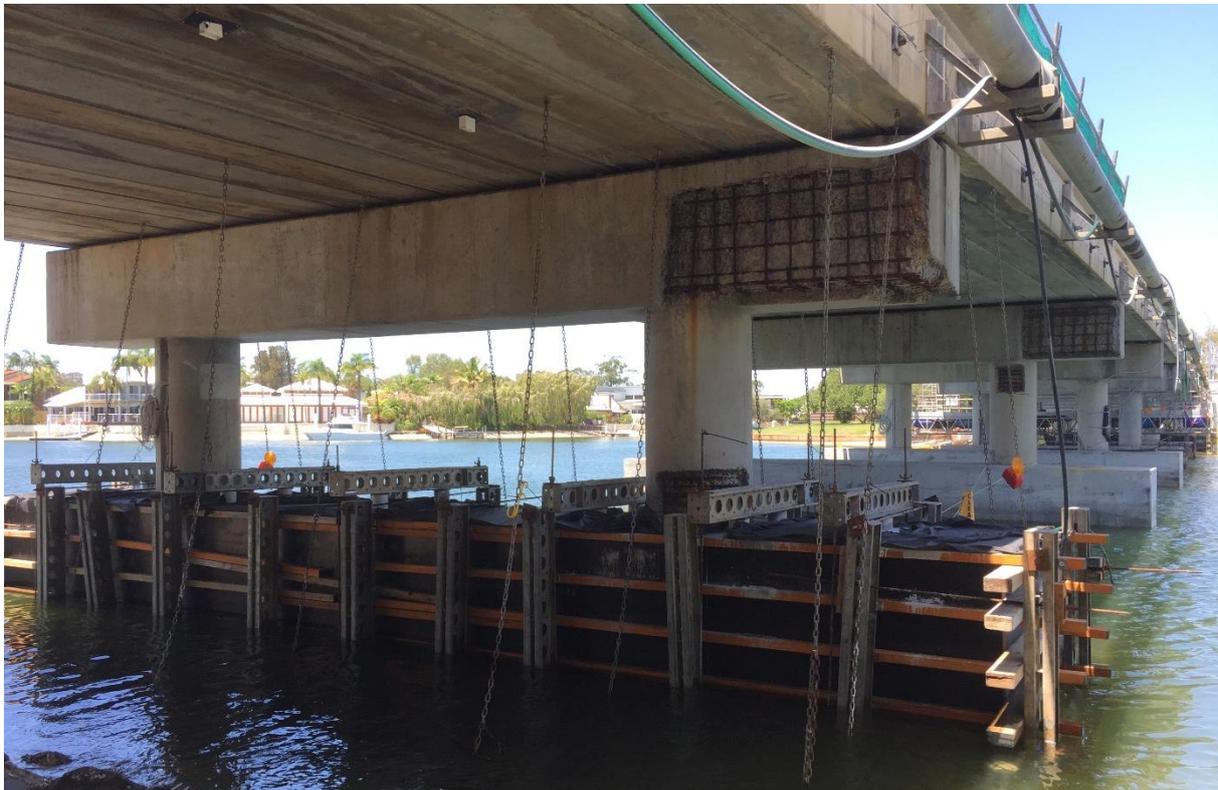
Photograph 3: Pile Cap Encapsulation & Headstock Repair

Isolated delaminations were found on some columns, headstocks and kerb units. These were repaired by breaking out the concrete to behind the corroding rebars, removing corrosion products from the bars and coating them with a zinc-rich primer. Sacrificial zinc anodes were fixed to the rebars around the perimeter of each repair and the patch was then backfilled with a polymer-modified repair mortar by hand rendering.

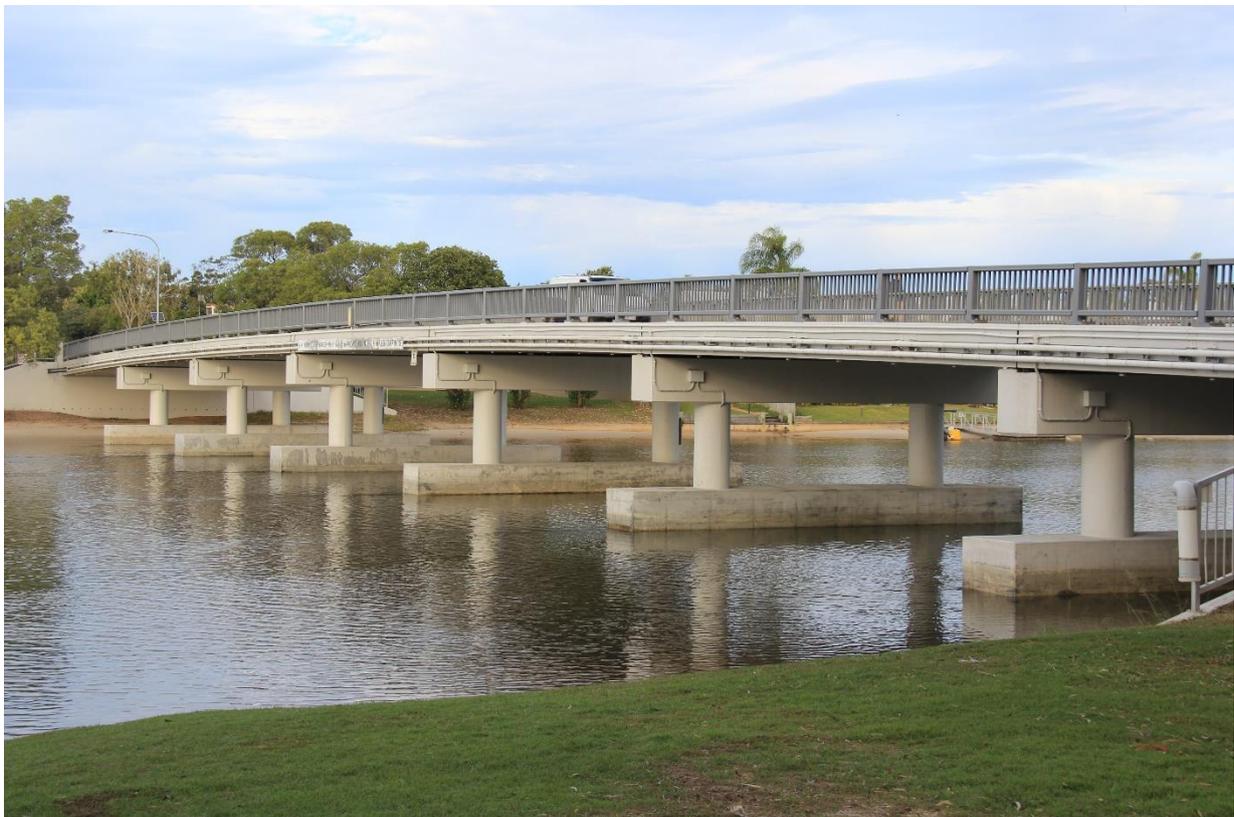
Photograph 4: Completed Project
