Performance of Protective Coatings on Small Steel Bridges Subject to Bushfires

William I K McLean, Peter J Golding, Ann M Sheehan. Galvanizers Association of Australia. Melbourne, Australia

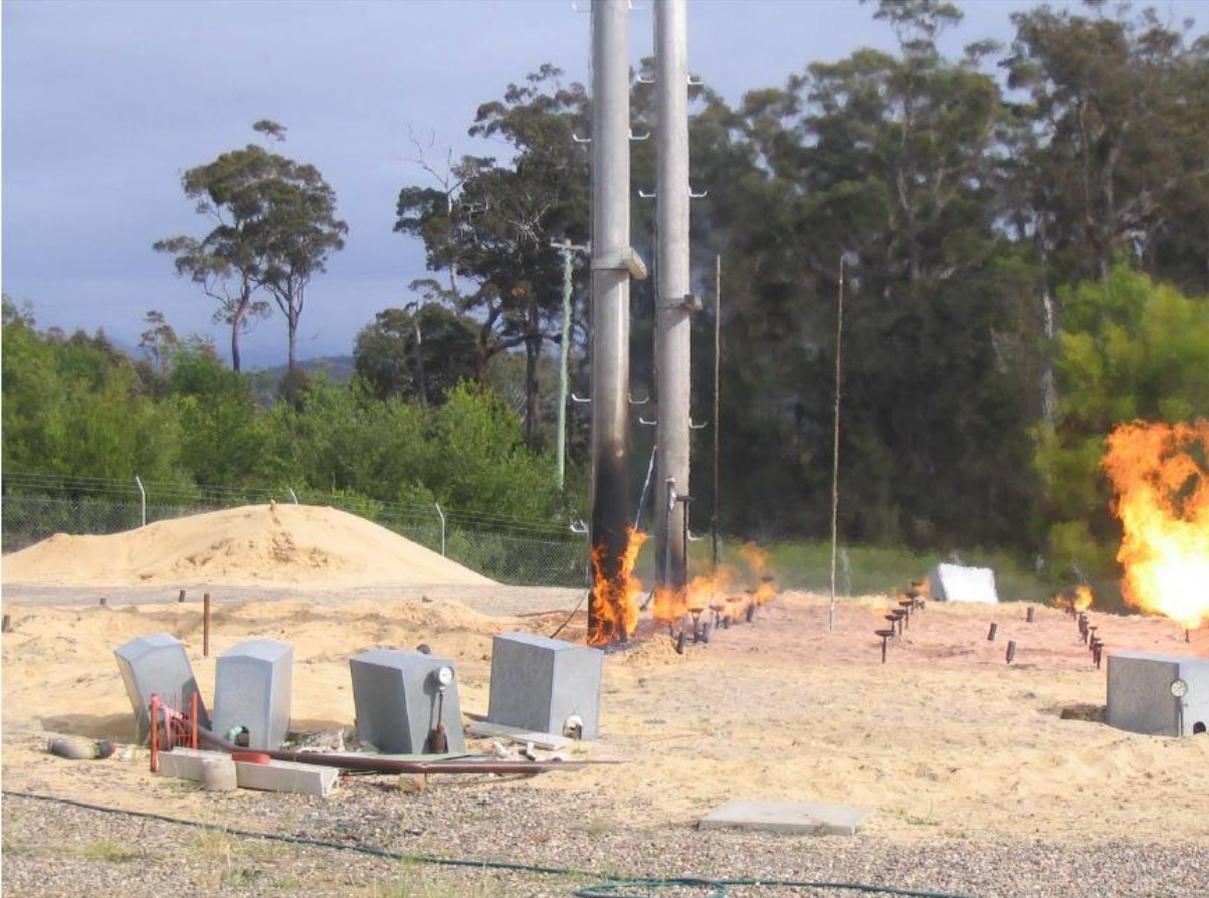
Figure 6. Appearance of galvanized coating after flame immersion testing with radiant burners still on (19).

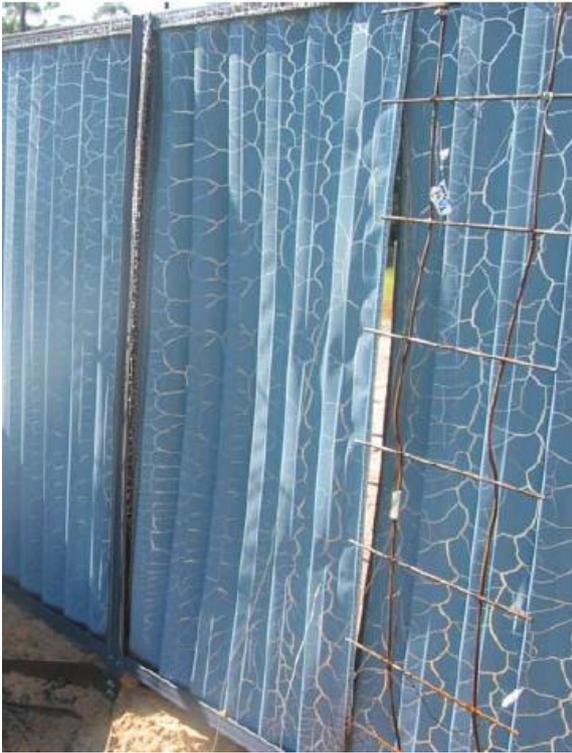
Figure 7. Appearance of sheeting consisting of powder coating over continuously coated sheet after being exposed to high temperatures (14).

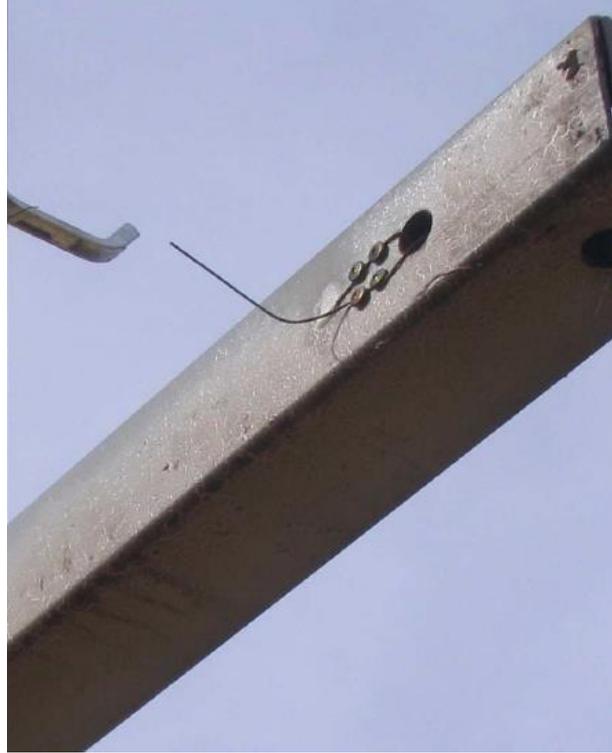
Figure 8. Appearance of powder coating over hot dip galvanizing after exposure to flames (19).

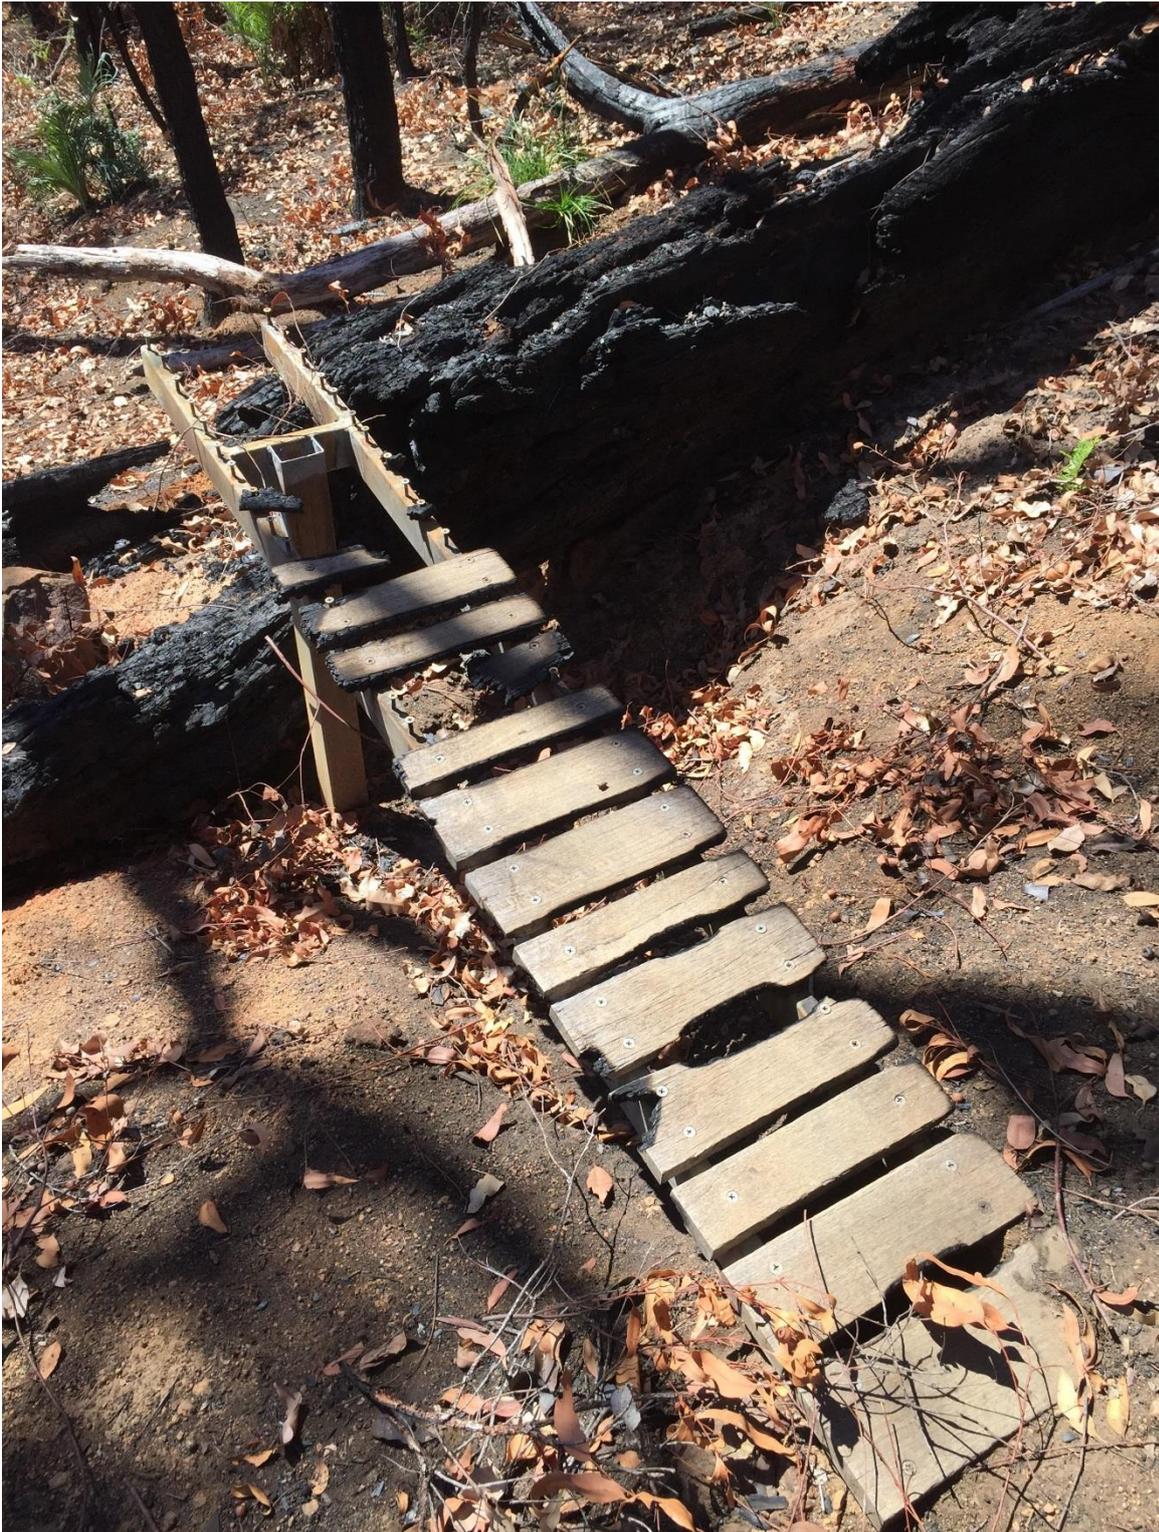
Figure 9. Small bridge likely constructed using continuously galvanized sections with paint repair on welded areas.

Figure 9 shows a small bridge which was likely constructed using continuously galvanized hollow sections with paint repair on welded areas. The timber slats used as the walkway have been destroyed in areas the flame could access from below. The galvanized coating looks largely unaffected from this distance, with staining in some places potentially due to rust, a decorative top coat burning during the fire, or

the timber and its preservatives burning or staining. In this case, cleaning the galvanizing and measuring the coating thickness is recommended as repair of the galvanized coating might not be required. If the burning temperature of the wooden slats is known, it may be possible to deduce the heat of the fire, which may have been higher at the end above the burnt tree branch.

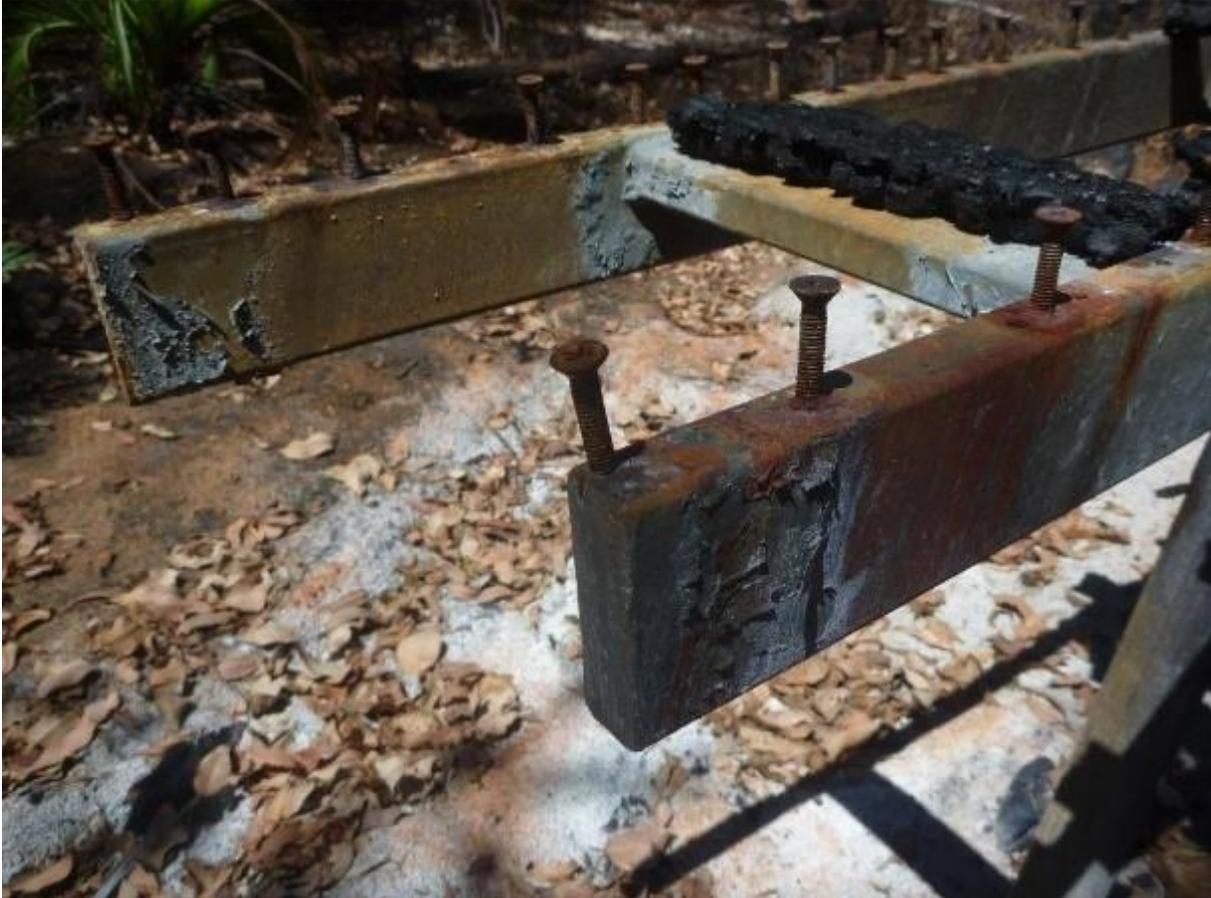
Figure 10. Small bridge likely manufactured from continuously galvanized hollow sections with paint used on weld repair.

Figure 10 shows a small bridge which was likely manufactured from continuously galvanized hollow sections and fabricated after galvanizing, with the welds repaired using paint. The paint repair is thick and peeling due to the heat. The paint used was likely to be a zinc rich epoxy as it is commonly used to repair galvanizing after welding. The marks which resemble rust on the section in the foreground may have been caused by a timber preservative or treatment, given the marks are most pronounced around the bolts.

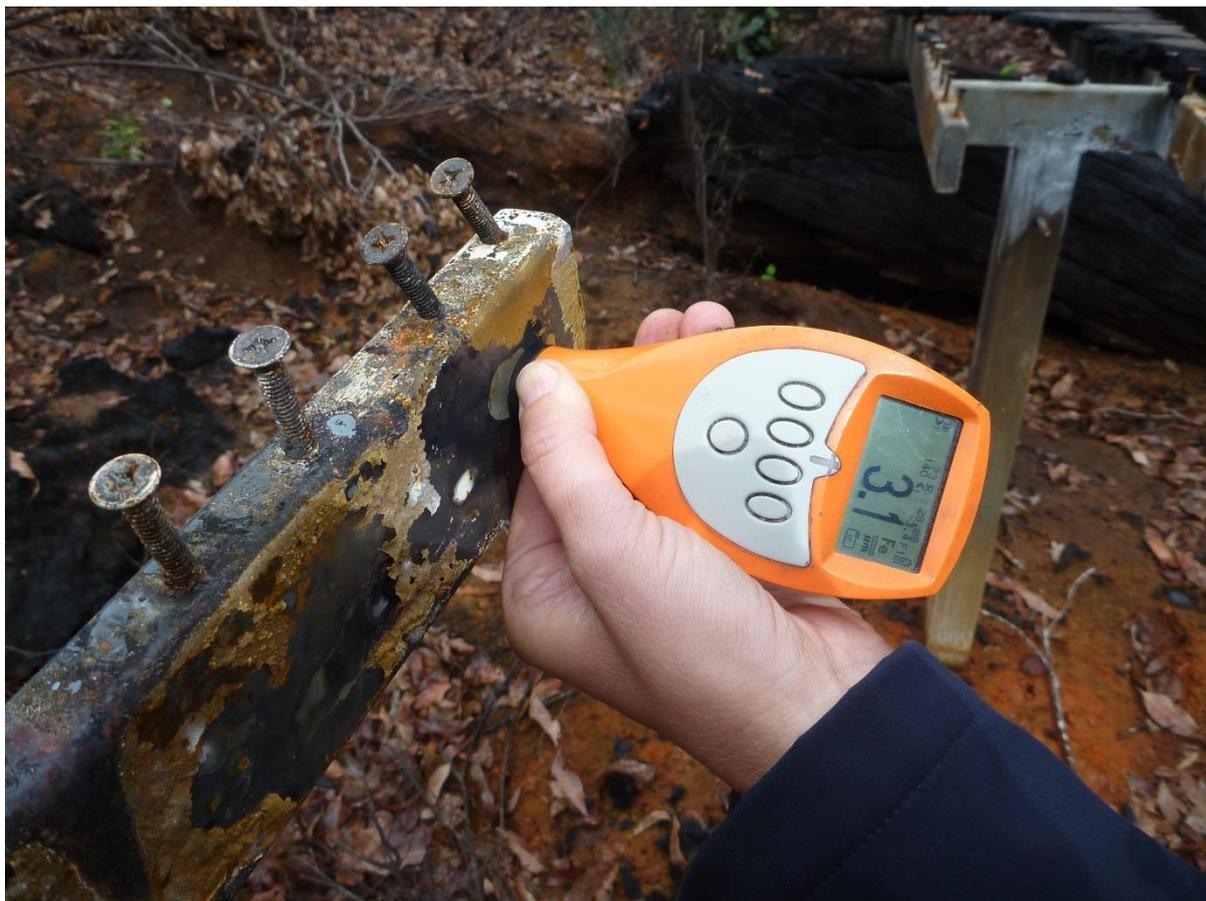
Figure 11. A low reading of 3.1 microns on an area of damaged coating.

When coating readings are very low, such as in Figure 11, the coating is unlikely to provide acceptable durability and repair is usually required. The surrounding areas should also be measured to determine how far along the member the repair is required.

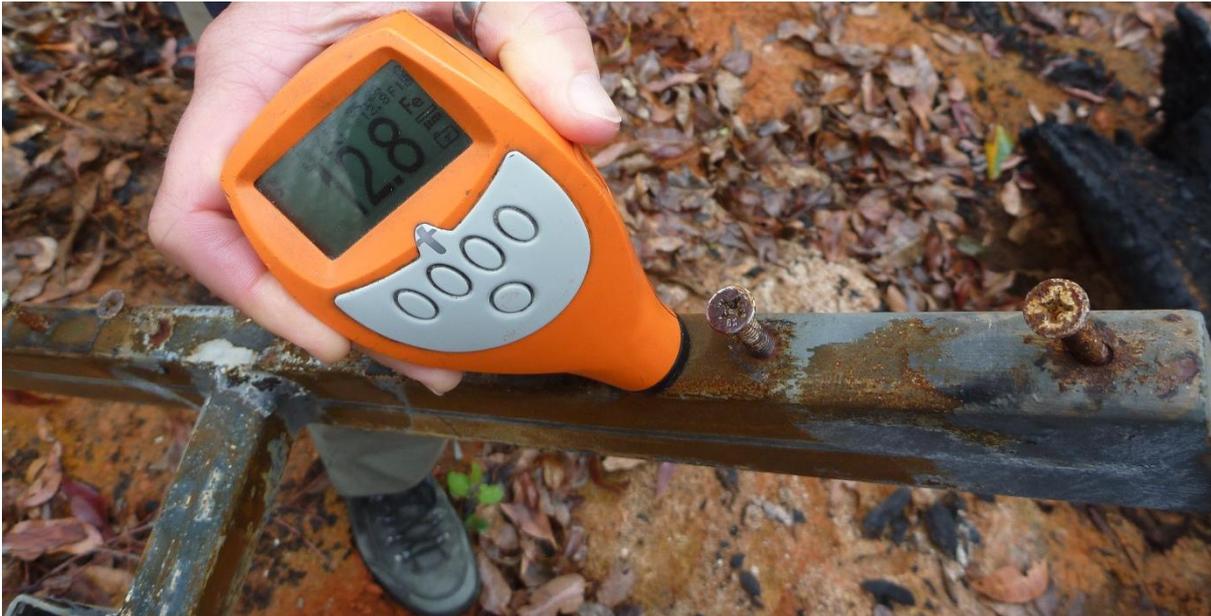
Figure 12. A reading of 12.8 microns taken on a member after a fire.

If the surface of the steel member has a colour similar to rust, it should be cleaned to ensure coating thickness measurements aren't compromised. A reading of 12.8 microns was obtained in Figure 12, which may have originally been Z275 or Z350 in-line galvanized tubing to AS 1397 (8). It is unclear whether the member has been cleaned after the fire and a repair may be required if a lower reading is obtained after cleaning.

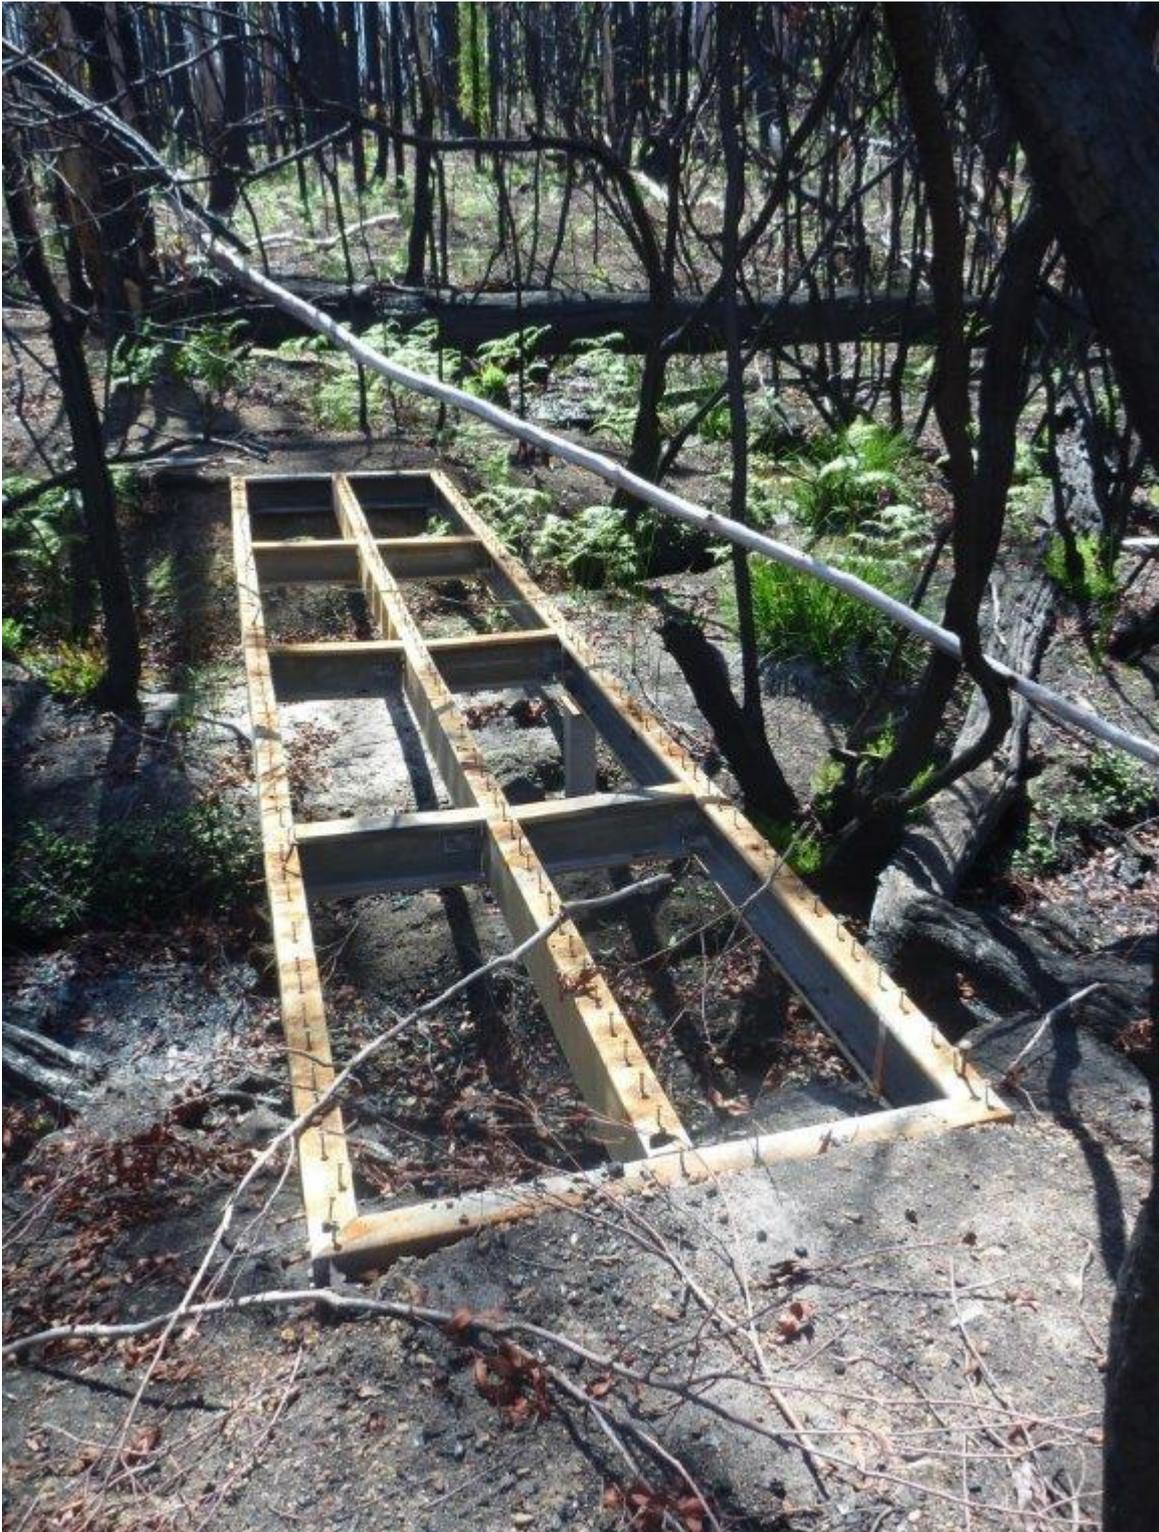
Figure 13. A small bridge constructed of bolted continuously galvanized sections.

Figure 13 shows a bridge initially constructed using predominantly cold formed continuously galvanized sections, which is made evident by the small lip at the top and bottom of the “C” shape. The sections appear to have been joined by bolting and some distortion of the steel members seems to have occurred. This could be due to the thin sections losing strength in the fire from an understrength initial design or a variety of other fire related phenomena. The timber slats which sat on top of the steel

were destroyed by the fire, however the galvanized coating looks largely intact despite some surface staining. In this case, it would be important for an engineer to determine the structural integrity of the bridge members to determine whether the steel will withstand the required loading and if replacing the bolts and tightening them would provide adequate capacity.

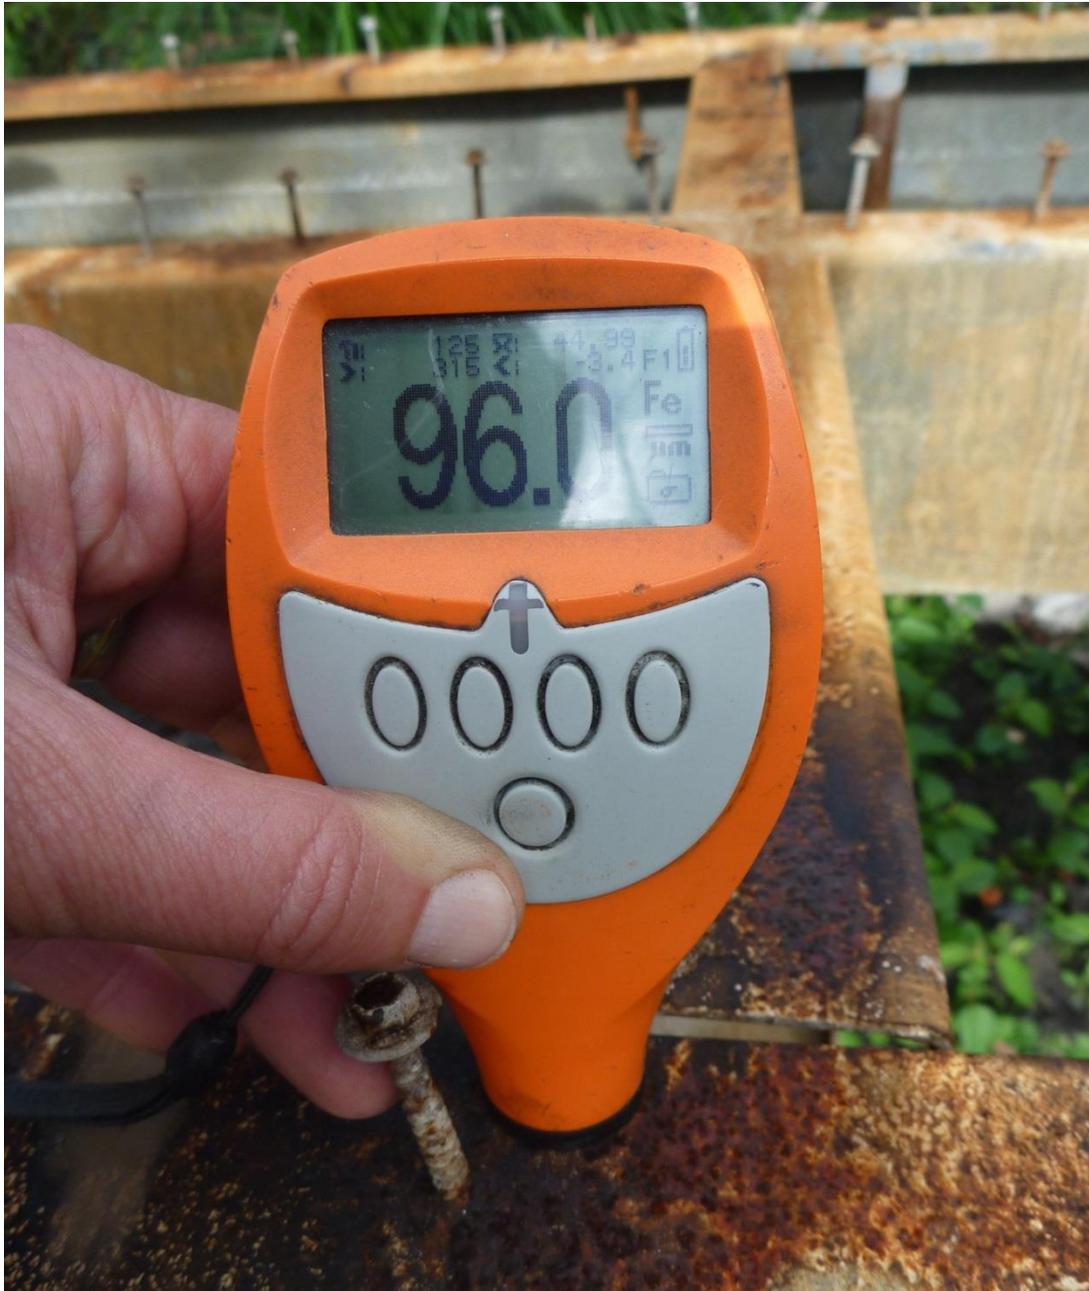
Figure 14. A high reading of 96 microns when measured on a charred surface.

Figure 14 shows a measurement being taken next to a bolt where a timber slat used to be. Since the measuring device uses a magnetic method to determine the distance between the probe and ferrous substrate, the charring on the surface is likely interfering with the measurement. Given the coating of the bolt and adjacent surfaces seem intact, the galvanized coating will likely have adequate thickness but lower than 96 microns when the charring is removed.

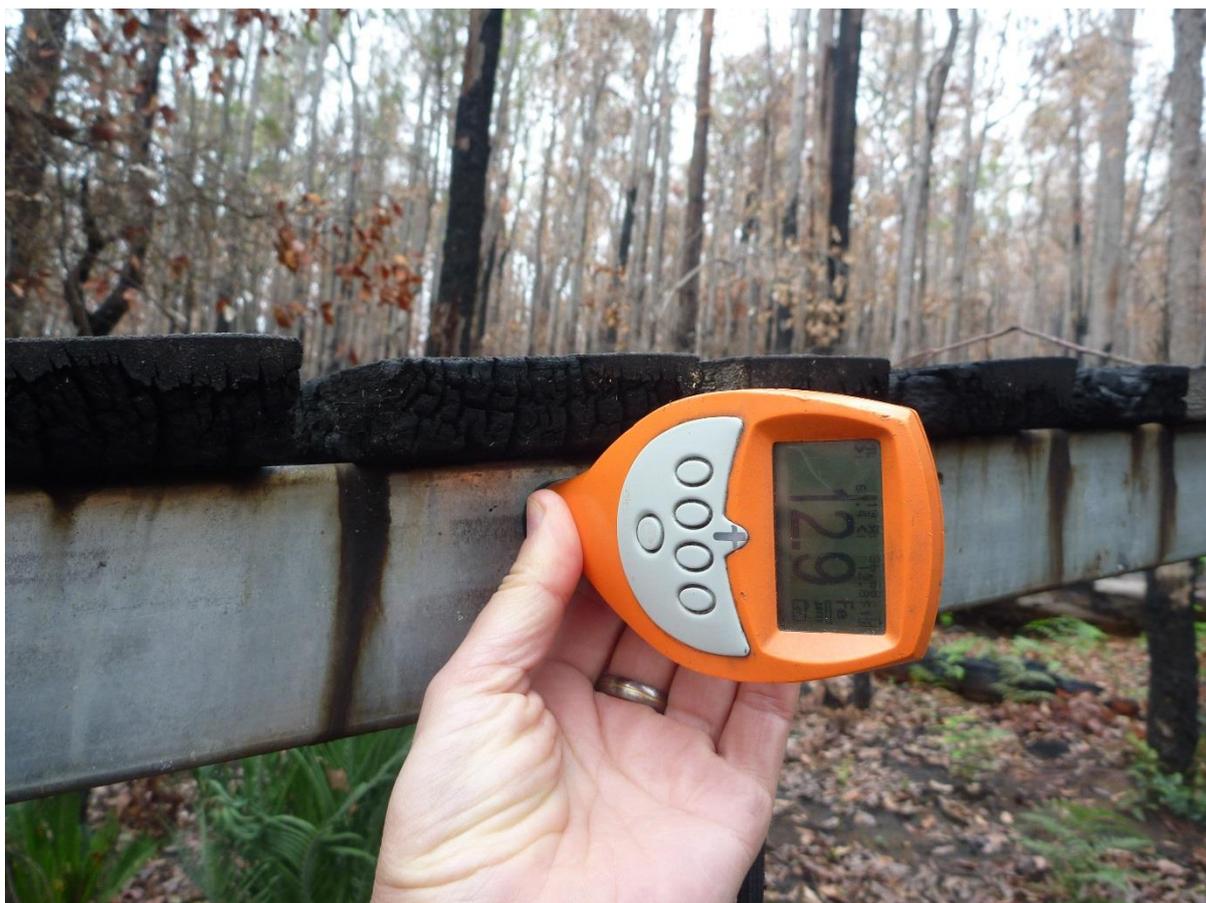
Figure 15. Reading of 12.9 microns on a continuously galvanized section.

Figure 15 shows a continuously galvanized section which is quite shiny in nature, suggesting the temperature didn't reach 450°C to melt the free zinc or convert the free zinc into zinc-iron alloy. Despite this, the wooden slats on top of the member have burnt and the coating under the contact areas should be checked for damage. In a low corrosivity zone the remaining coating would be expected to last between 18 and 100 years based on the corrosion rates in AS/NZS 2312.2 (10).

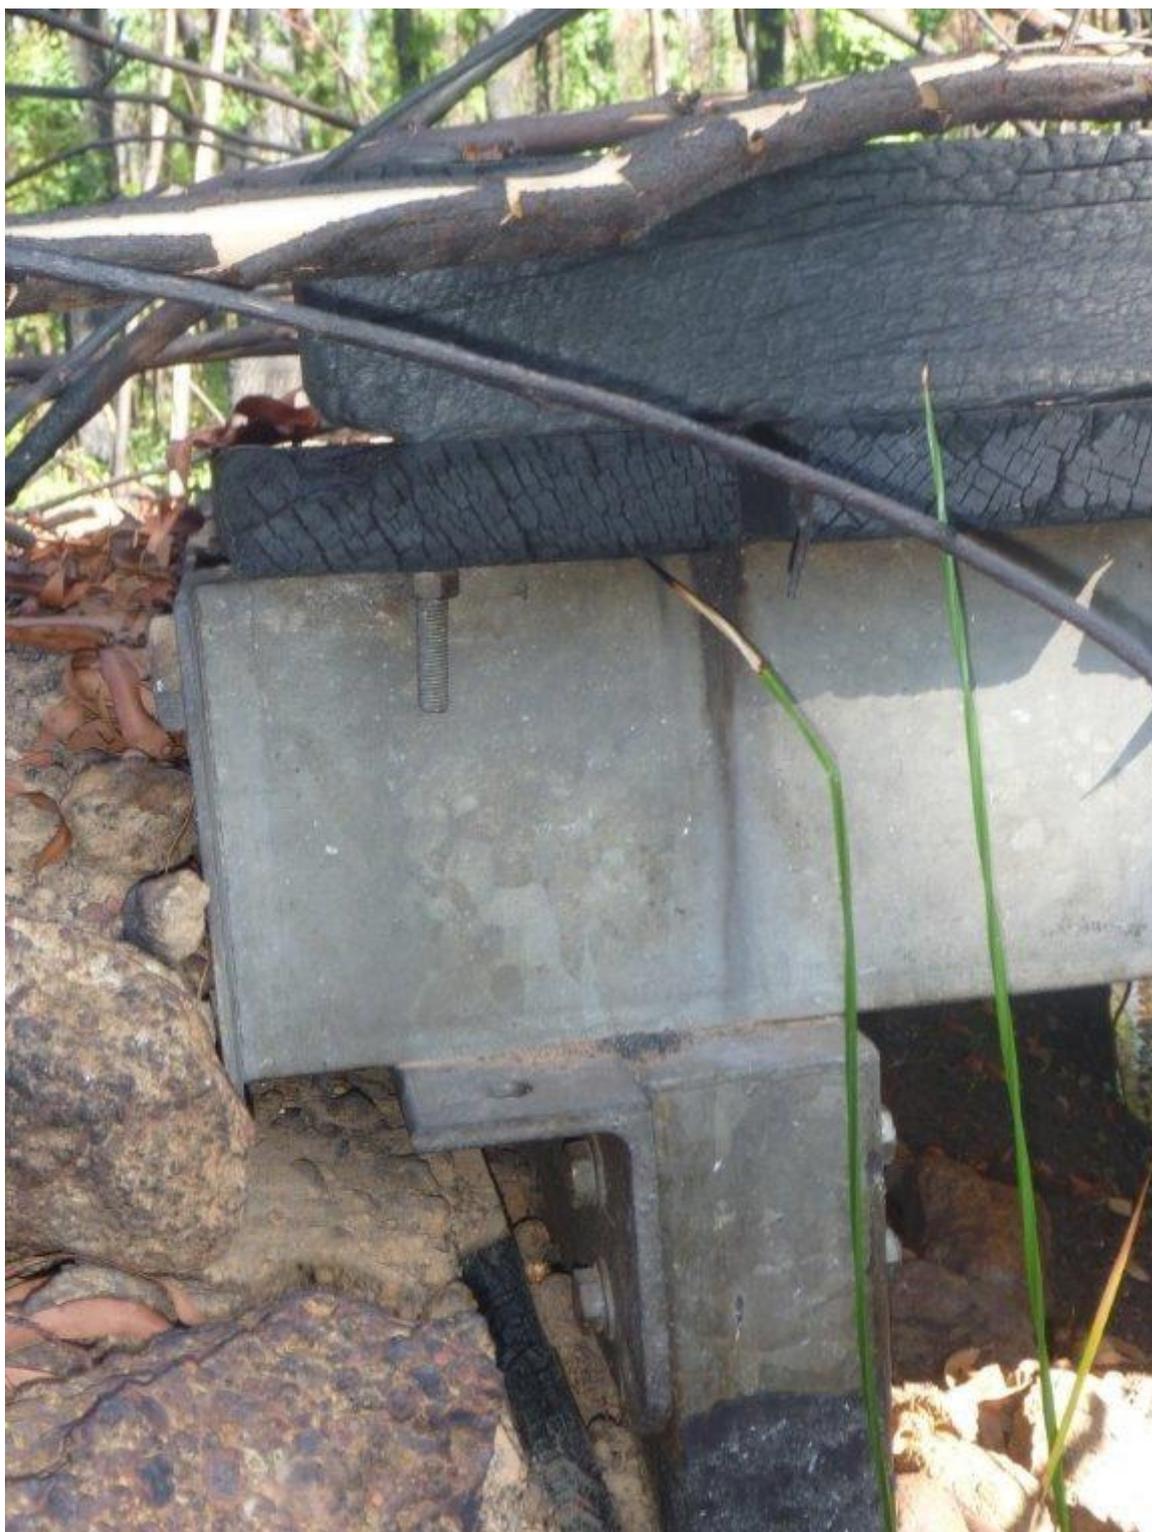
Figure 16. Close-up of a batch hot dip galvanized corner post, beam and structural bolts.

Figure 16 Shows a close-up of a batch hot dip galvanized corner post, beam and structural bolts. The remaining galvanized coating looks sound, even on the bolts that were securing the timber slats which burnt during the fire. Some charring is evident on the section going into the ground, which are likely the remains of a paint or tape used to protect the galvanizing from corrosion in reactive soil.

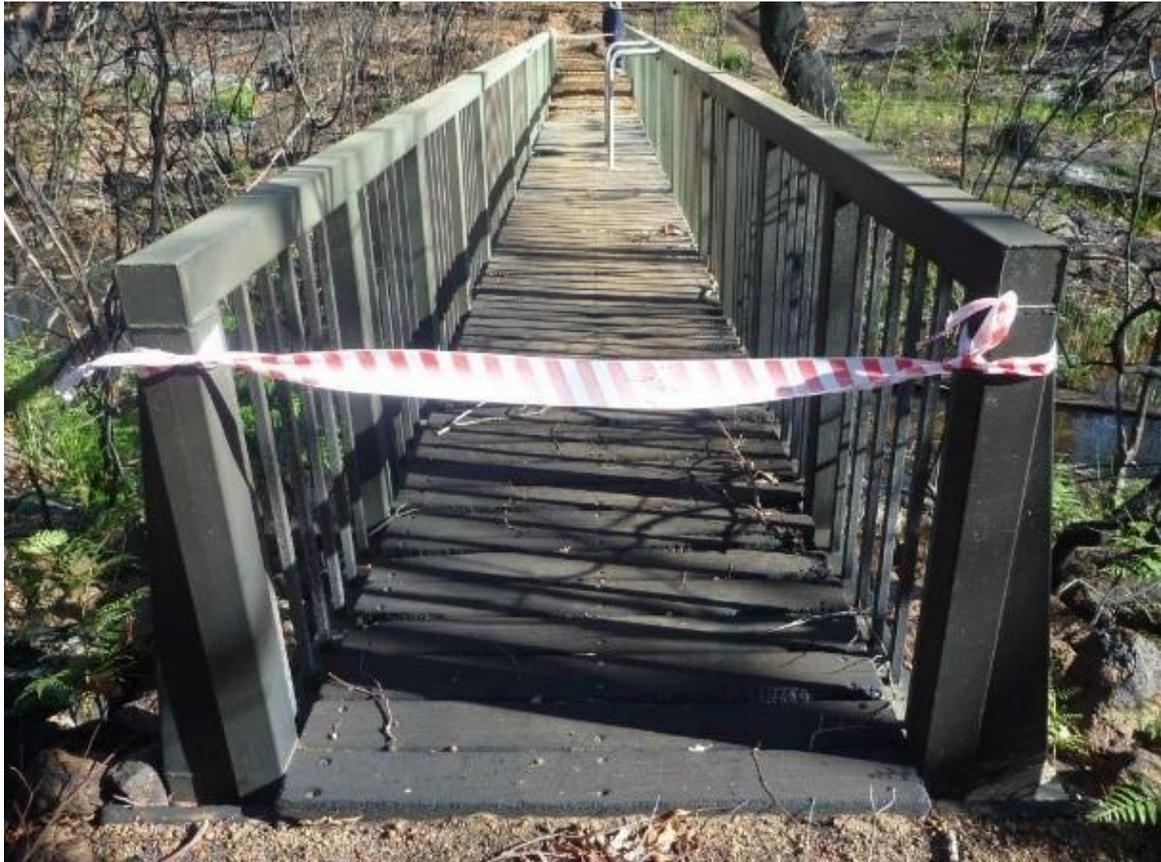
Figure 17. More substantial small bridge made of after fabrication hot dip galvanized steel with a paint topcoat.

Figure 17 shows a bridge made of thick fabricated steel that was hot dip galvanized. Some of the timber slats have been damaged by fire, however the damage to the steelwork seems only cosmetic. The decorative paint top coat has been damaged, with crazing visible on some of the smaller uprights. The aesthetics of the bridge can be restored by repainting.

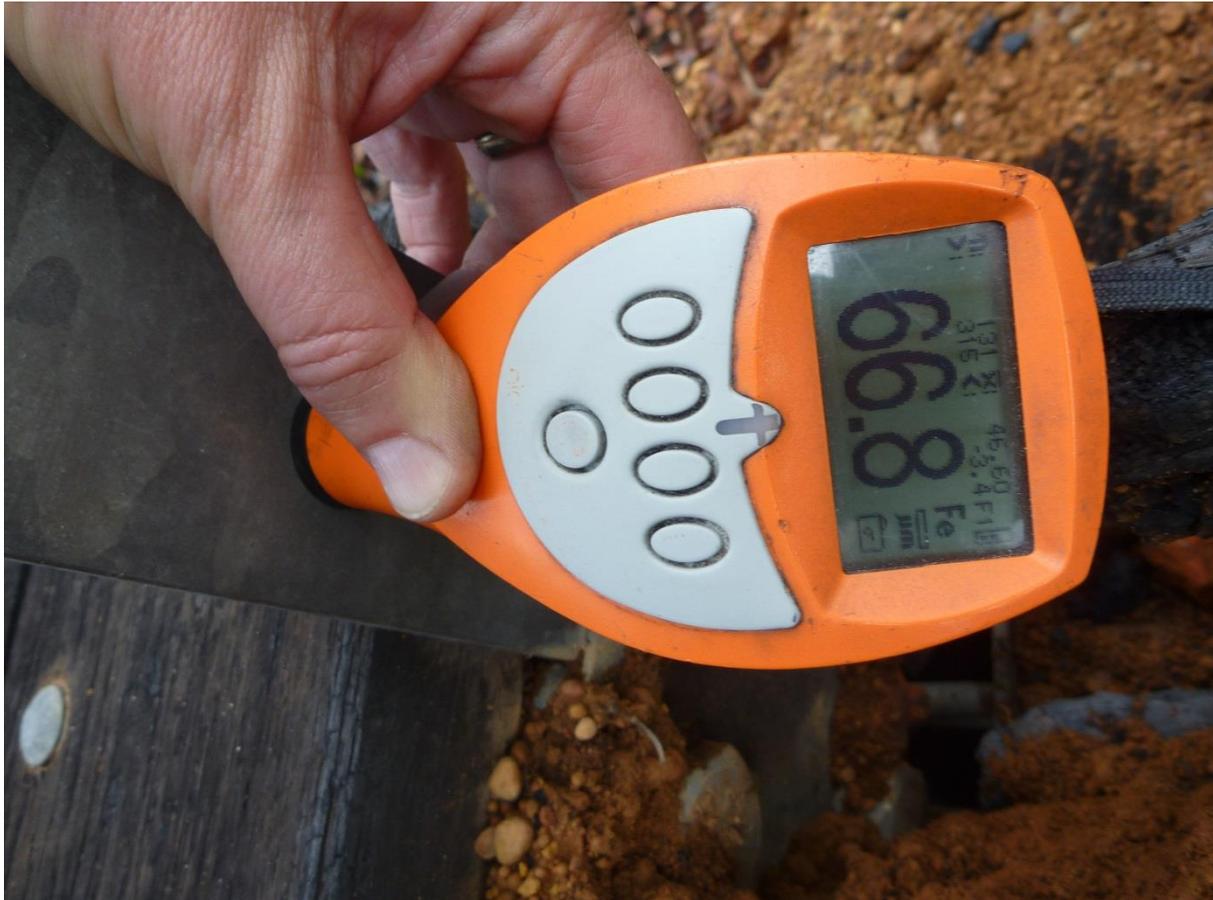
Figure 18. A hot dip galvanized coating which seems unaffected by the fire.

Figure 18 shows a coating thickness of 66.8 microns remains on the steel despite the bushfire exposure. In this case, the coating is likely adequate to be returned to service, with an expected life of at least 95 years in a low corrosivity zone based on AS/NZS 2312.2 (10) first year corrosion rates.
