Lessons Learned

Christopher Substation

Obrien Substation

Rolling Hills Substation

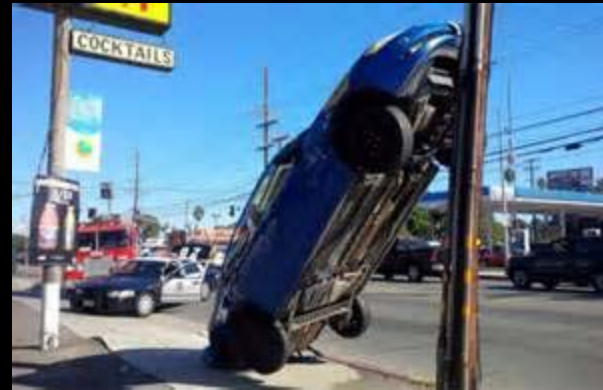
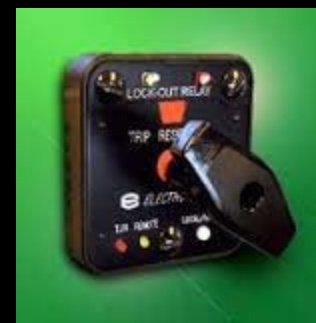
- Car pole accident on feeder 22
- Transformer LOR rolled and tripped entire station offline
- 6000 customers
- Pretty sure it's not supposed to work like that!

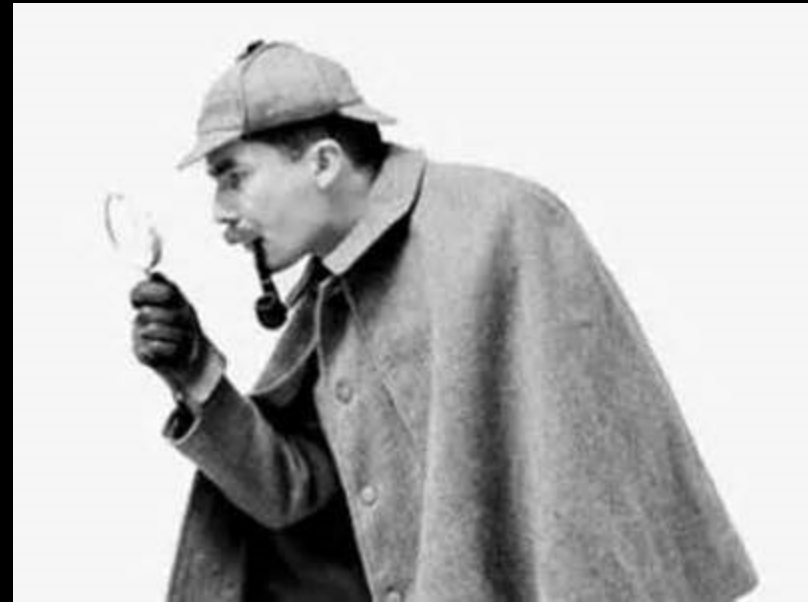
- Conclusions
 - Pay very close attention to the relay elements and logic
 - Understand the intended operation of each relay element
 - Always fill out the log book for even the smallest actions
