Seattle Public Utilities
Green Stormwater
Infrastructure:
O&M Program

## Operations and Maintenance

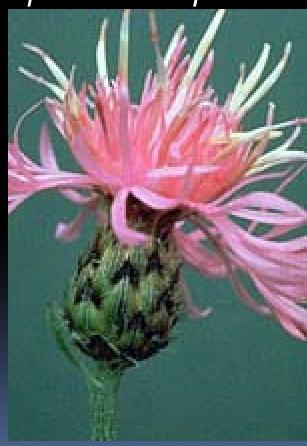
Spotted Knapweed

#### Noxious and Nuisance Weeds

- Special considerations need to be identified
- Provide link to jurisdiction's web site
- Photos
- Identification key
- Reporting requirements if applicable

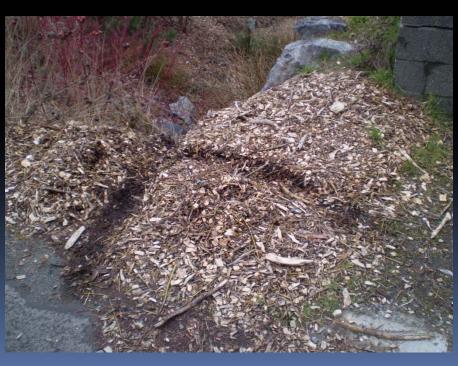
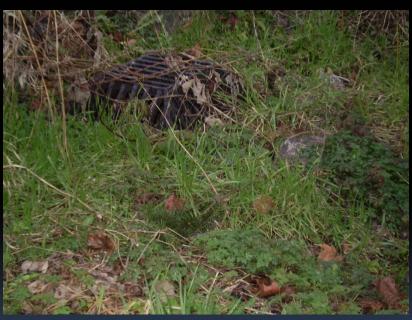
Debris and sediment removal

Clearing and cleaning

- Long Term Maintenance
  - Every fifteen years
  - Remove and replace top two inches of sediment
  - Prevent swale clogging
  - Maintains infiltration rates

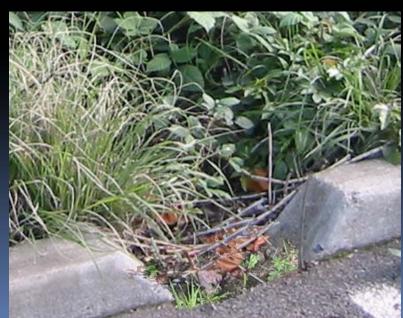
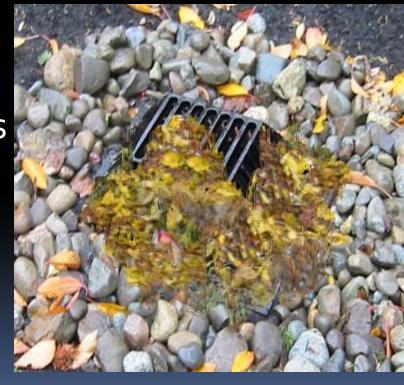
## Hardscape and Infra-Structure

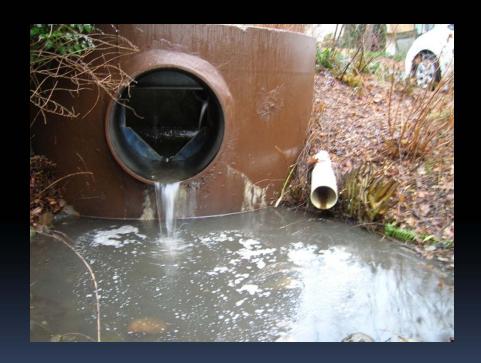
# All Levels of Service-Meet permit requirements

Stormwater
 sedimentation
 structures are less
 than ½ full or in
 accordance with
 NPDES
 requirements

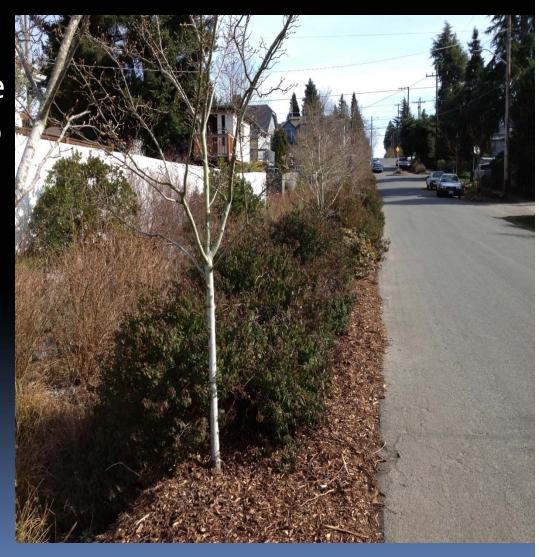
#### 4-Infiltration Failure

- Evidence of a cell holding water for more than 24 hours needs to be reported
- Operations and Maintenance Asset Manager
- Monitor swale for ponding water
- Retrofit swale

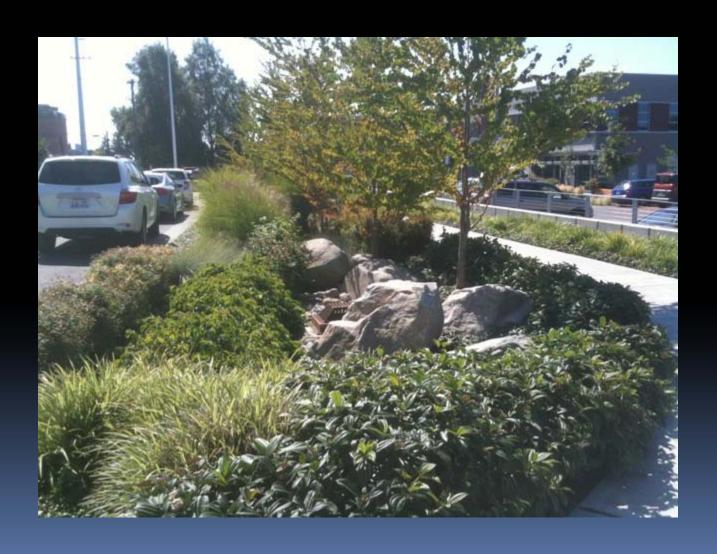
## Maintenance Costs

#### Total Maintenance Cost

- Total \$\$ = Vegetation + Hardscape
- Initial Vegetation 3 years
  - SPU cost: \$2.21
  - Watering method and frequency increase cost up to 4X
- Established Vegetation 4 plus
  - SPU cost: \$1.66
  - 25% reduction
- Replacement costs \$0.50 per sq. ft.
- Hardscape \$0.31 per sq. ft.
