2017 ONPHA Conference and Trade Show

Session 303

Prolonging asset life
and saving you capital

Pretium Anderson Building Engineers

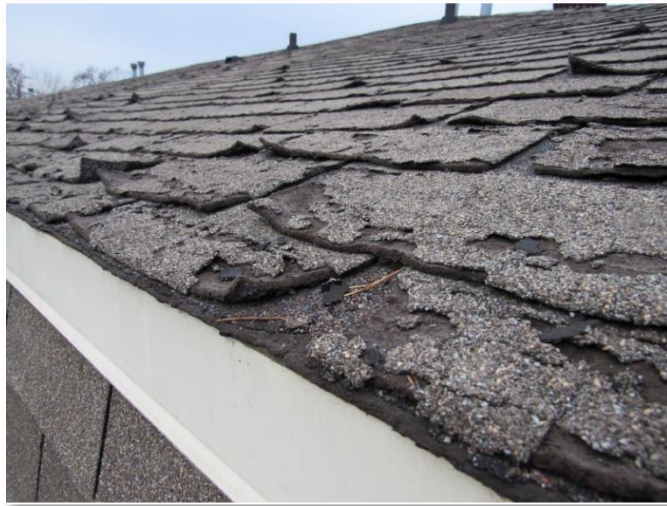
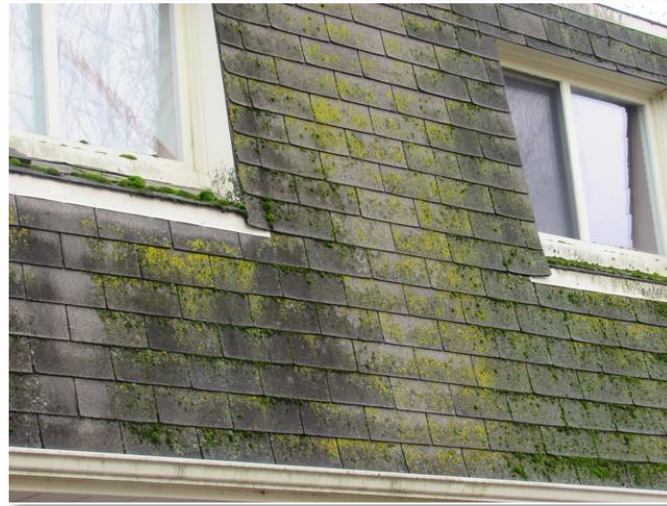
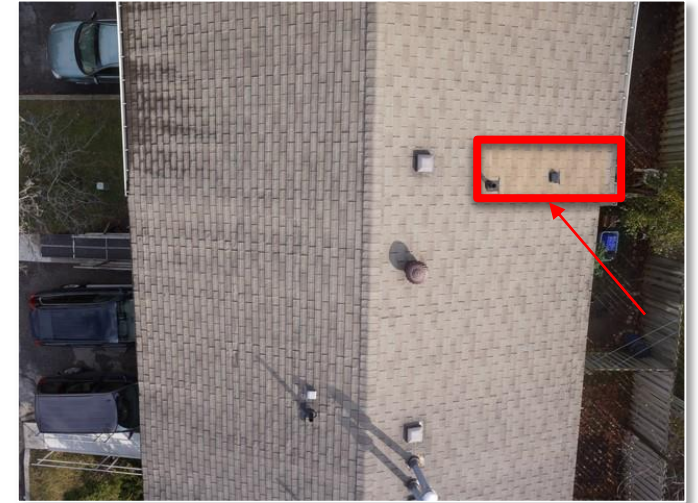
- Sloped Shingle Roofing

- Summary:
 - Expected Useful Life = 15 – 25 Years
 - South elevations tend to deteriorate faster
 - Trim back nearby trees - every Fall.
 - Check attics upon vacancies.
 - Remove organic growth – twice per year.
 - Respond to leak reports immediately.
 - Visual review for ice damming – every Winter.
 - Visual review of shingle deterioration – every summer.

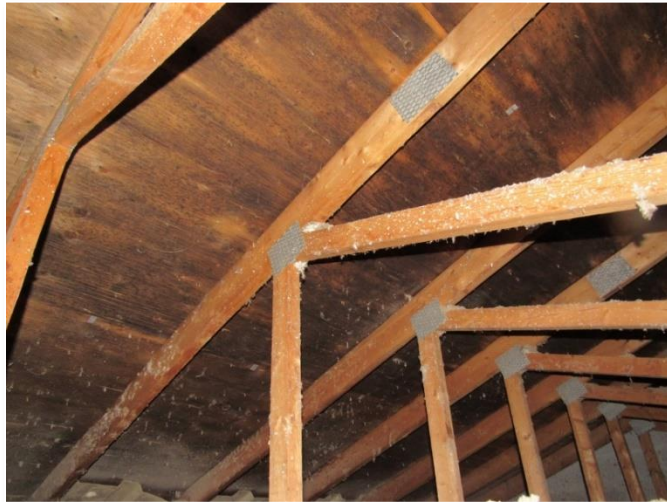
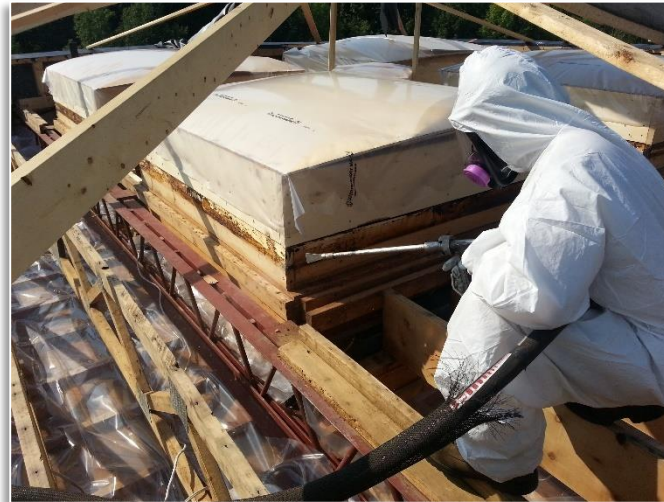
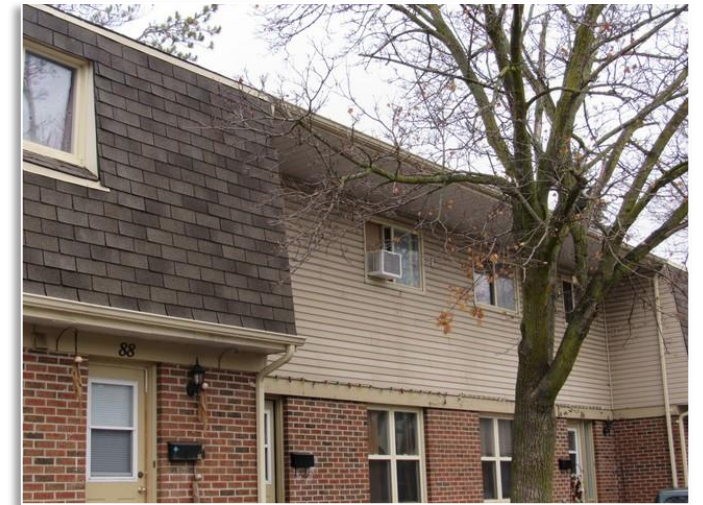
- Sloped Shingle Roofing

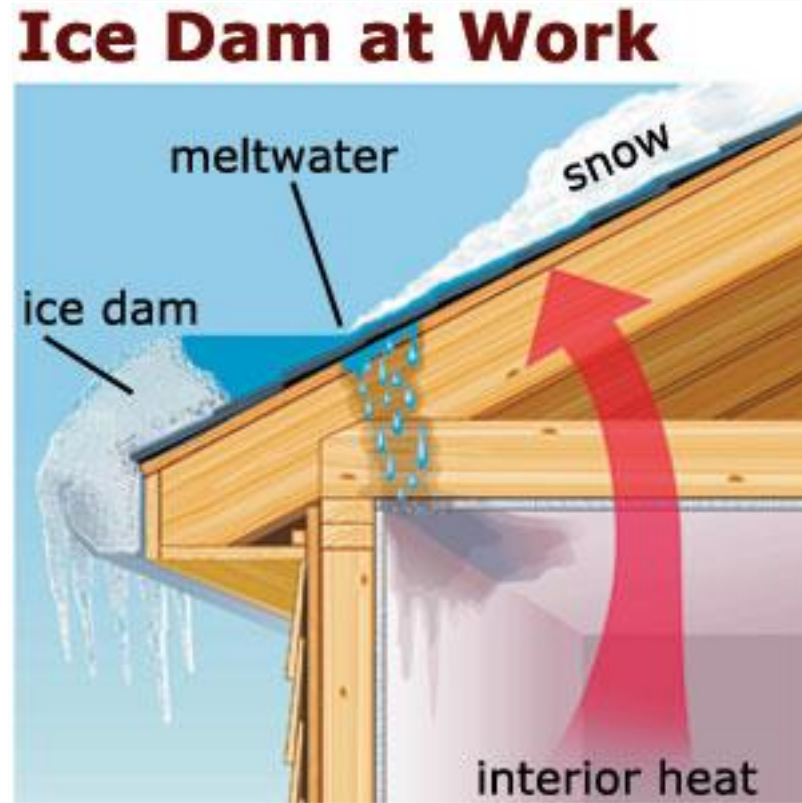
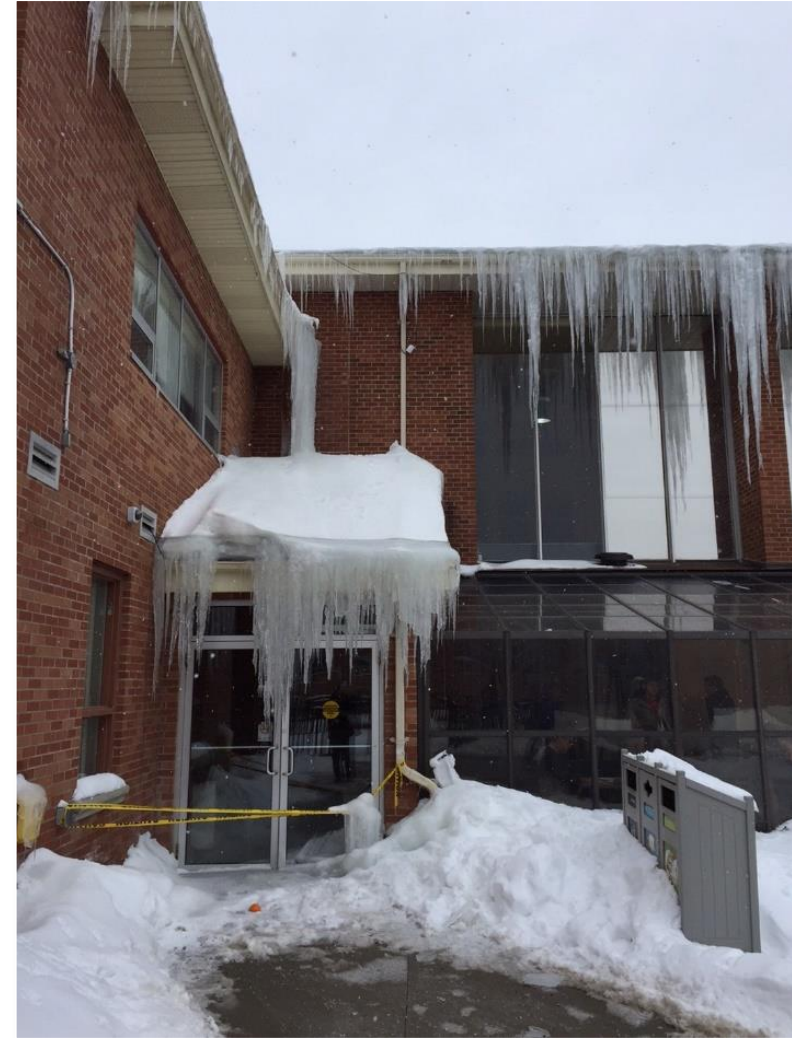
- Sloped Shingle Roofing

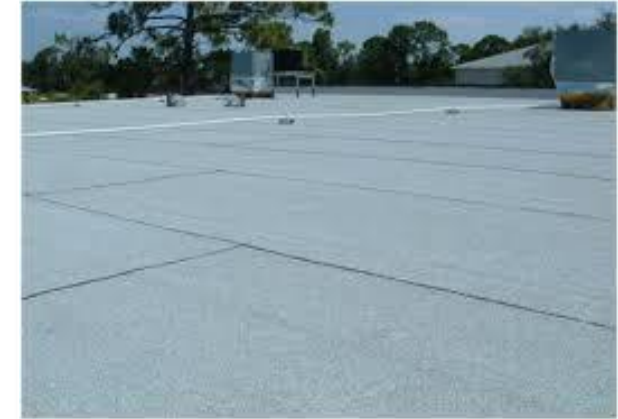
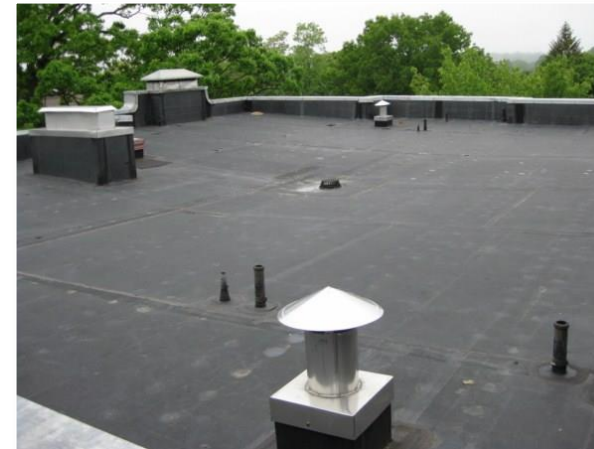
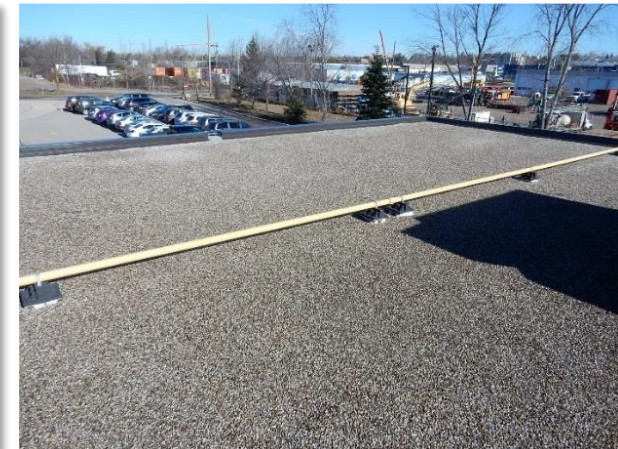
- Built-Up Roof (BUR)
- 2-Ply Modified Bitumen
- EPDM
- Others (TPO, PVC, etc.)

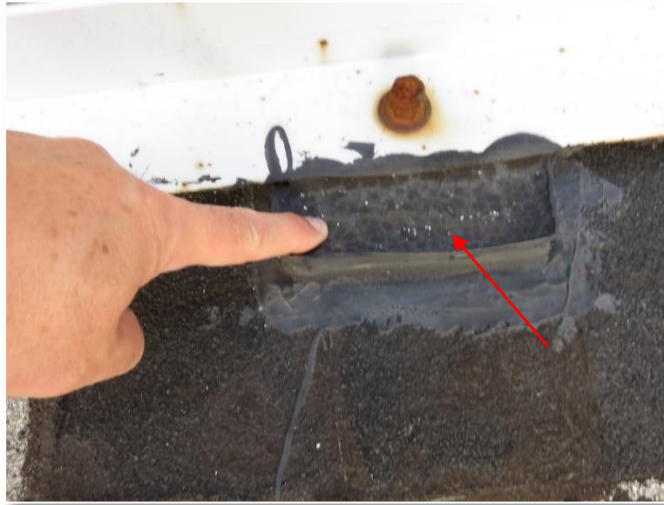
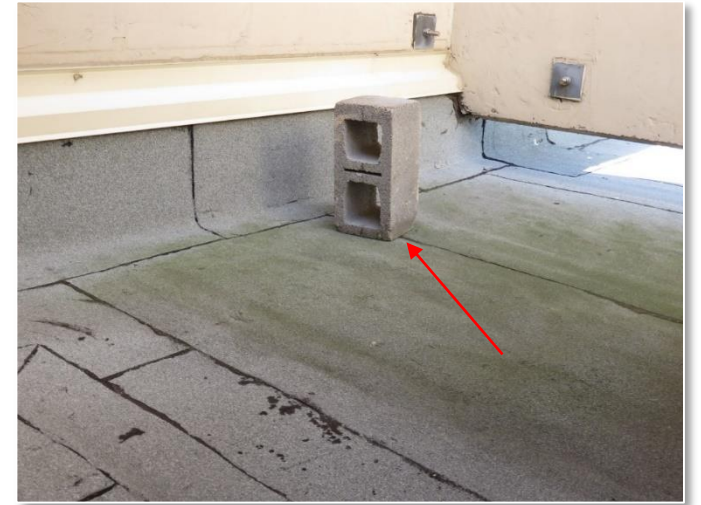
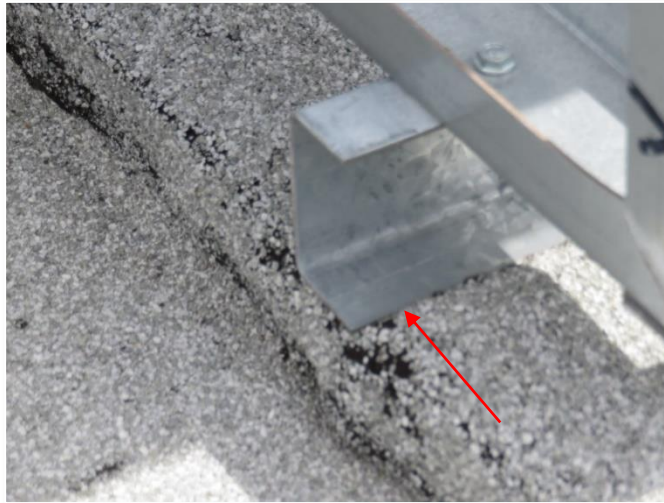
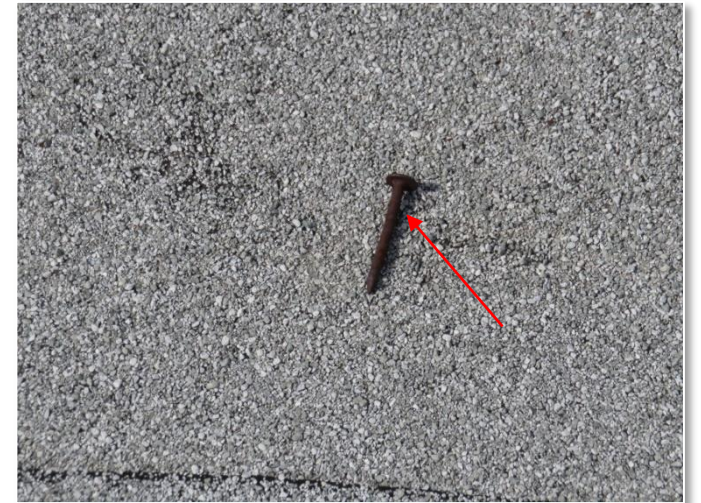
- Low-Slope Roofing

- Low-Slope Roofing Summary:
 - Expected Useful Life = 20 – 25 Years
 - Remove all organic growth – Twice per year.
 - Remove all debris - Ongoing.
 - Check ballast – Once per year.
 - Check pitch pockets – Once per year.
 - Check sealant around all penetrations – Once per year.
 - Address leaks immediately.
 - Intrusive Assessment on Roofs > 25 years old – Once every two or three years.
 - Warranty inspections – As required.

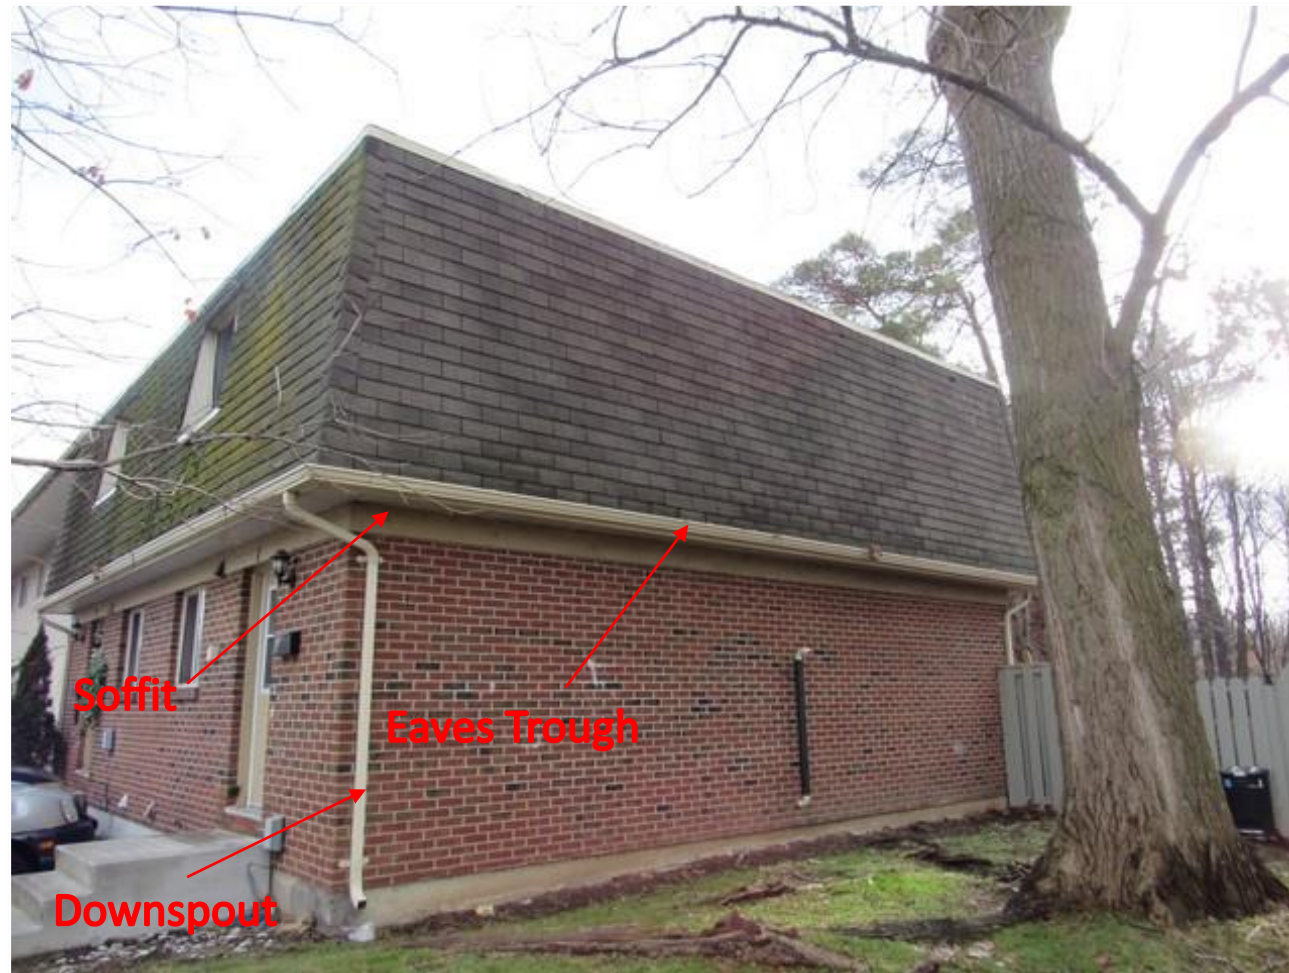
Eaves Troughs, Downspouts, Soffits, and Fascia (EDSF)

- Summary:
 - Expected Useful Life = 25 – 35 Years
 - Check eaves trough – Once per year in the Fall.
 - Check downspouts – Twice per year in Fall and Spring.
 - Check soffits and fascia – Once per year.

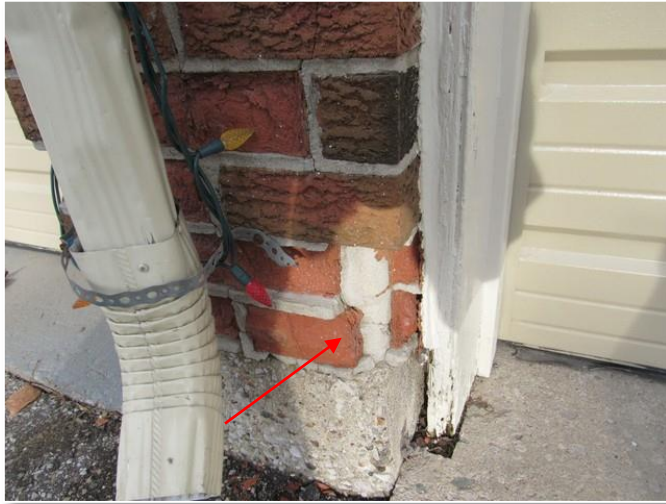
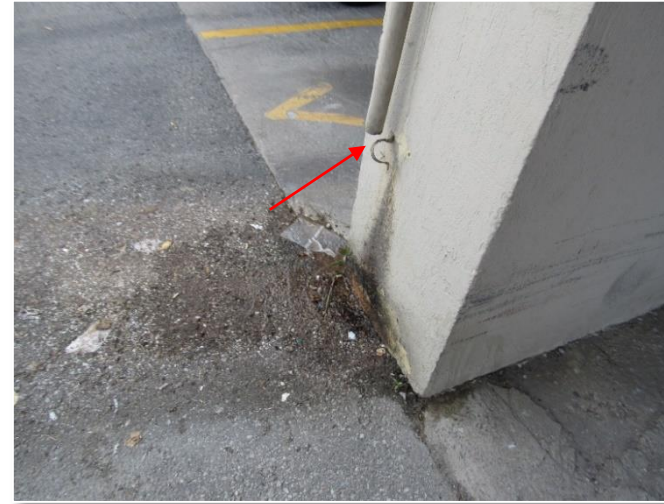
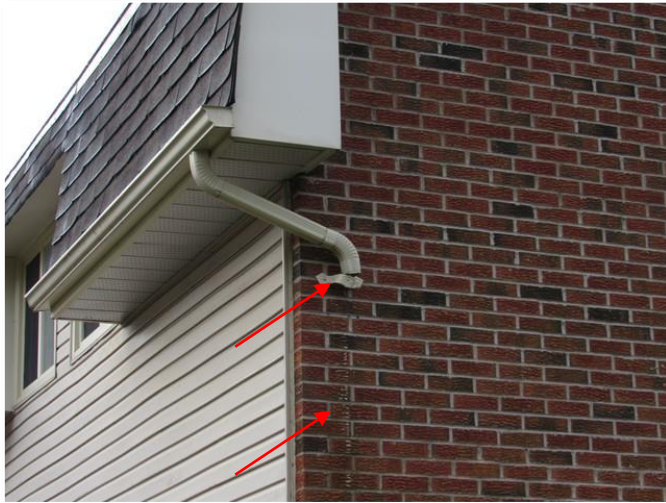
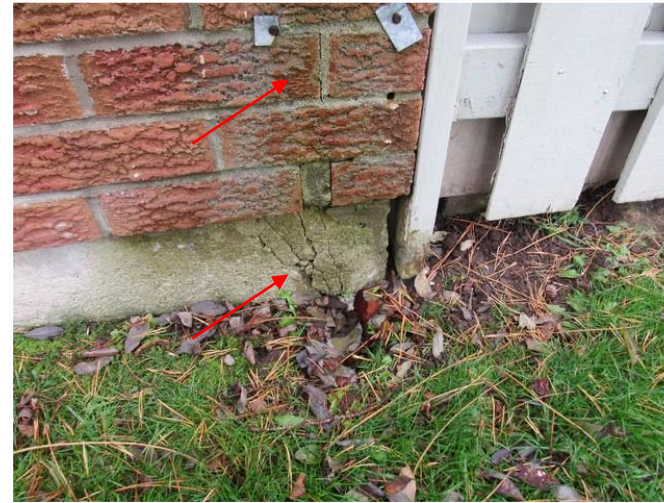
Eaves Troughs, Downspouts, Soffits, and Fascia (EDSF)

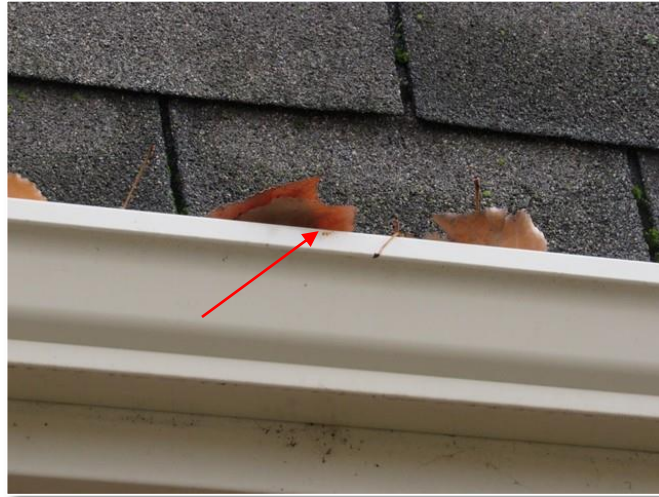
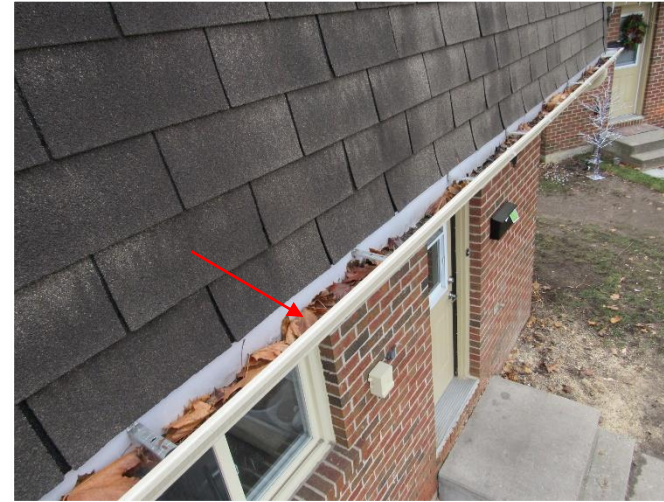
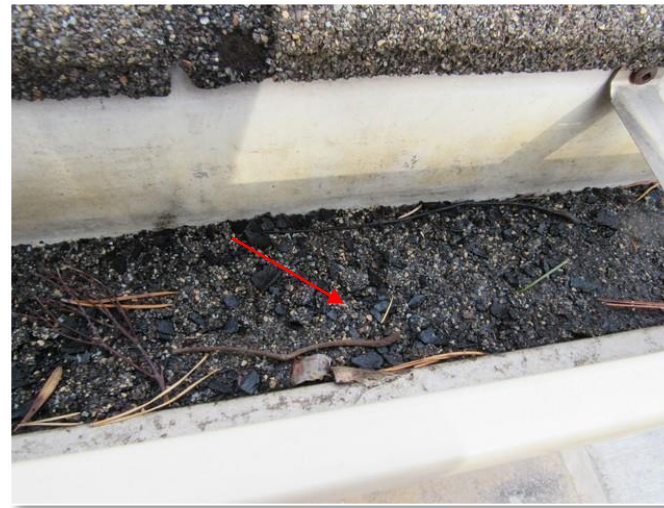
Eaves Troughs, Downspouts, Soffits, and Fascia (EDSF)

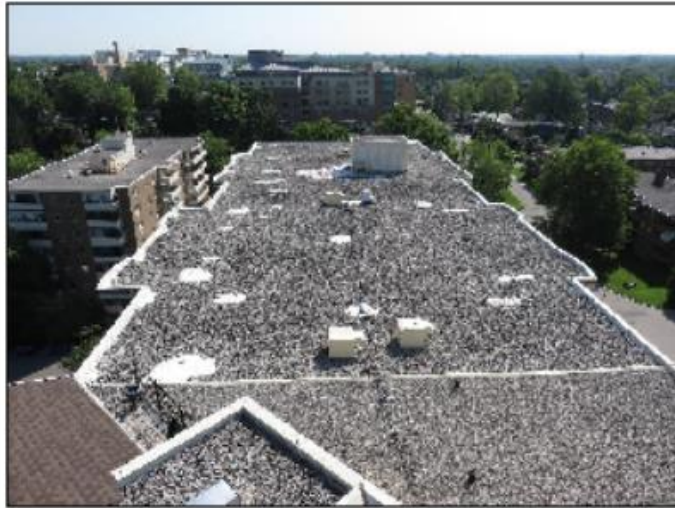
P1 - Inverted Roof

-Unevenly distributed ballast.

-Slippery
-Membrane punctures at exposed areas
-Possible UV degradation
-Susceptible to wind uplift

-Redistribute ballast.

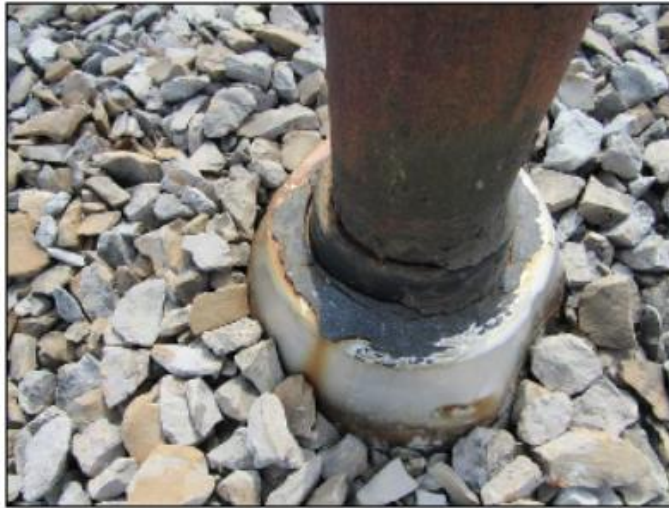
P2 - Inverted Roof

-Missing and failed sealant at a plumbing stack.

-Leakage into building.
-Interior finish repairs.
-Roof deck repairs.
-Mould remediation.

-Remove and replace sealant.

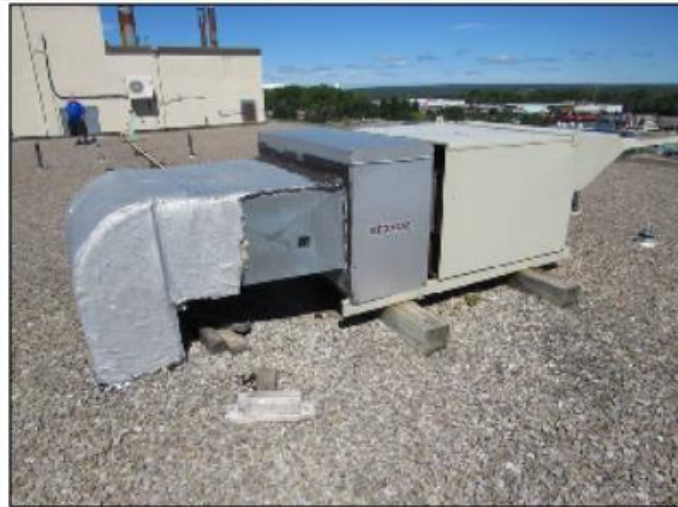
P3 - Rooftop HVAC Unit

-Loose debris.

-Debris could be blown off roof.
-Debris could damage the membrane.

-Remove debris.

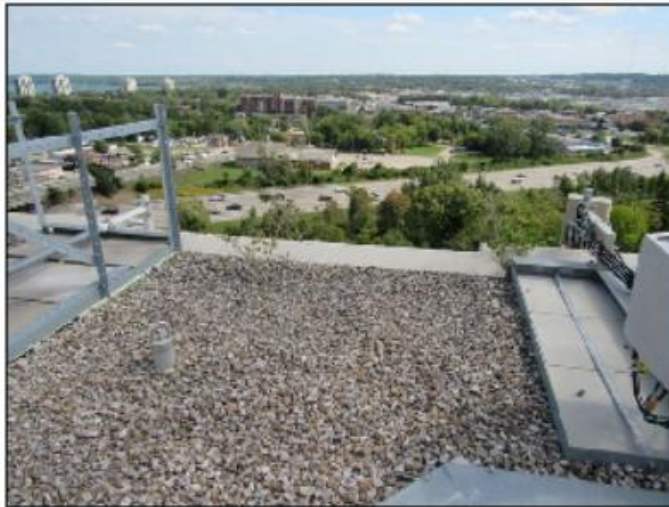
P4 - Inverted Roof

-Two trees growing out of the roof.

-Leaks into building.
-Damage to interior finishes.
-Damage to the roof deck.
-Unhappy tenants.

-Check if roots are through membrane. If so, contract a roofer to remove trees and repair membrane.

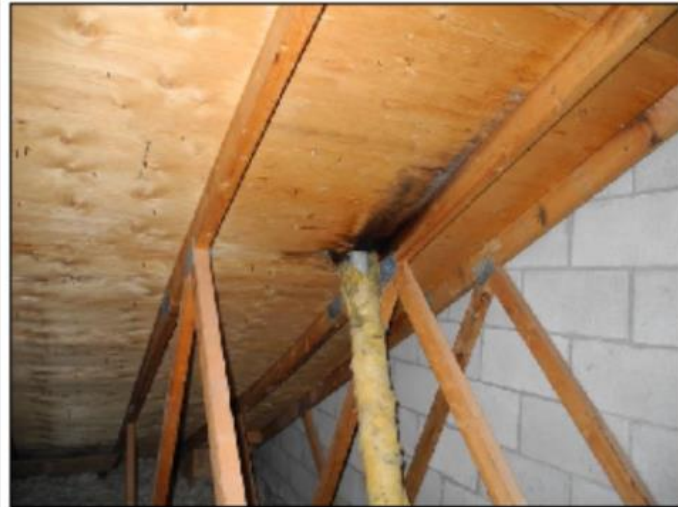
P5 - Attic

- Poor air seal between the exhaust duct and the roof vent which is leaking warm air and condensing on the roof deck. The condensation has caused localized rot and mould growth in the wood deck.
- Damaged insulation on the duct.

- Major mould growth throughout the attic.
- Major decay in the wood deck (could eventually compromise the structure in that area).

- Remove and replace the roof vent.
- Localized remediation of mould and/or rotted wood deck.

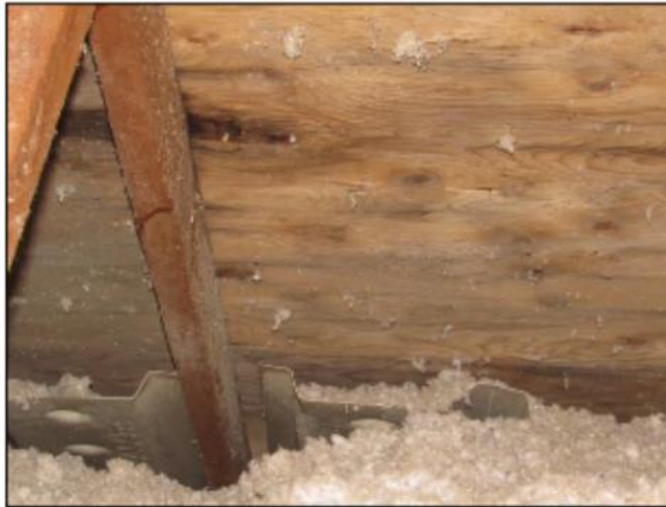
P6 - Attic

- Blocked soffit baffle.

- Reduced ventilation in the attic can lead to overheating, which could cause severe ice damming in the winter and accelerated shingle deterioration in the summer.
- Potential for mould growth.

- Remove insulation inside the baffle.

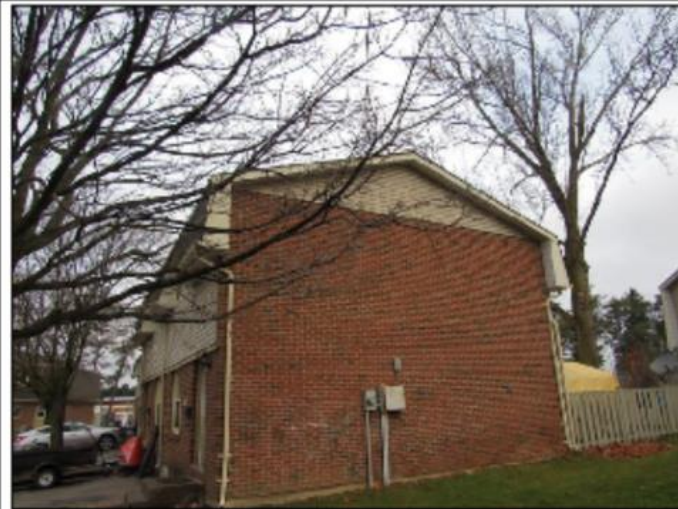
P7 - Sloped Shingle Roof

- Trees too close to the roof edge.

- Organic growth on the roof.
- Shingle deterioration.
- Higher chance of damage due to insects and animals.
- More frequently blocked eaves troughs.

- Trim back trees.

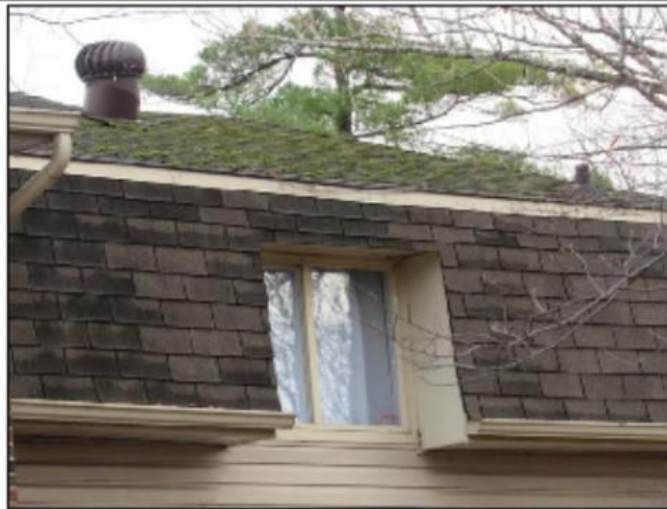
P8 - Sloped Shingle Roof

- Organic growth on the roof.

- Accelerated deterioration.
- Reduced drying capacity after rain events.
- Aesthetic issues.

- Remove organic growth and trim back trees.

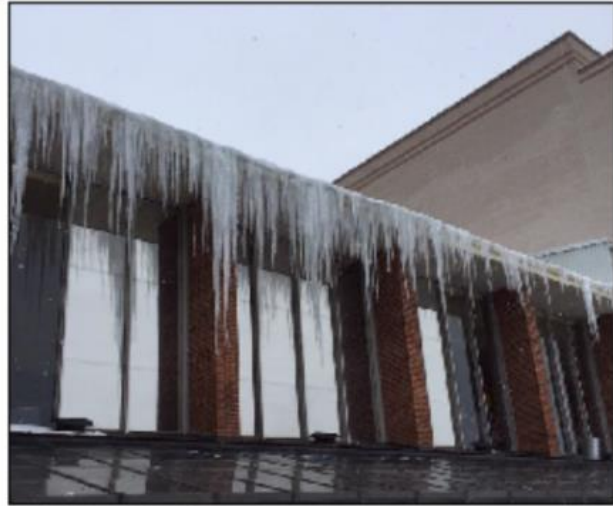
P9 - Sloped Shingle Roof

Deficiency?
-Ice damming

Deferred Repair?
-Accelerated deterioration of shingles.
-Premature failure of eaves troughs and downspouts.
-Safety hazard.
-Potential for structural damage to the roof deck.

Maintenance Repair/Strategy?
-Multiple causes. Bring in a qualified consultant.

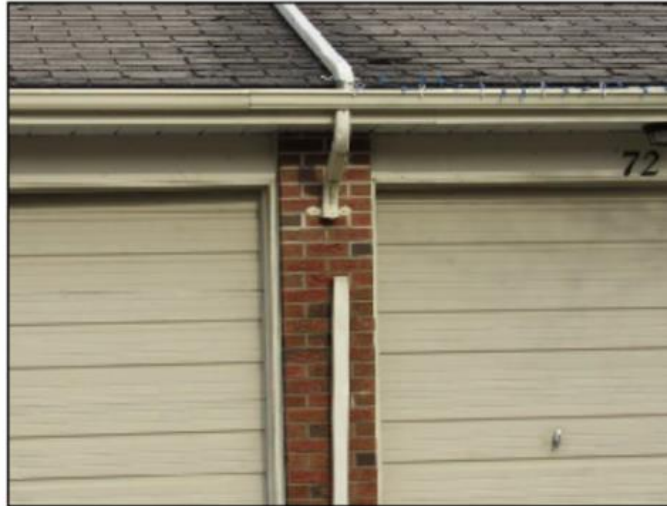
P10 - Eaves trough and Downspout

Deficiency?
-Disconnected downspout.

Deferred Repair?
-Brick deterioration.
-Garage door frame deterioration.
-Potential for leaks into the basement.
-Slipper conditions in the winter.

Maintenance Repair/Strategy?
-Reconnect downspout and discharge away from foundations.

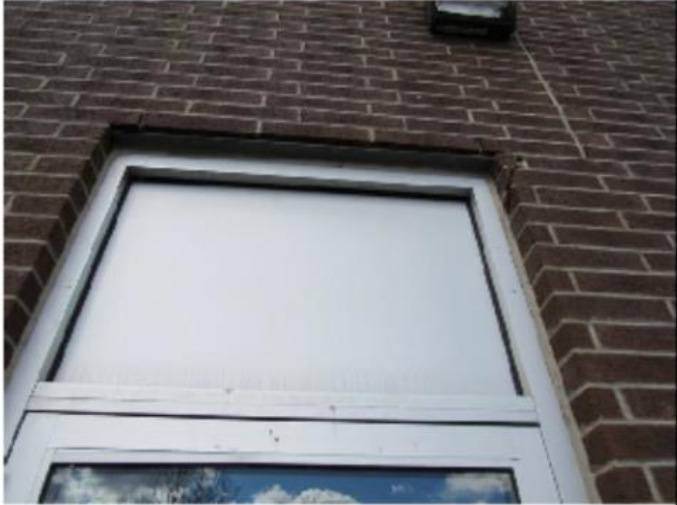
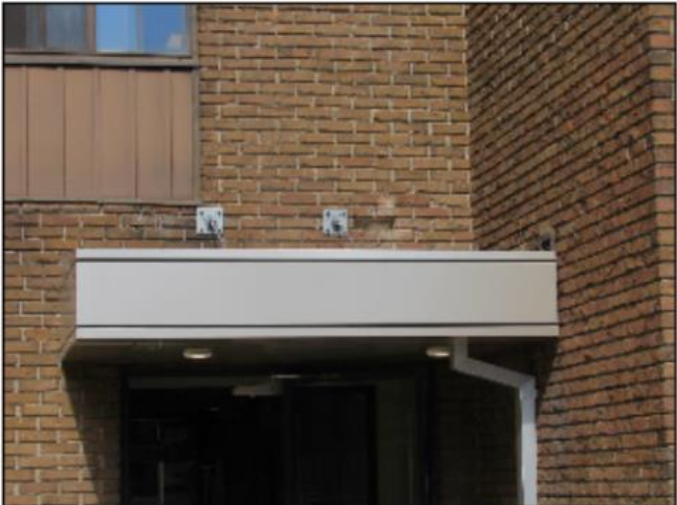
P1 - Brick Veneer	P2 - Brick Veneer
Deficiency? -Dislodged bricks at top right corner.	Deficiency? -Missing brick.
Maintenance Repair/Strategy? -Knock off loose bricks. -Replace the bricks.	Maintenance Repair/Strategy? -Replace the missing brick.
Deferred Repair? -Potential safety hazard. -Water and air penetration into the building.	Deferred Repair? -Water and air penetration into the building.

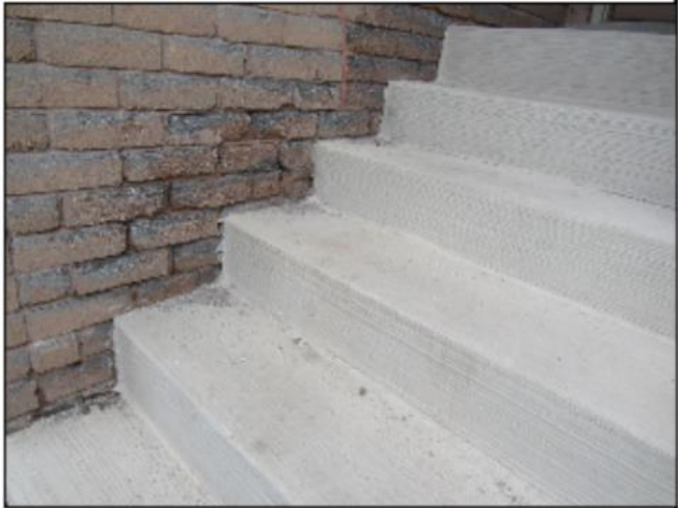
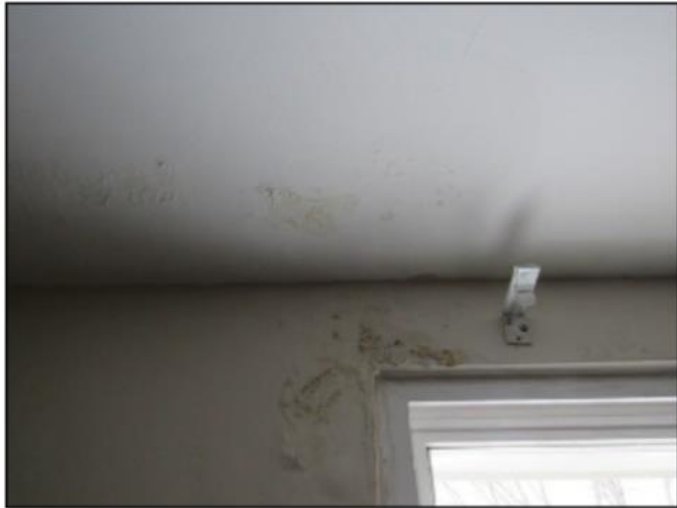
<p>P3 - Brick Veneer</p>	<p>P4 - Window Lintel</p>
<p>Deficiency?</p> <ul style="list-style-type: none"> -Brick deterioration beside the steps. 	<p>Deficiency?</p> <ul style="list-style-type: none"> -Leakage behind wall and ceiling finishes.
<p>Maintenance Repair/Strategy?</p> <ul style="list-style-type: none"> -Repoint the mortar joints. -Obtain proper de-icing salts chemicals (i.e. urea or calcium magnesium acetate. -Avoid calcium and sodium chlorides 	<p>Maintenance Repair/Strategy?</p> <ul style="list-style-type: none"> -Multiple causes. Bring in a consultant for investigation.
<p>Deferred Repair?</p> <ul style="list-style-type: none"> -Brick spalling. -Accelerated deterioration of bricks and joints leading to eventual air/water penetration. 	<p>Deferred Repair?</p> <ul style="list-style-type: none"> -Deteriorated wall studs. -Deteriorated finishes. -Potential for mould growth. -Deteriorated structural elements.

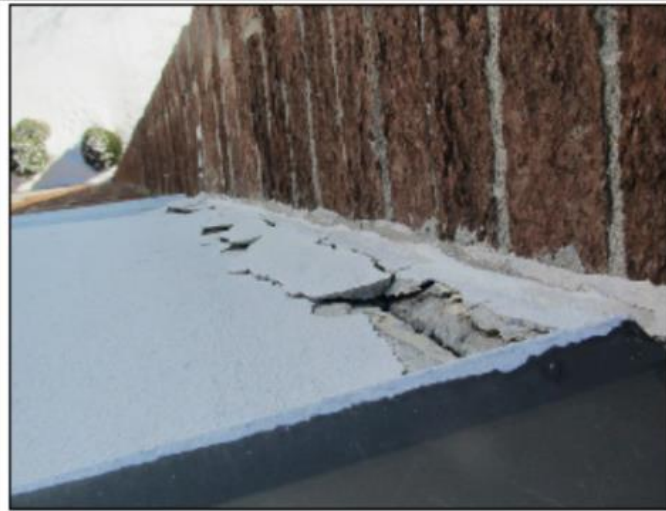
P5 - Concrete Parapet Wall – Looking Down

-Spalling and delamination of concrete at parapet.

-Safety hazard.
-Accelerated deterioration of the parapet wall/structure.
-Air/water infiltration.

-Immediately have the loose pieces knocked off.
-This type of spalling is not typical and should be investigated. Bring in Consultant to review.

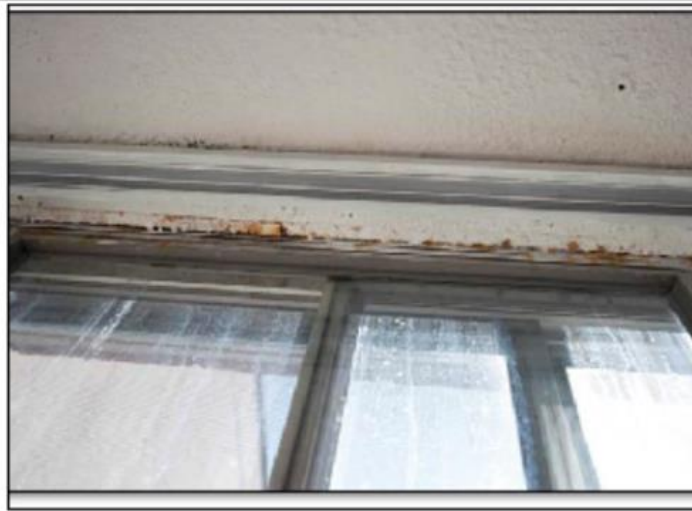
P6 - Window Lintel

-Corrosion on window lintel indicating a leak.

-Rot and mould growth within the wall assembly.
-Damage to structural elements.
-Damage to interior finishes.

-Multiple causes. Bring in Consultant to review.

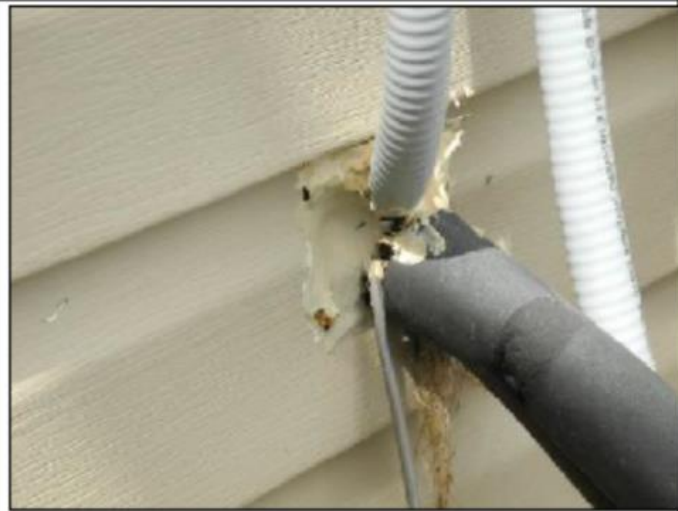
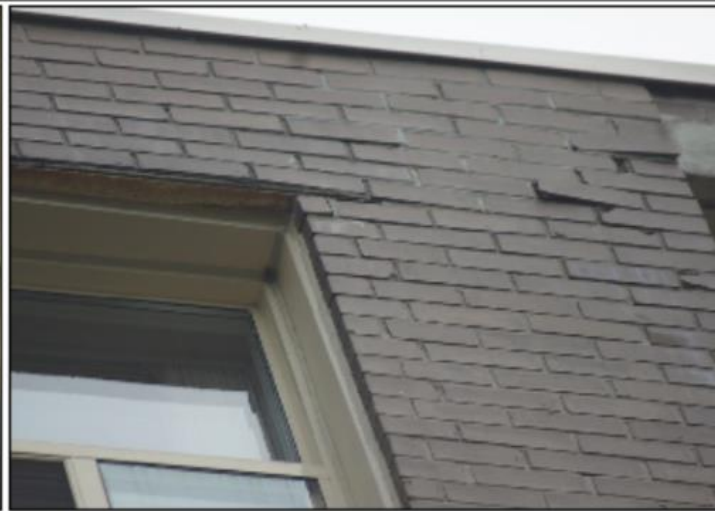
P7 - Siding Penetration	P8 - Brick Veneer
Deficiency? -Poorly installed sealant at wall penetration.	Deficiency? -Spalling bricks.
Maintenance Repair/Strategy? -Remove and replace sealant.	Maintenance Repair/Strategy? -Have loose bricks knocked off – safely. -Replace bricks.
Deferred Repair? -Air/water leakage into the building. -Damage to interior finishes.	Deferred Repair? -Safety hazard. -Accelerated deterioration as more air/water are able to get behind loose bricks. -Deterioration of brick ties, window lintels, wall assemblies, and possibly structural elements.

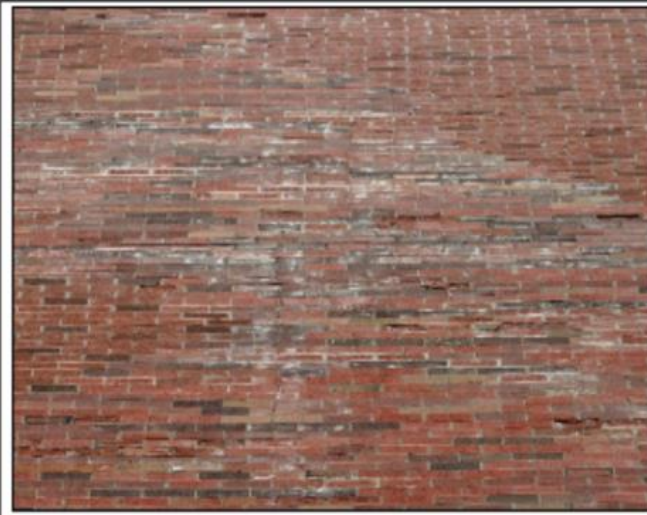
P9 - Brick Veneer

-Efflorescence (salts).

-Deterioration of brick ties and other structural elements.
-Aesthetic issues.

-Not typical. Bring in a Consultant to review.
-Potential for major moisture issues within the wall assembly.

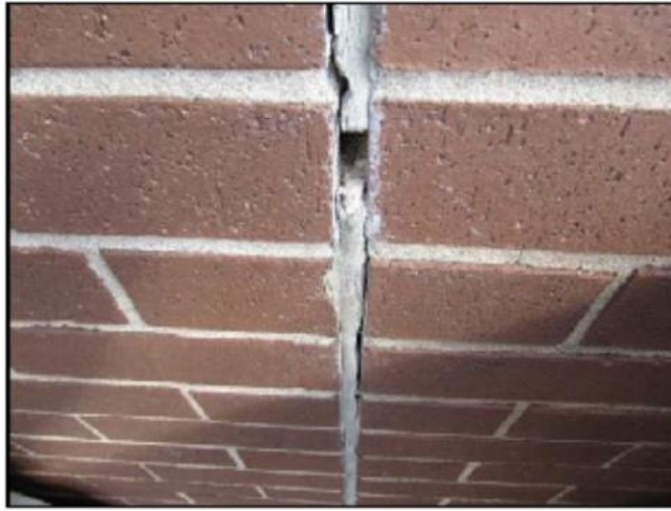
P10 - Brick Control Joint

-Adhesively failed and missing sections of sealant.

-Air/water infiltration into building.
-Insects.

-Remove and replace sealant.

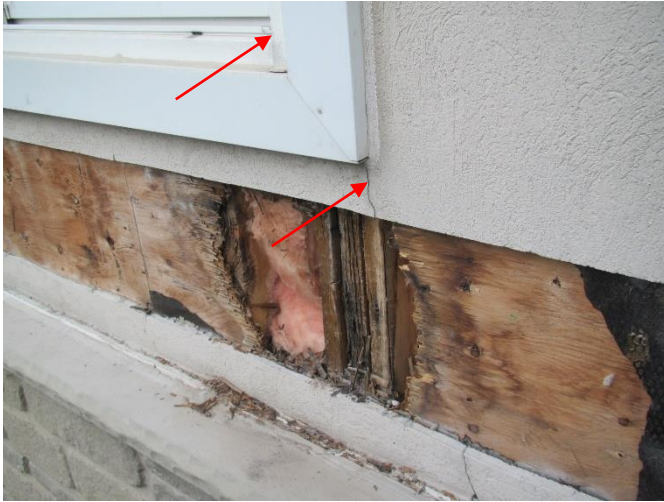
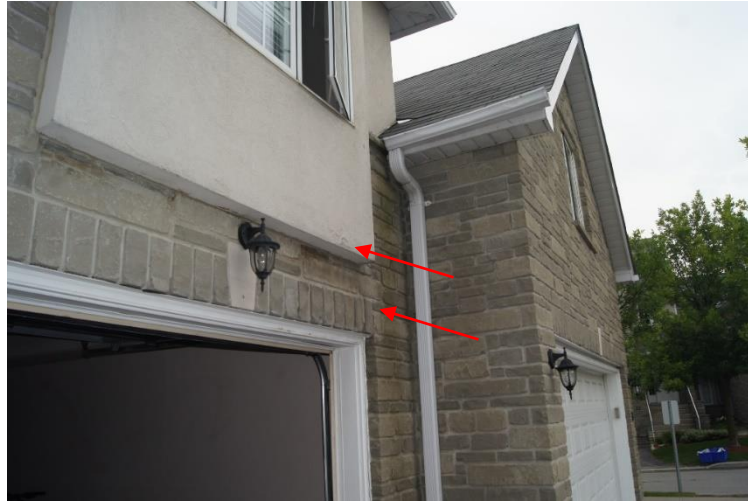
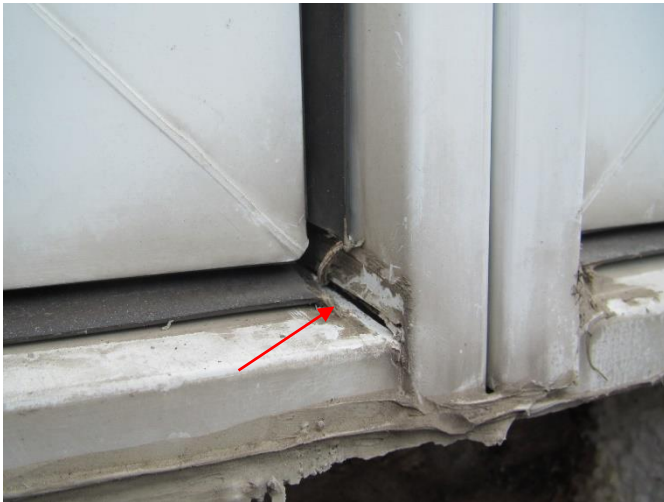
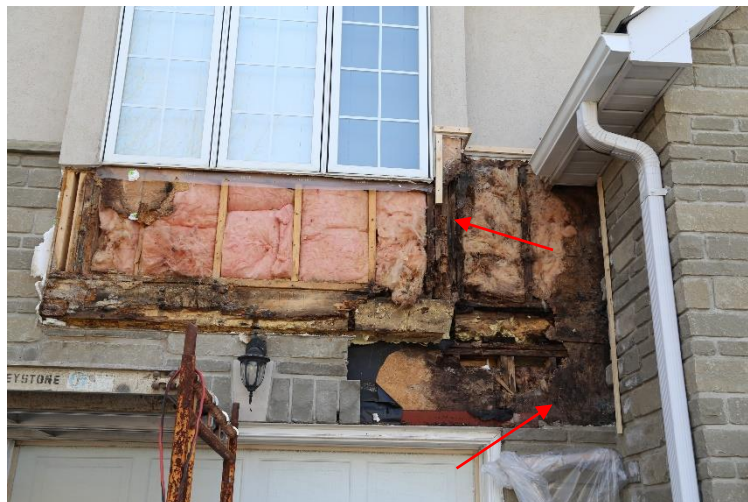
- Summary:
 - Expected Useful Life of Windows and Doors = 35 Years
 - Expected Useful Life of Sealants = 10 to 15 Years
 - Check sealants – Once per year.
 - Check corners of windows on the interior – Ongoing.
 - Check operability – Twice per year.
 - For high-rise multi-res buildings, check for open windows during precipitation events – Ongoing.
 - Check for closers on operable sashes – Ongoing.
 - Check for worn and damaged weather-stripping at doors and operable window perimeters.

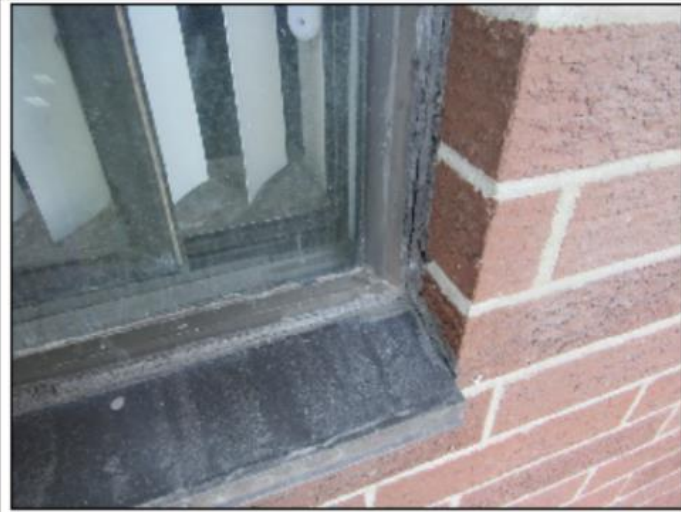
P1 - Single Glazed, Metal Framed Window

-Cracked and deteriorated window sealants.

-Air/water infiltration.
-Deterioration within the wall assembly and interior finishes.
-Condensation and potential for mould growth.
-Tenant discomfort.

-Remove and replace sealants.
-Likely that all similar sealants are failing, in which case a Consultant should be involved.

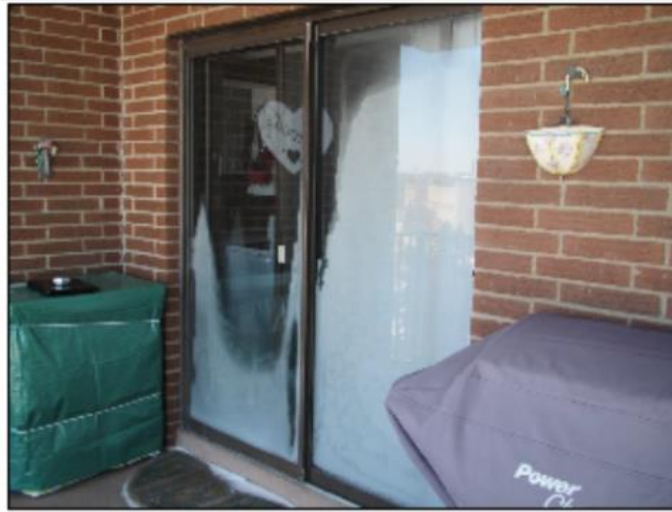
P2 - Single Glazed, Metal Framed Balcony Sliding Door

-Ice on inside of door.

-Not fully operable.
-Tenant discomfort.
-Air leakage into unit.
-Condensation and potential mould growth.

-Multiple causes. Bring in a Consultant to review.

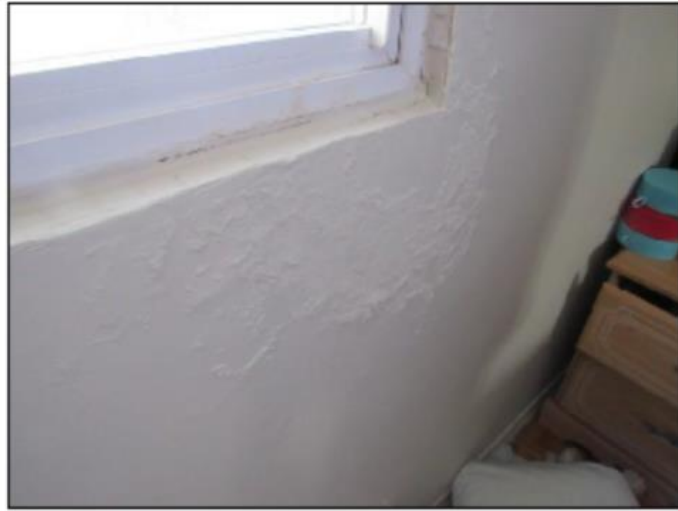
P3 - Interior Wall Below a Bedroom Window

Deficiency?
-Deteriorated finishes.

Deferred Repair?
-Leakage/deterioration within wall assembly.

Maintenance Repair/Strategy?
-Multiple causes. Bring in Consultant to review.

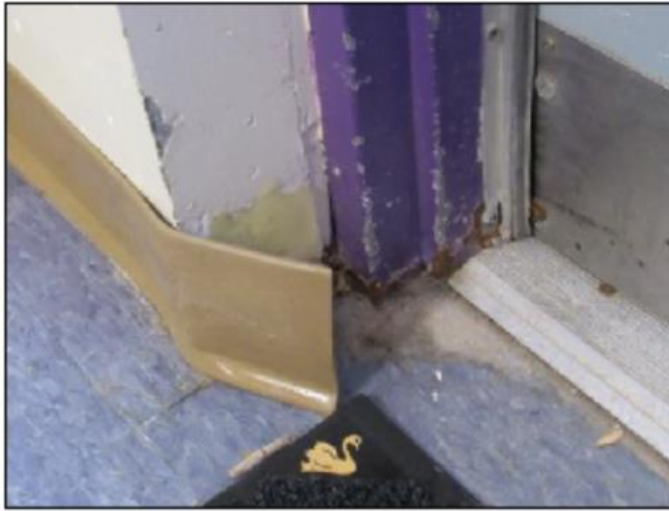
P4 - Emergency Exit Door

Deficiency?
-Corrosion at base of door frames.
-Damaged baseboard.

Deferred Repair?
-Further deterioration of interior finishes.
-Further corrosion of door frame, requiring eventual replacement.
-Leakage into wall assembly.

Maintenance Repair/Strategy?
-Monitor during heavy rain event.
-Check sealants around outside of door.
-Check for ponding water outside of door.

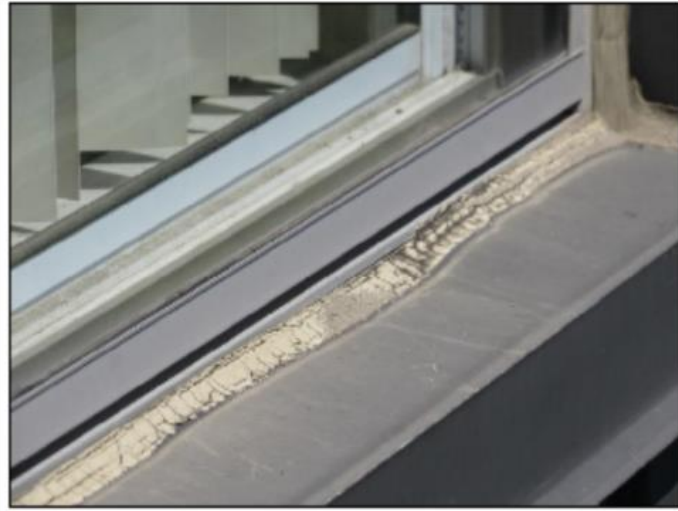
P5 - Single Glazed Window and Metal Sill Flashing

Deficiency?
Deteriorated window sealants.

Deferred Repair?
-Air/water infiltration.
-Deterioration within the wall assembly and interior finishes.
-Condensation and potential for mould growth.
-Tenant discomfort.

Maintenance Repair/Strategy?
-Remove and replace sealants.
-Likely that all similar sealants are failing, in which case a Consultant should be involved.

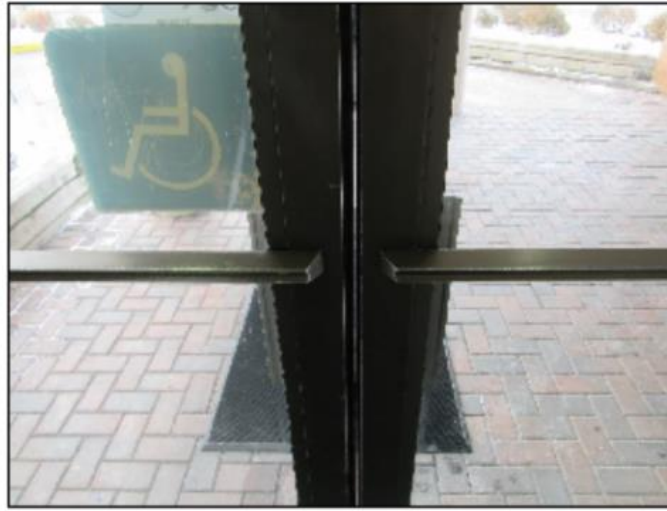
P6 - Main Entrance Double Doors

Deficiency?
-Large gap between entrance doors.

Deferred Repair?
-Air leakage.
-Energy loss.

Maintenance Repair/Strategy?
-Install new weatherstripping.

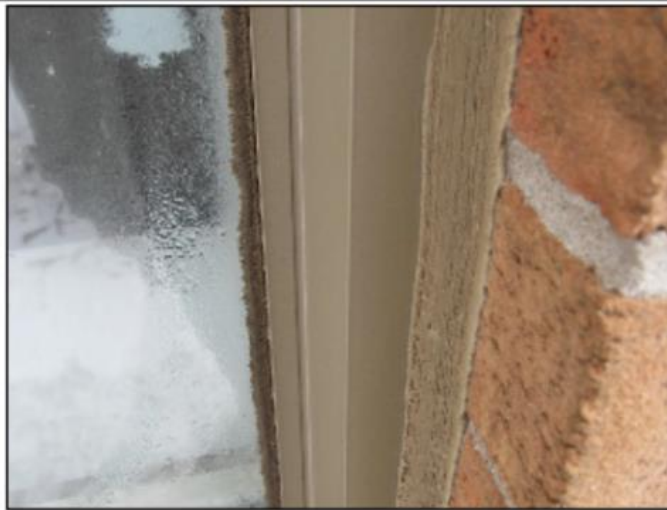
P8 - Insulated Glass Bedroom Window

-Deteriorated window sealant.
-Failed insulated glass unit.

-Energy loss.
-Air/water infiltration causing deterioration within wall assembly.

-Replace window.

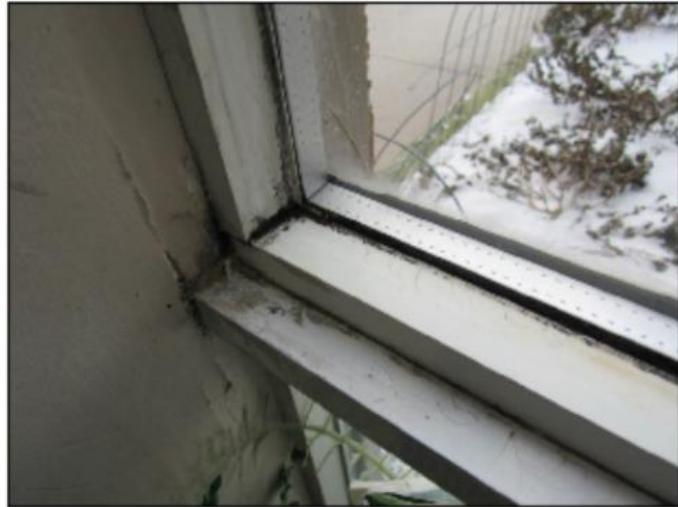
P9 - Insulated Glass Hallway Window

Deficiency?
Mould on inside of window frame.

Deferred Repair?
-Air/water infiltration causing deterioration within wall assembly.
-Potential mould growth.

Maintenance Repair/Strategy?
-Replace window.
-If widespread failure, a consultant should be involved.
