2017 ONPHA Conference and Trade Show

Session 303

Prolonging asset life
and saving you capital

Pretium Anderson Building Engineers

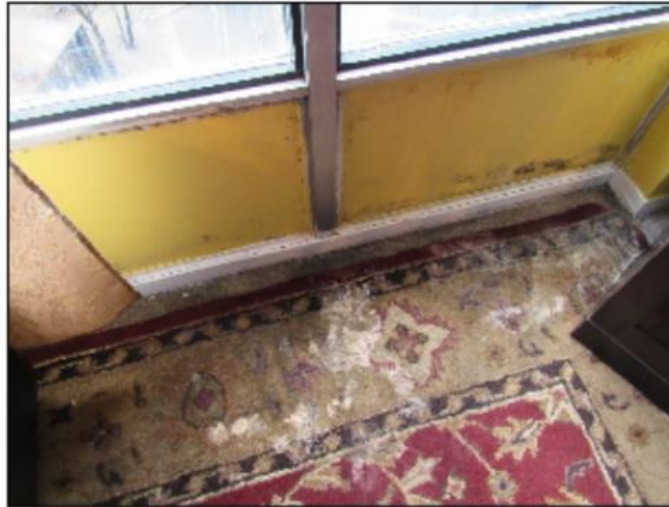
P10 - Living Room Spandrel Panel Windows

Deficiency?
-Mould on windows, frames, and back of spandrel panels.
-Damaged flooring and rug.

Deferred Repair?
-Further mould growth.
-Continued deterioration of window frame, wall assembly, structural elements, and interior finishes.

Maintenance Repair/Strategy?
-Multiple causes. Bring in Consultant to review.

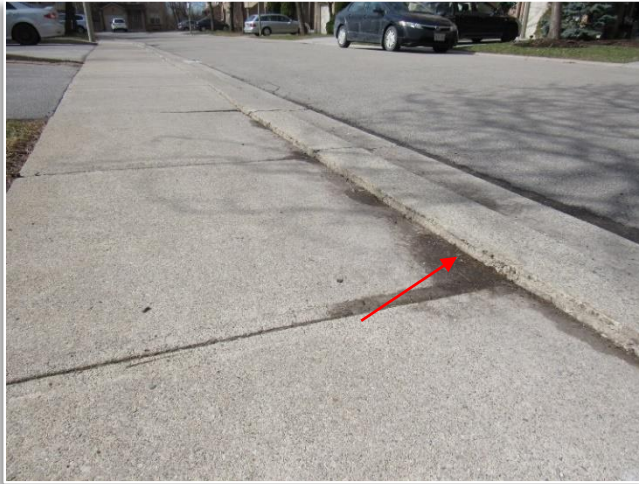
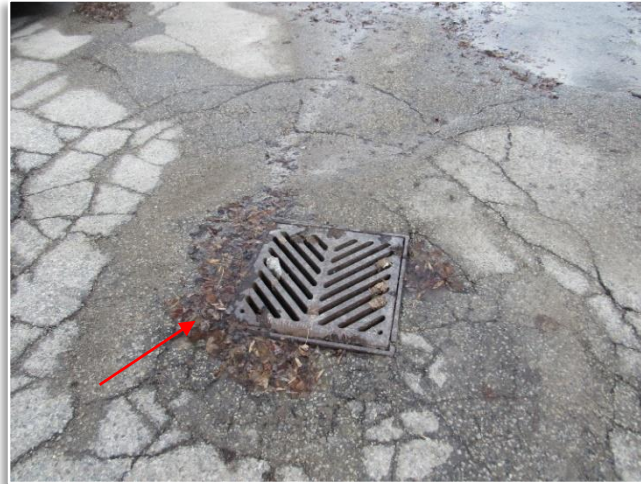
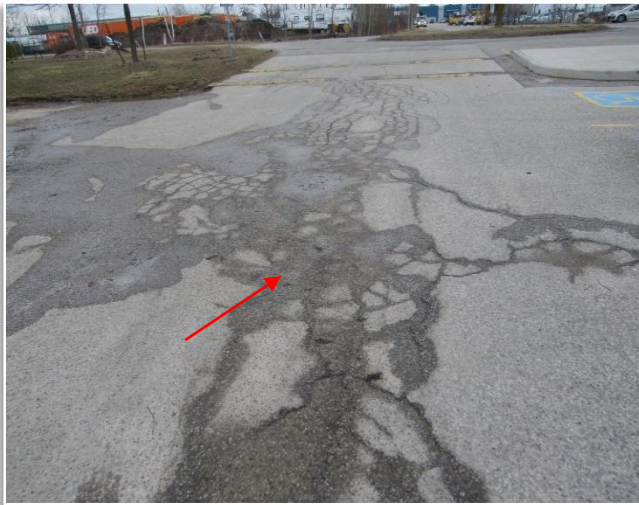
Site and Landscaping

- Summary:
 - Check wood elements (e.g. decks, posts, beams, etc.)
 - Check guard railings
 - Check fences and retaining walls
 - Check height of grading around the foundation walls
 - Obtain proper de-icing salts chemicals (i.e. urea or calcium magnesium acetate)
 - Avoid calcium and sodium chlorides

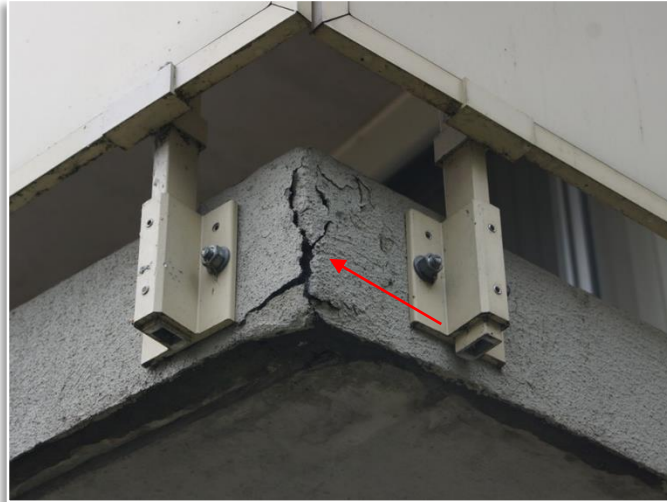
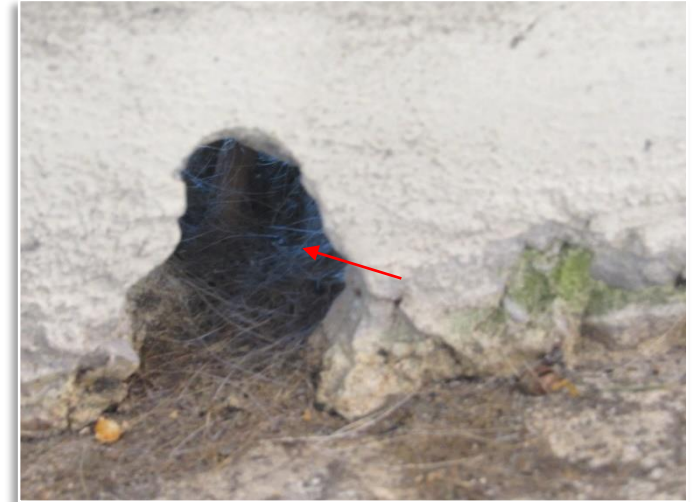
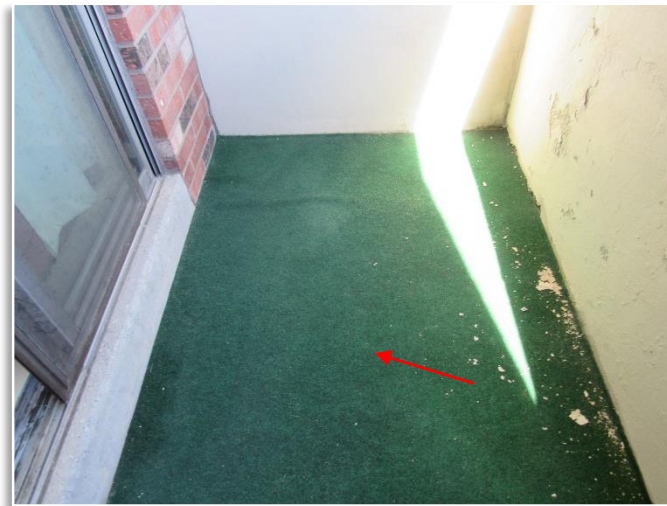
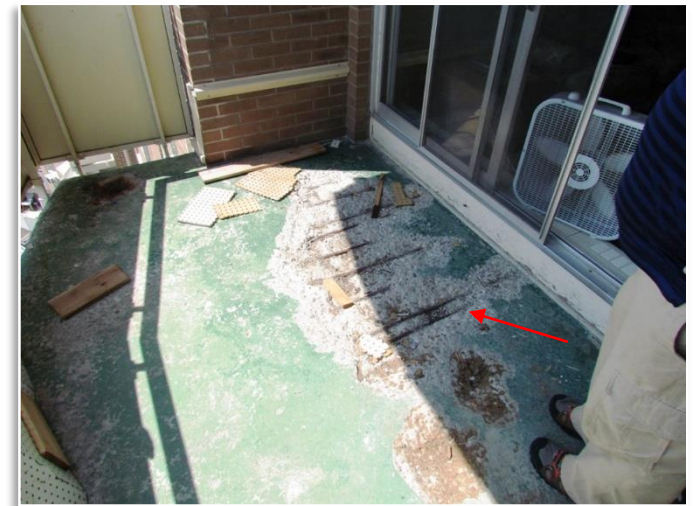
- Balconies

- Balconies:
 - Expected Useful Life of Guards = 30 Years
 - Expected Useful Life of Slab Waterproofing = 20 Years
 - Expected Useful Life of Structure = Life of Building
 - Visual Review from Exterior – Once Per Year.
 - Check for Staining (i.e. corrosion) – Ongoing.
 - Check for Cracking – Ongoing at Tenant Turnover.
 - Remove Carpets – Ongoing at Tenant Turnover.
- Parking Garages:
 - Expected Useful Life of Roof Slab Waterproofing = 30 Years
 - Expected Useful Life of Expansion Joint Waterproofing = 25 Years
 - Expected Useful Life of Structure = Life of Building
 - Walk-through Entire Garage – Twice per year.
 - Check for Cracking – Ongoing.
 - Check for Leaks – Ongoing.
