LITHIUM ION BATTERY CELL R2R MANUFACTURING

AIMCAL R2R Technical Conference USA 2017

Lithium Ion Battery Cell R2R Manufacturing

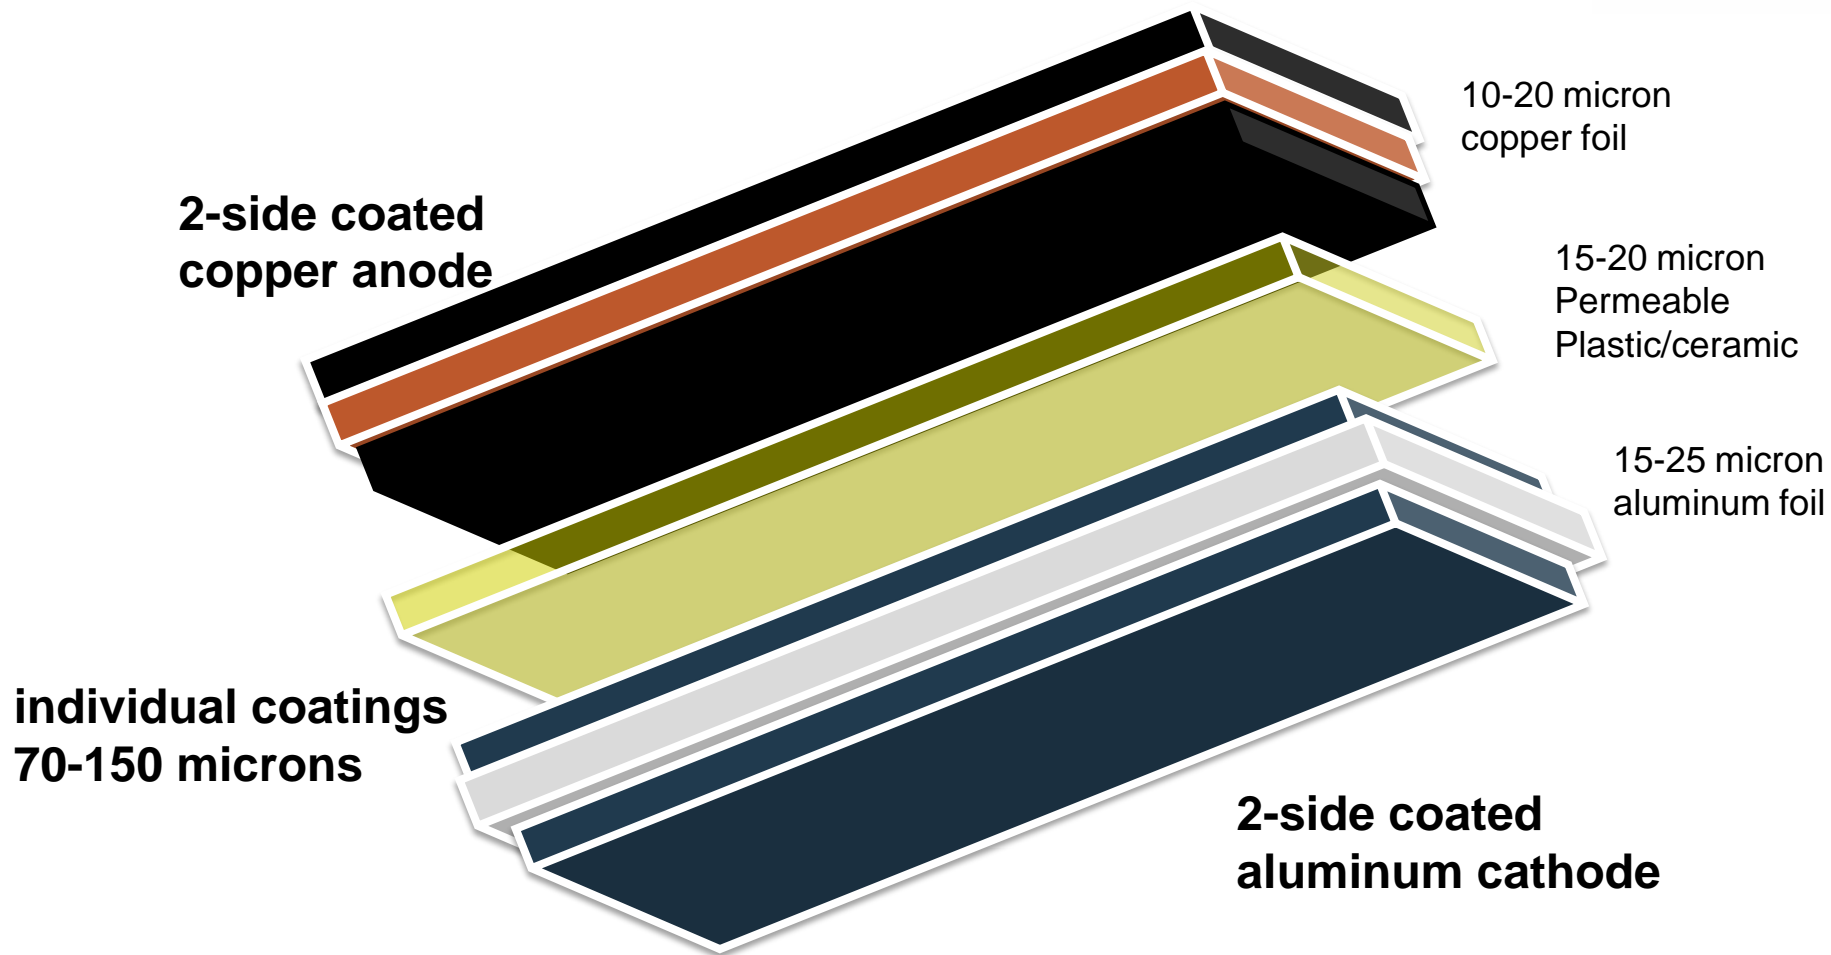
- **Electrolyte liquid bath**

- Organic Carbonate
- e- insulator
- Li⁺ transport medium
- **FLAMMABLE**

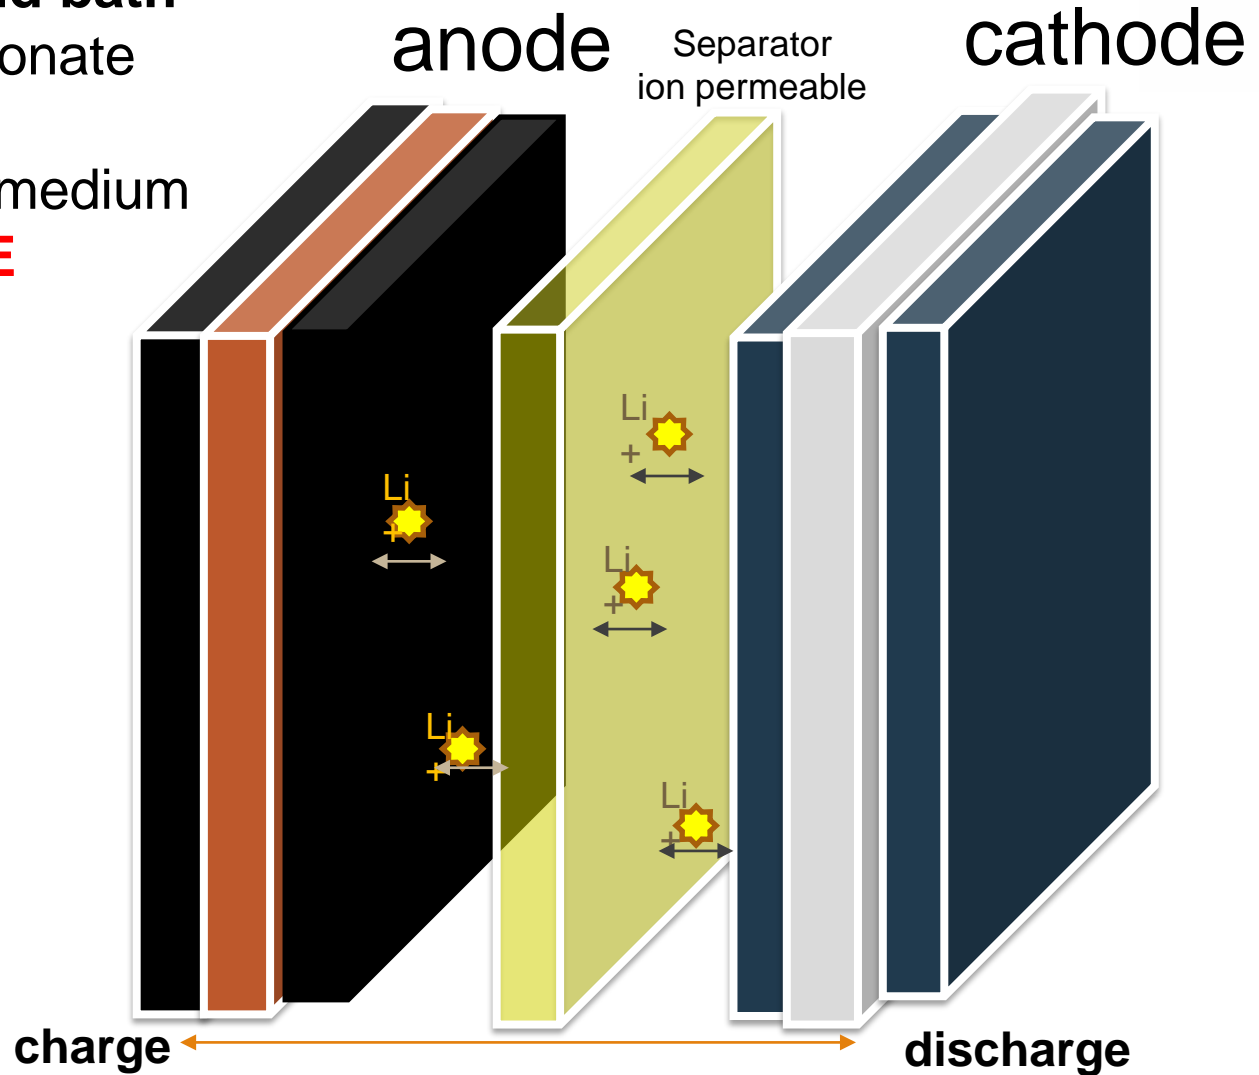
Internal Damage SHORT CIRCUIT

- **Dramatic** temp increase
- Vaporization of electrolyte
- Bulging/rupture of pouch
- Spark source.....
- **EXPLOSION/FIRE**

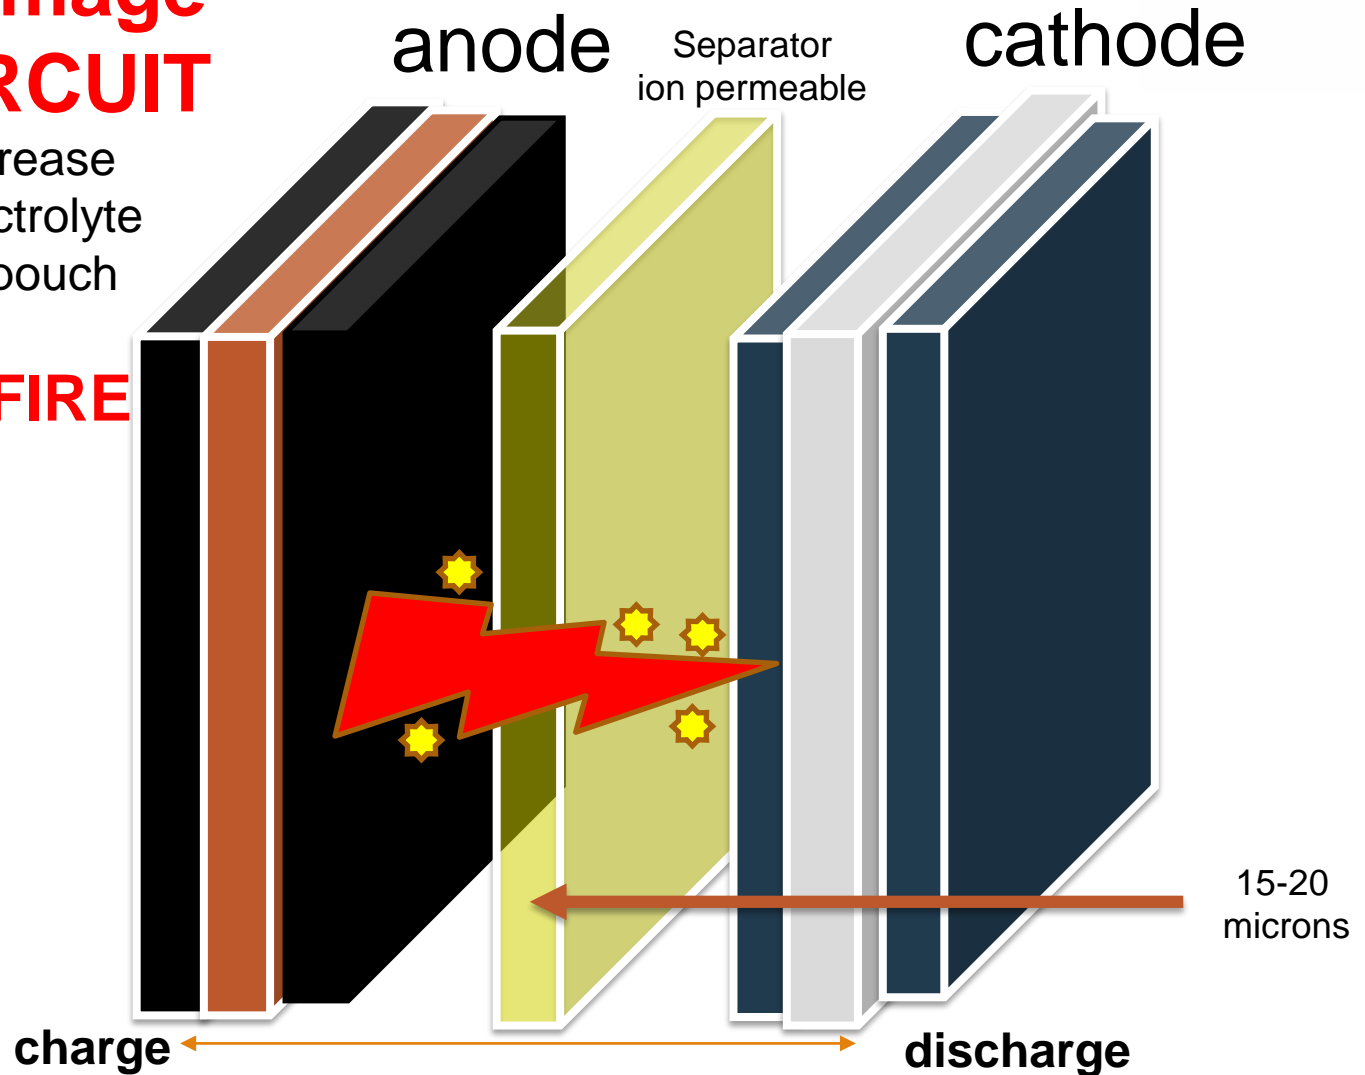
Internal Damage

SHORT CIRCUIT

- Coating-imbedded particles
- Ambient air particles
- Flaking coating
- Metal substrate shards
- Coating defects
- Edge/edge contact
 - Misaligned electrode
 - Mis-cut electrode
 - Misaligned separator
 - Pouch deformation
- **Manufacturing faults**

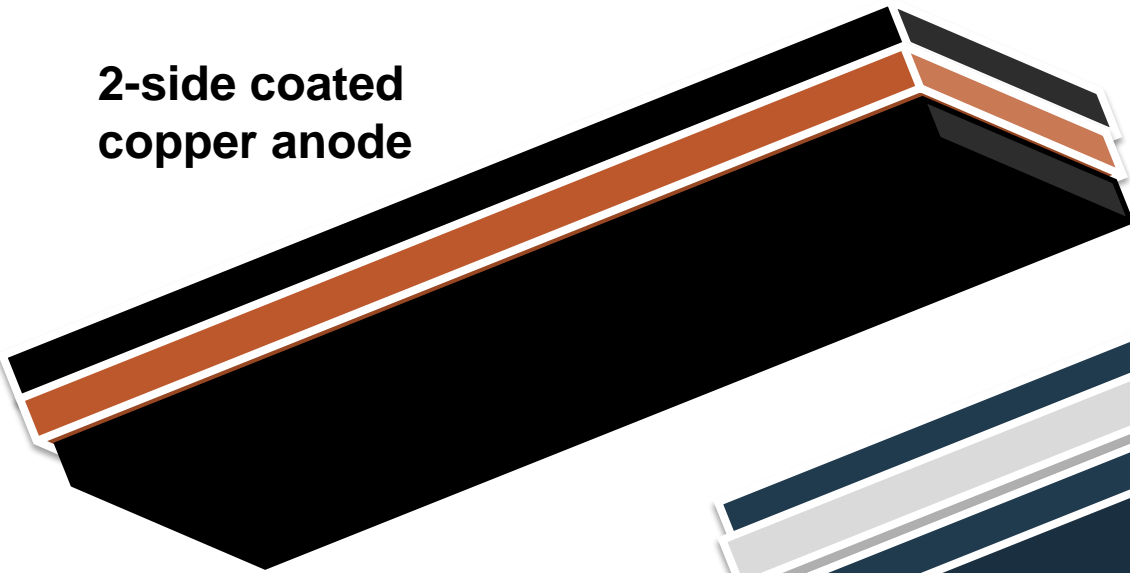
2-side coated
copper anode

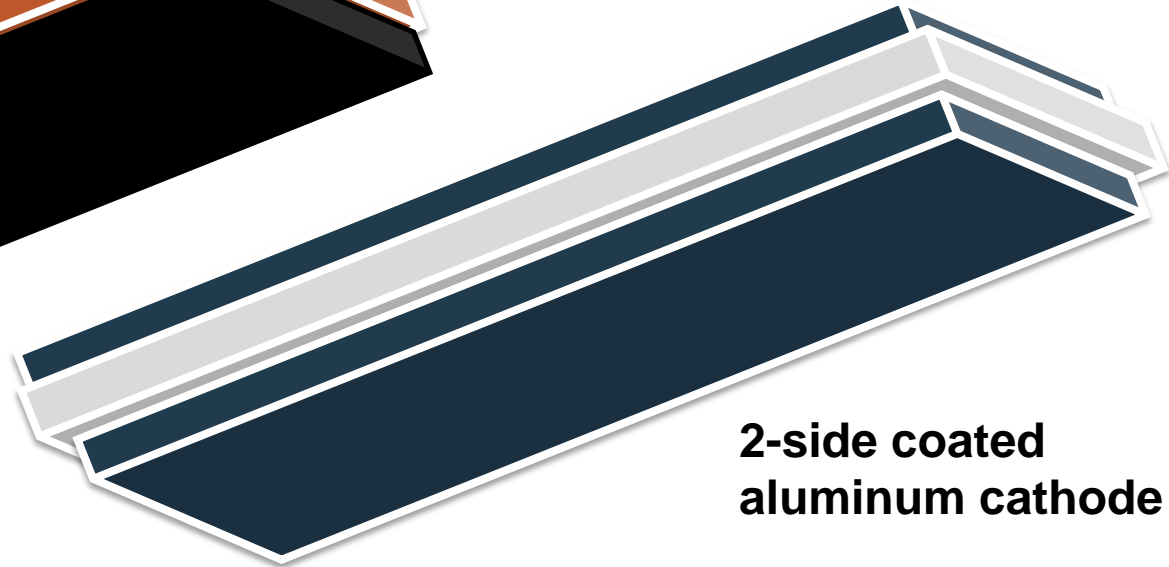
2-side coated
aluminum cathode

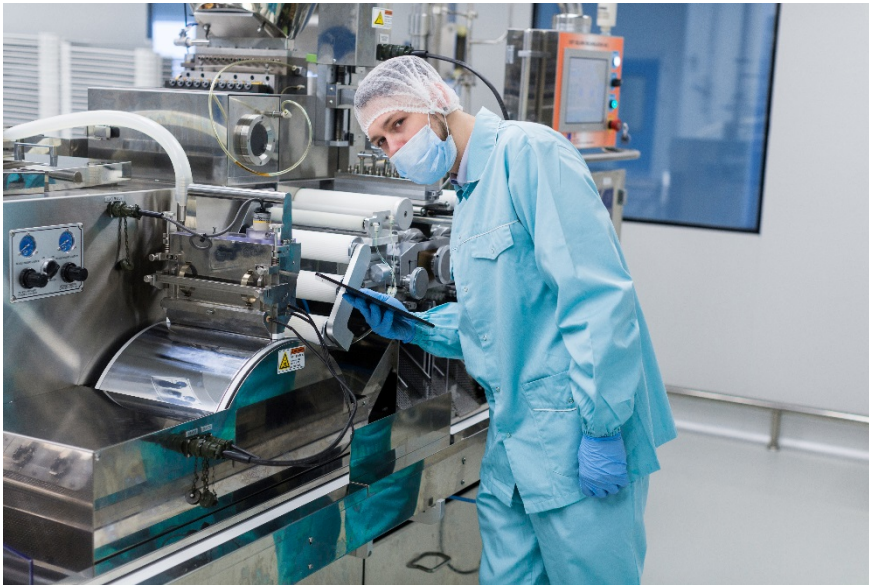
R2R Manufacturing Anode and Cathode Electrode

- Environment
 - Clean Room
 - Class 10000,
 - Class 1000
 - Dry room
 - < 10% RH
 - Expensive sq. footage

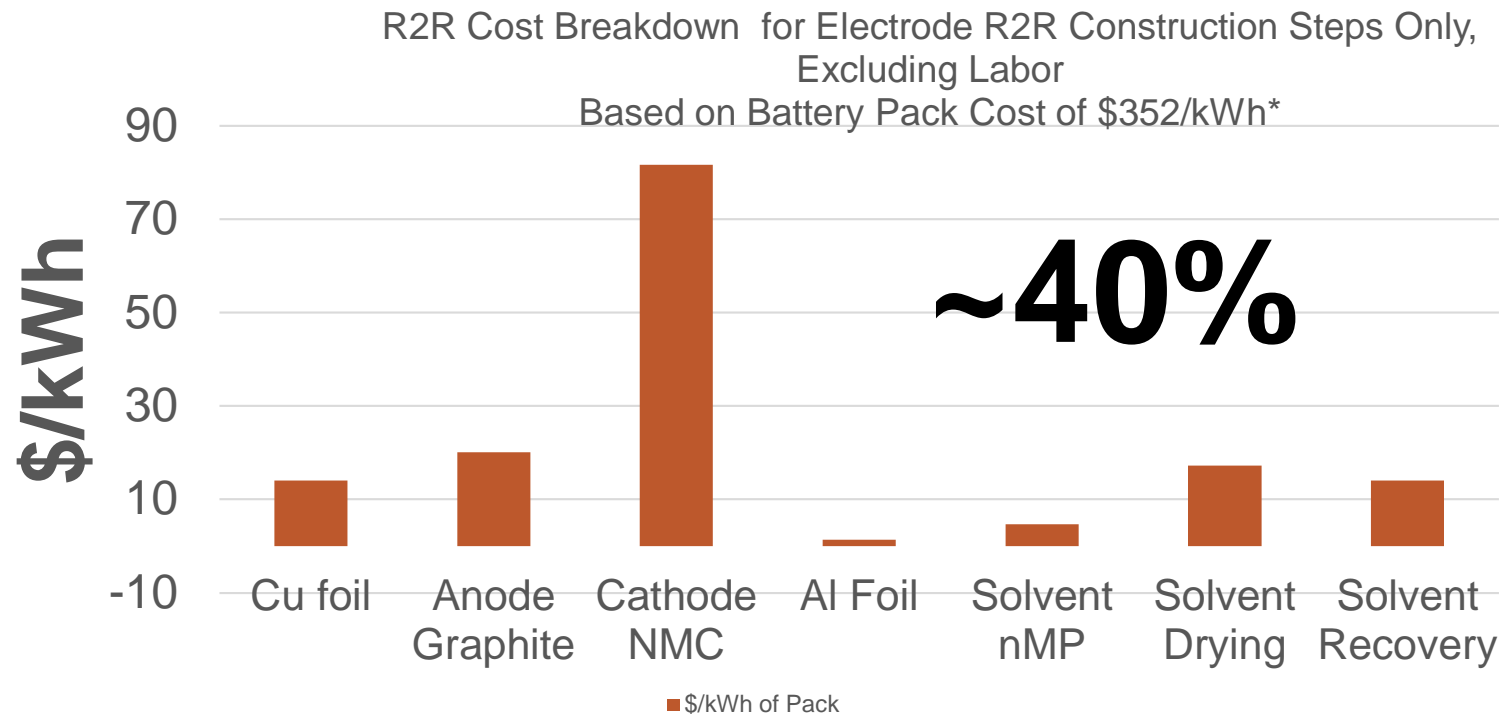
Approximate R2R Electrode Processing Cost Contribution to a Battery Pack*

*Power Cells 52 Ah, 3.5 V

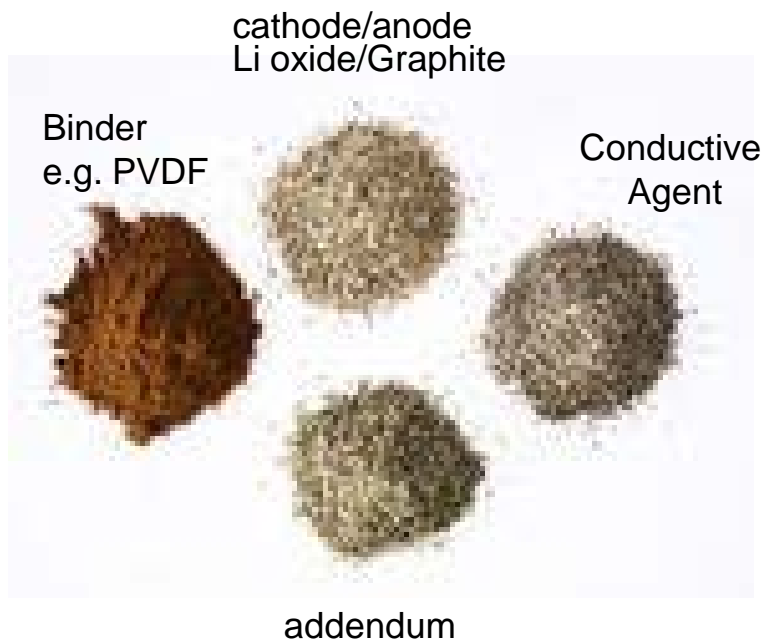
Typical Chemistry

- Anode – graphite
- Conductive agent – carbon black
- Binders
 - PVDF in solvent (nMP)
 - Water soluble (e.g. CMC, SBR)
- Others
- Cathode – Li oxide

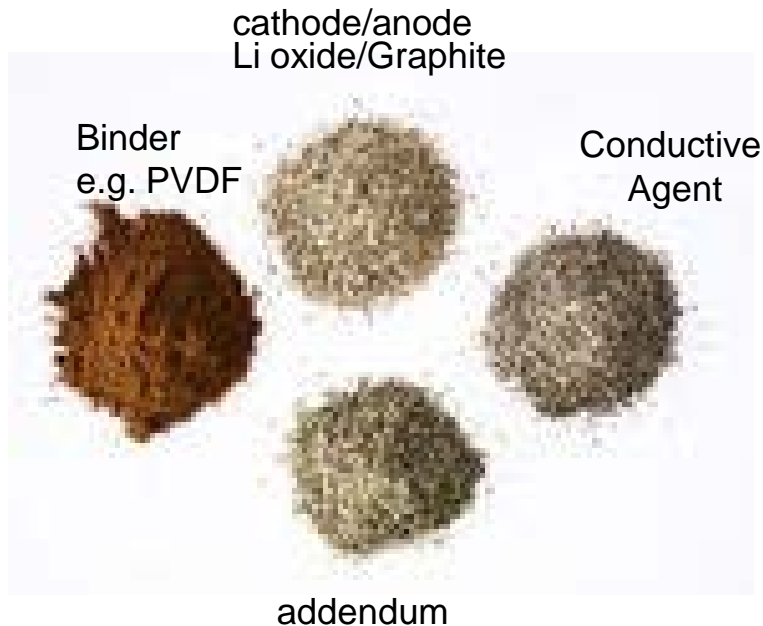
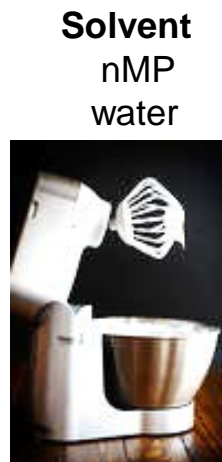
Typical Slurry Characteristics

Solvent
nMP
water

- 10-40K cps (@10/s)
- Very high P/B
- High % solids
- Well dispersed
- No agglomerates

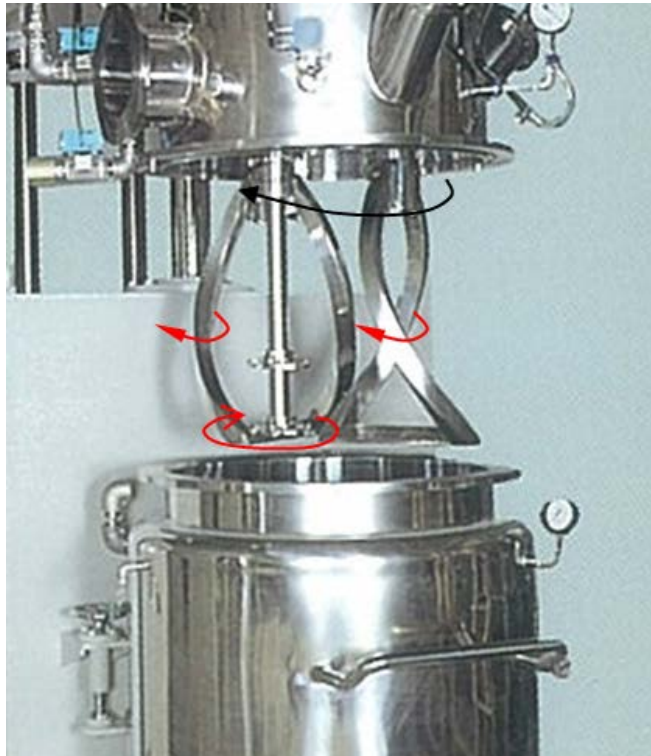
Cowles Blade Dispersing Technology

- Cowles blade dispersing
- Planetary blades bulk mixing
- Mixing 5-7 hours
- 3-Vessel configuration/pumps
 - Mixing
 - Deaeration
 - Delivery
- Significant material in process
- Mixing mechanism above tank
 - Contamination/cleaning issues

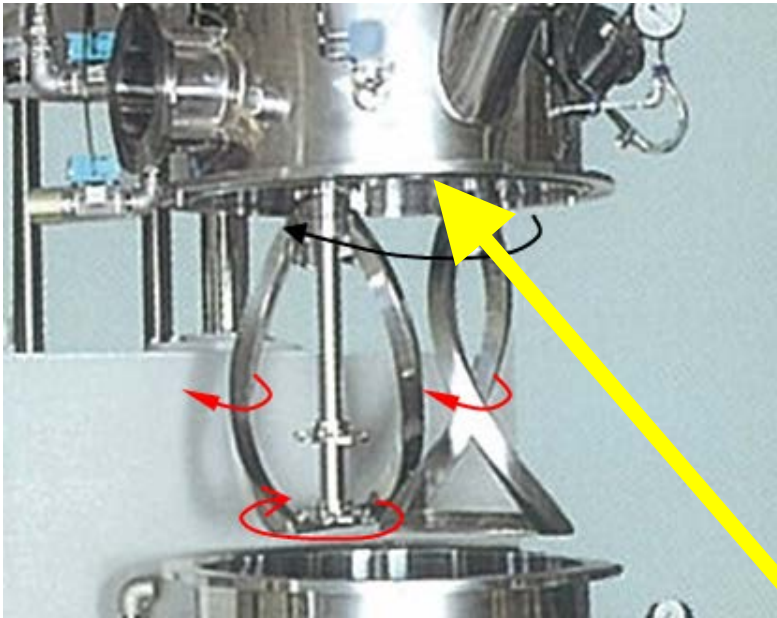
Cowles Blade Dispersing Technology

- Cowles blade dispersing
- Planetary blades bulk mixing
- Mixing 5-7 hours
- 3-Vessel configuration/pumps
 - Mixing
 - Deaeration
 - Delivery
- Significant material in process
- Mixing mechanism above tank
 - Contamination/cleaning issues
