Planning for the Hopkins River Bridge Project.

David Hildebrand: Senior Asset Management Officer, VicRoads Western Victoria

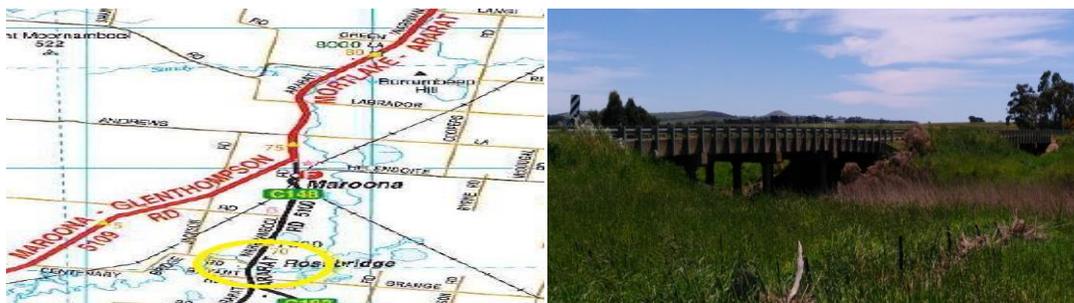
Figure 1. Location of Works and picture of site

The Hopkins River runs through a small locality known as Rossbridge and is located 24km south of Ararat in Western Victoria. The river is crossed by the Mortlake to Ararat Road and is bridged by two small structures completed in 1954 and separated by less than 20m; the main structure over the Hopkins River is a 4 span u-slab structure 24.5m long and the smaller bridge is a 3 span u-slab 18.4m long¹.

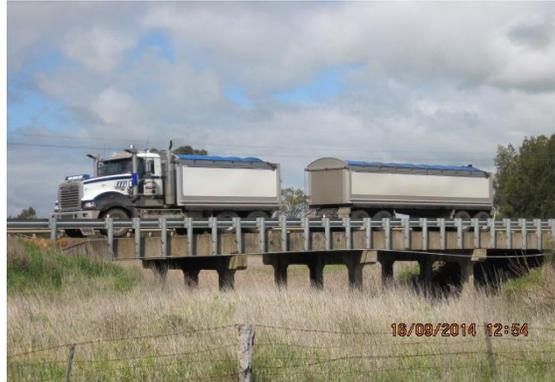
Figure 2. The developing arch like profile of the main bridge

As can be seen in the preceding images the main structure was developing an almost arch-like form that was definitely not in the original design. On closer inspection it was determined that both abutments had subsided considerably – estimated to be up to 200mm in places; this displacement at either end of the structure placed undue stress on the 1950's era u-slabs, crossheads etc with some obvious displacement visible in the soffit of the u-slab beams³.

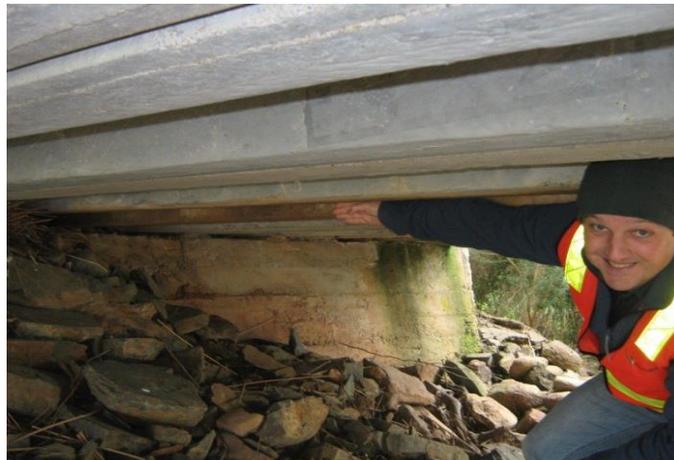
Figure 3. Picture of the author during a closer inspection where discrepancies in u-slab beam levels due were immediately obvious and due to abutment subsidence on the main bridge.

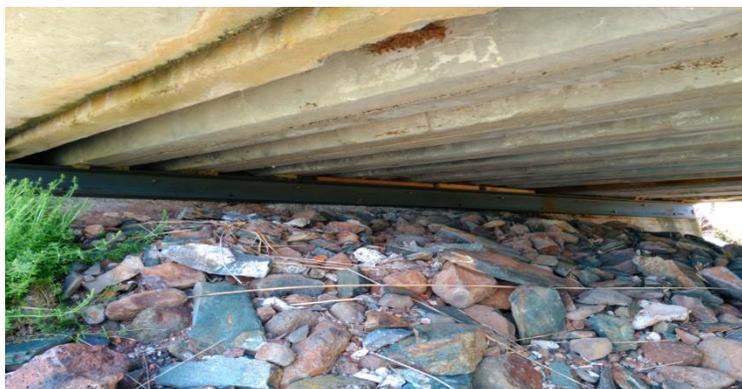
Figure 5. Steel c-section bolted through to the abutment, bracing it and preventing further subsidence
