Replacement Of Four Long Bridges In Fiji Islands

Abstract: Four bridges in the Fiji Islands were recently replaced using a Design and Construction procurement method for the Fiji Road Authority. The bridges provided vehicle, pedestrian and Fiji Sugar Corporation cane trains over waterways subjected to significant flood events. Design of the replacement bridges was specified to Fiji and New Zealand standards for a 100 year design life. This high specification required additional concrete cover and high strength concrete mixes with supplementary cementitious materials and corrosion inhibitors to ensure durability. Ground conditions at the sites were generally poor and one site had no rock proven in investigations to 65m below ground level. Design requirements to NZ standards required stringent seismic performance criteria to be met. To meet these, the design used ground improvements at the abutments to control abutment stability and movements and the bridge structures were detailed for a ductile seismic response. Standardisation of the replacement bridges was developed into the designs to achieve efficiencies through repetition. Construction of the bridges required innovation to bui

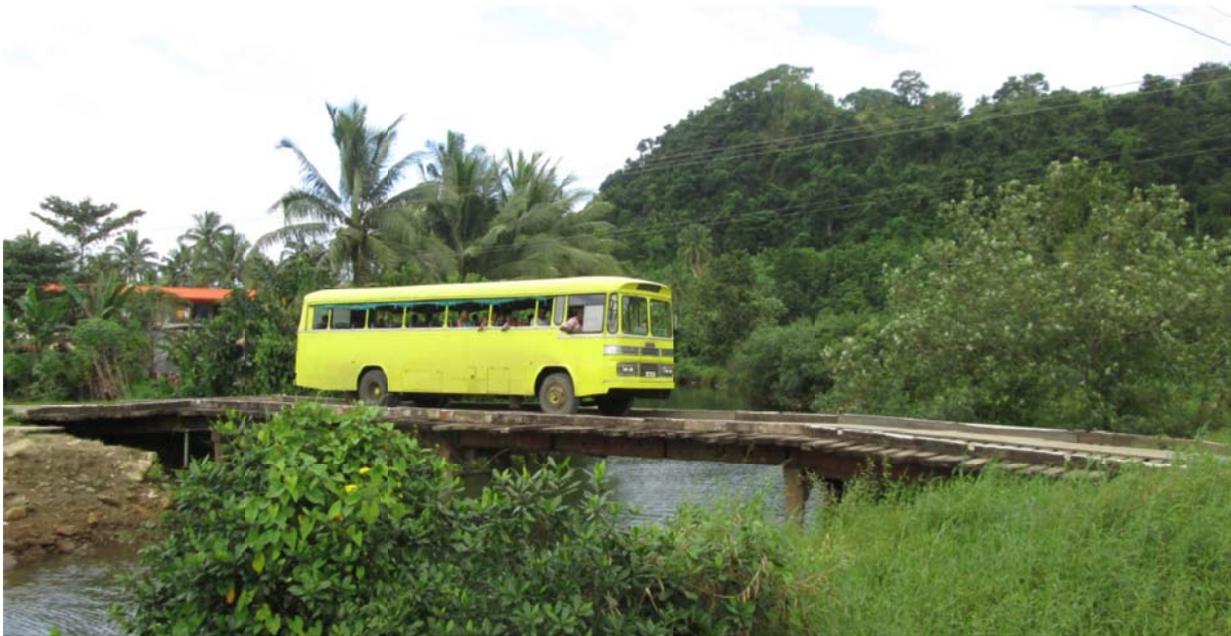
Figure 2. Existing Vunidilo bridge.

The bridges provided access for vehicles, pedestrians and Fiji Sugar Corporation (FSC) cane trains over waterways. The bridges were located on local road networks with traffic volumes of approximately 100 vehicles per day, however, where important for routes for FSC trains were these were carried by the bridges. The existing bridges were multiple span structures with total lengths of between 30 to 60m long and typically constructed using short I-girder spans with a timber deck. The waterways were in most cases prone to significant flooding and over topping of the bridge decks.

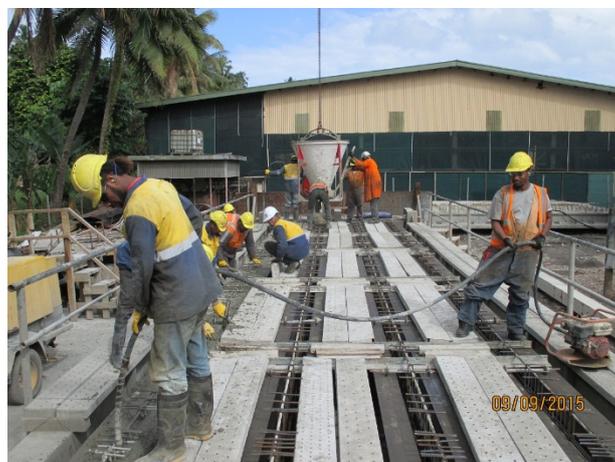
The benefits of this location were evident when, due to poor quality aggregates in the Central Division of Viti Levu, the 50Mpa concrete required for the beams proved challenging to make. To overcome this, concrete suppliers would use a very high cement content of 550Kg/m³. This high cement content coupled with warm ambient temperatures resulted in a mix that would lose workability quickly, thus affecting the placement and compaction of the concrete in tight forms as shown in Figure 6. The precast yards close proximity to an established batching plant overcame this issue.

Figure 6. Precasting operations in the Suva yard.

It was chosen to manufacture the precast beams for all of the bridges in Suva and incur the additional cost of transporting them to the sites on trucks that were specially procured by our logistics supplier for the project. This decision was quality driven as the yard’s close proximity to substantial infrastructure meant that we could have oversight of the suppliers supplying the materials for the precast beams as well as back up generators for reliable power supply and mains potable water for curing the concrete and cleaning the bed ensuring fast turnaround of the beams.

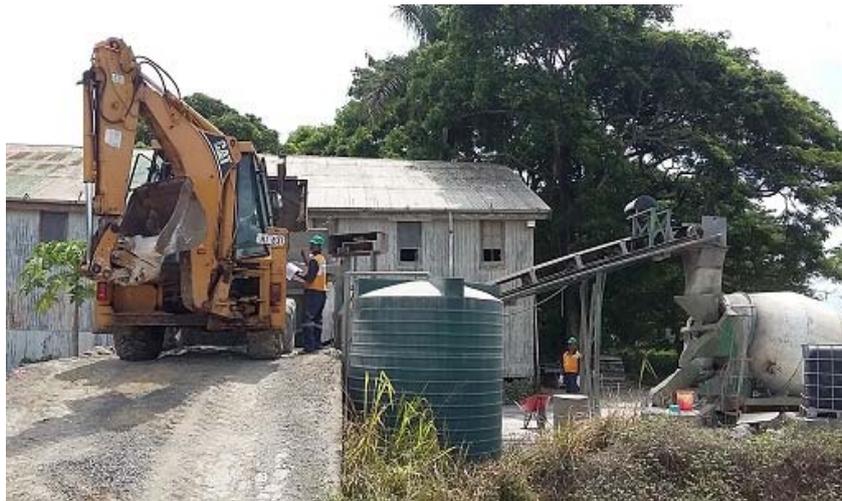
In addition to the logistics challenges described above, the other main challenge we faced at this site was that the only concrete plant in Labasa (Figure 8) was dated and used a very manual process where cement was added by hand. This resulted in limited production of concrete: in the vicinity of 10m³/ hour. As the quality of the concrete was key to the project's outcomes, we engaged the supplier five months prior to commencement on site to conduct initial trials to overcome these concerns. Although the concrete reached the desired 40Mpa in the initial test, there remained concerns around quality control at the plant and their ability to deliver the consistent concrete that we required to ensure correct placement and compaction. Initial investigation required that the scales have calibration certificates issued and that a flow meter be installed to ensure that the correct amount of water was added to the mix. We employed the technique of cooling the aggregate stock pile overnight and conducting early morning pours to help combat the concrete becoming unworkable on the 30 minute commute to site. This in turn created consistency issues as the supplier had traditionally used an assumed water content in their mix design and did not carry out any adjustment to allow for the water in the aggregates. To overcome this issue an adjustment spreadsheet was developed so that our site staff could calculate an adjusted mix design based on the moisture content of the aggregates. Thus it was ensured that the accuracy of measurement in table 2.2 of NZS3104:2003 was achieved and that consistent mix was delivered to site.

Figure 8. Concrete batching plant in Labasa.
