Efficient Bridge Deck Inspection and Assessment Framework Utilizing Image-Based Non-destructive Evaluation Methods

Presented by Shuhei Hiasa

Ph.D., Visiting Scholar at University of Central Florida, and
Civil Engineer at West Nippon Expressway Company Limited (NEXCO-West)

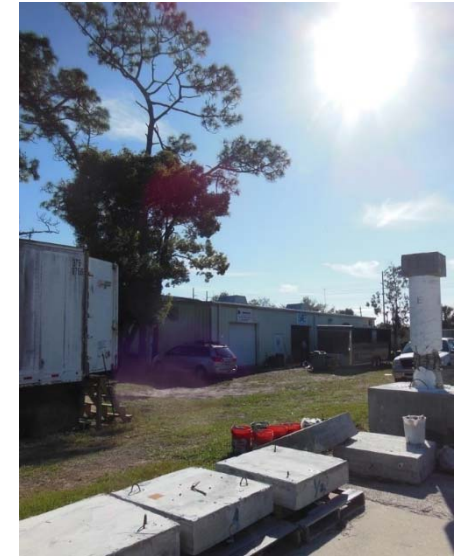
(a) Test site situation

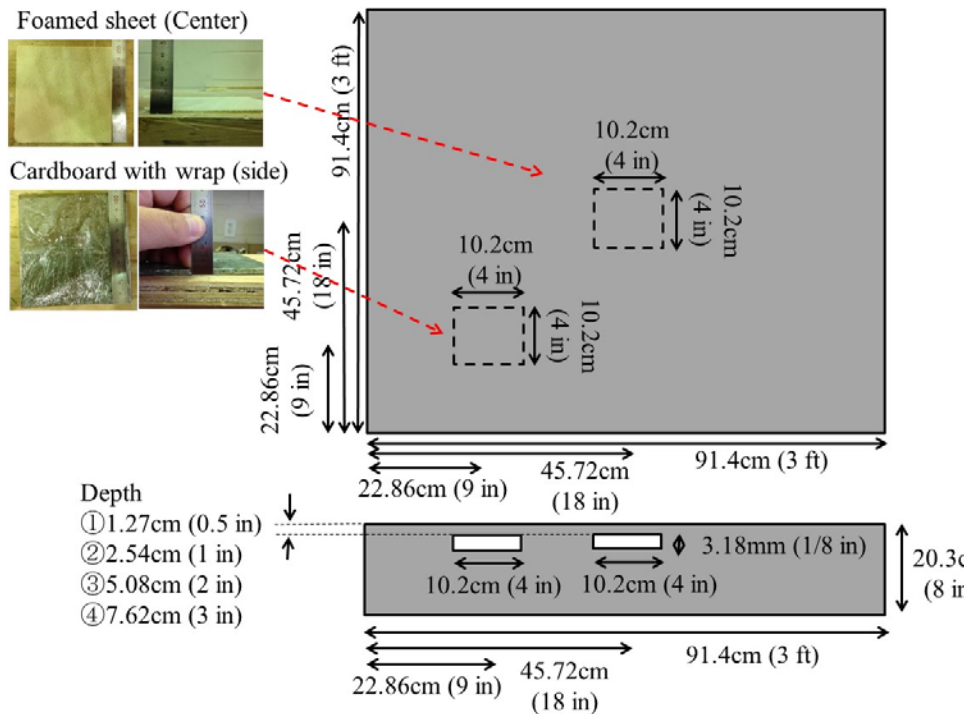
(b) Dimensions of test specimens

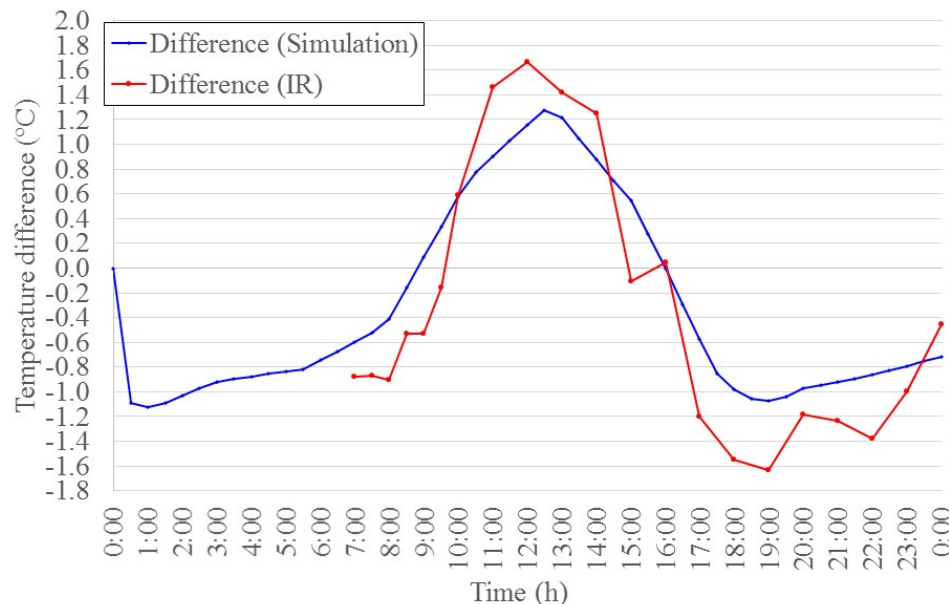
Compared temperatures of delaminated and sound points

(a) 1.3 cm depth of delamination

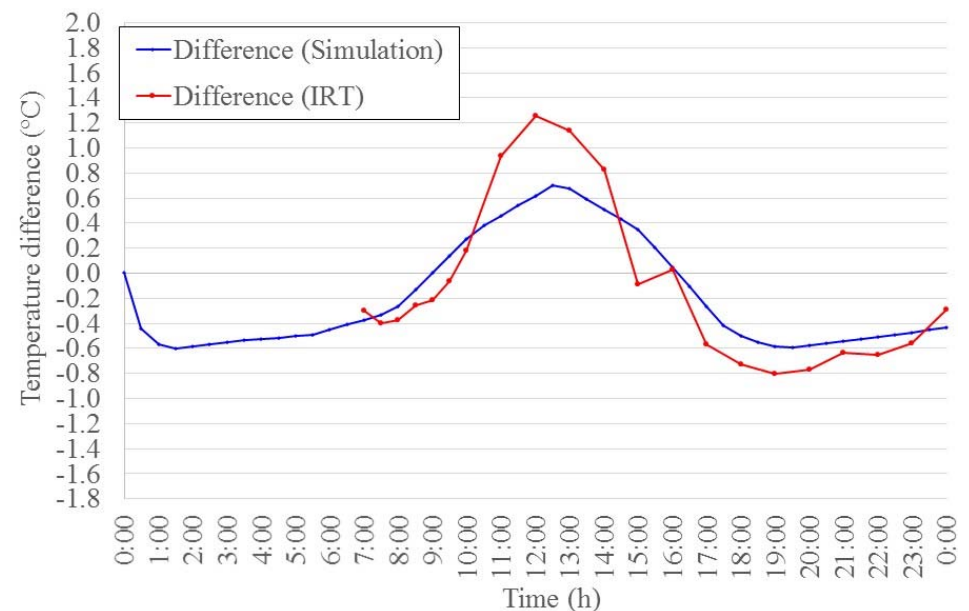
(b) 2.5 cm depth of delamination

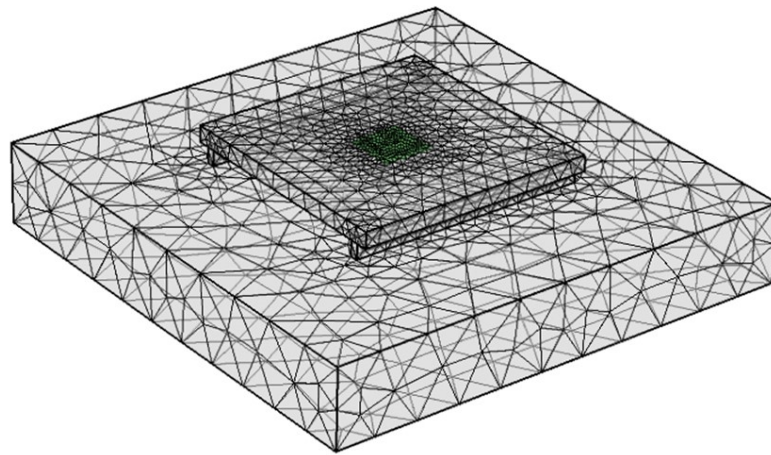
(a) General view

Dimensions of FE model:

- Concrete block: $300 \times 300 \times 20.3$ cm (expanded)
- Delamination area: $L = 10, 15, 20, 30, 40, 50$ & 60 cm
- Delamination thickness: $T = 0.1, 0.3, 1, 10, 15$ cm
- Depth of delamination: 5.1 cm (2 in.) depth (typical top concrete cover)

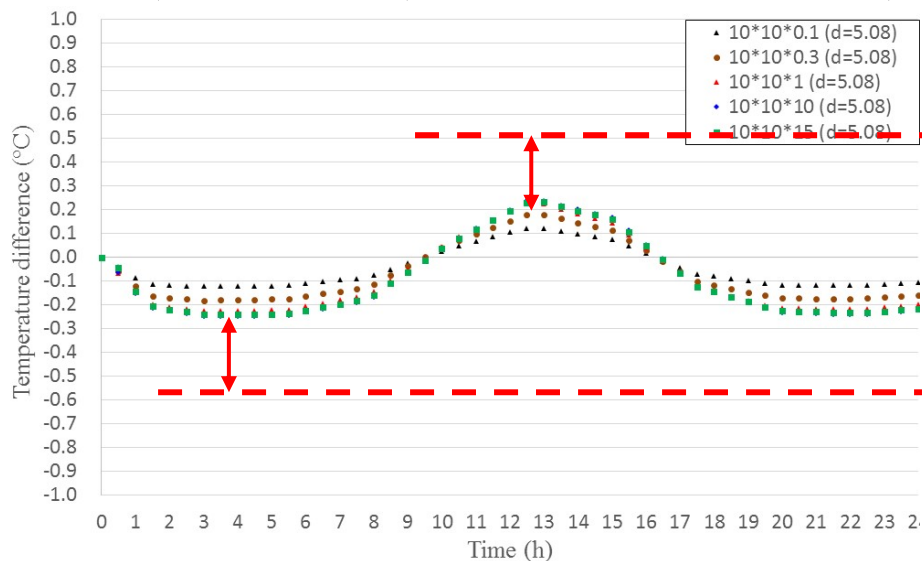
- $A = 100 \text{ cm}^2$: thickness and volume \Rightarrow insignificant impact on ΔT
- $A = 900 \text{ cm}^2$: ΔT increases as the thickness increases
- The effect of thickness increases as the area increases
- The effect of thickness converges to a certain value: approx. 1 cm
- Volume has no effect on ΔT

(a) $10 \times 10 \times T \text{ cm}$ (5.1 cm depth)

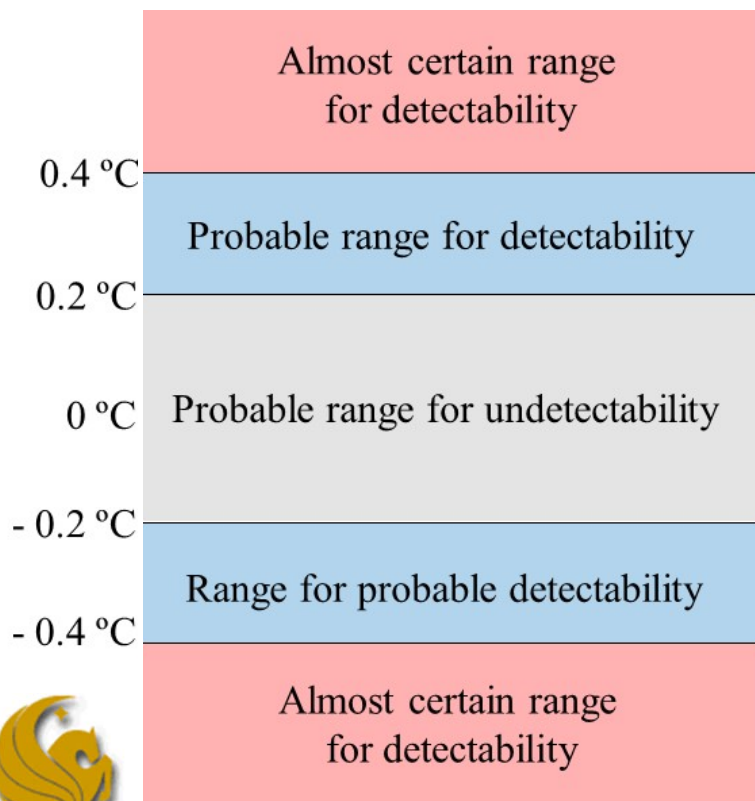
Detectable depth by IRT

➤ Outside of ± 0.2 °C: probably detectable by IRT

➤ If $A \geq 15 \times 15$ cm ($T = 0.3$ cm)

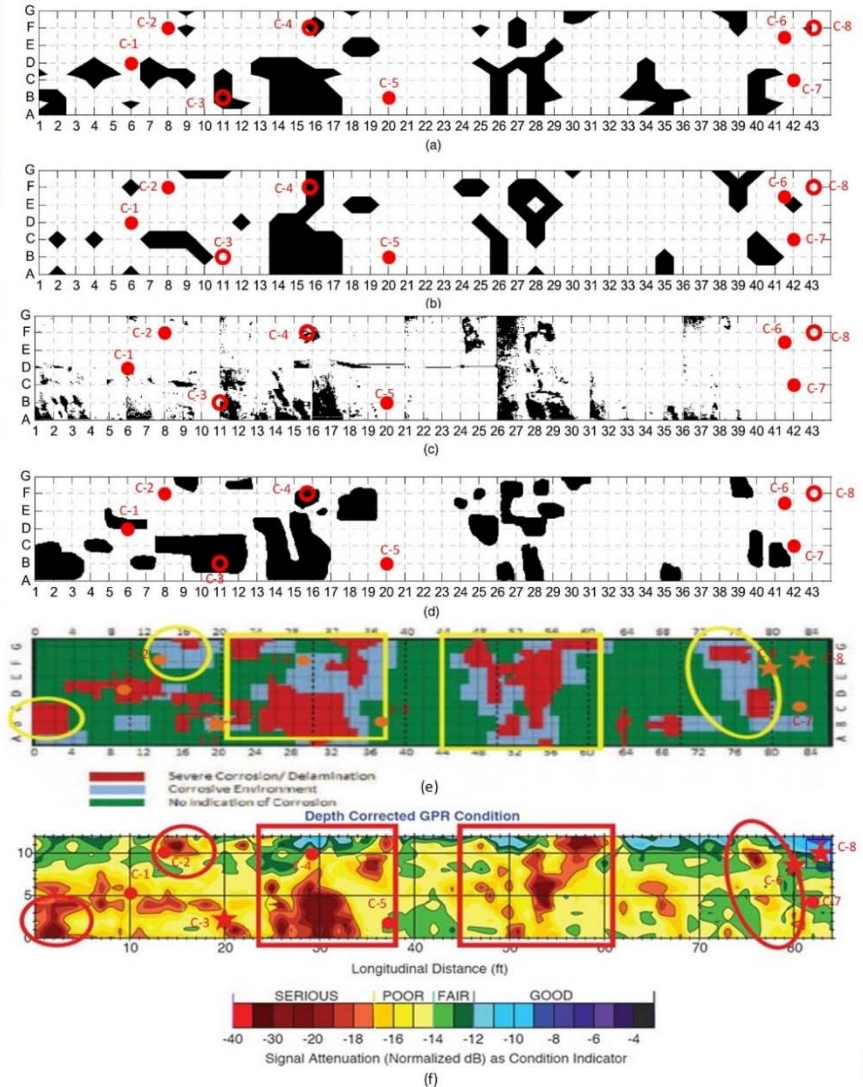
(3) Test results: (a), (b) IE; (c) IRT; (d) Chain drag; (e), (f) GPR

(Source: Gucunski et al. 2013; Oh et al. 2013) (Empty circles indicate cores from delaminated areas)

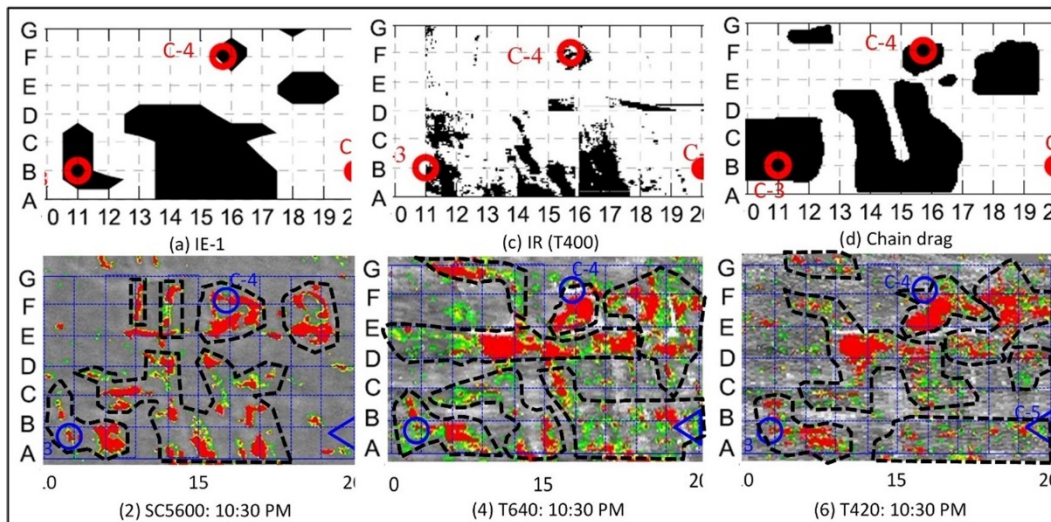
- SC5600 shows identical indication with other NDE methods
- T640 & T420 show larger area of damage indications
- Uncooled cameras were affected by high-speed application

(a) 10 to 20 of Horizontal Test Coordinate

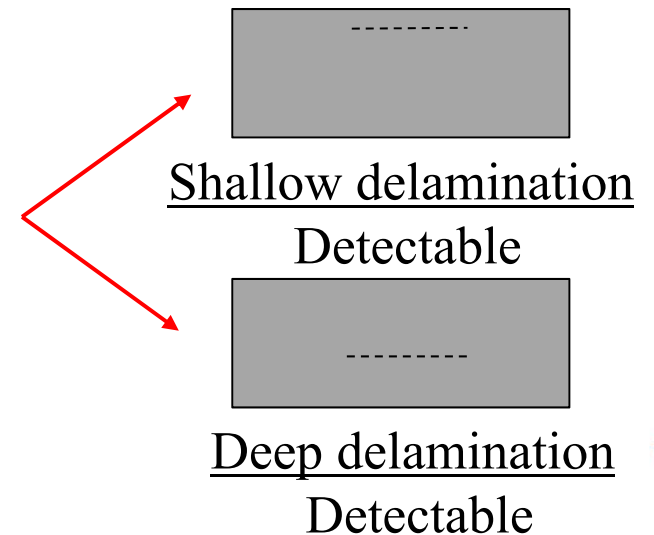
If area of delamination: large

Concrete slab
