# Will you still need me... when I'm sixty-four? A story of ageing bridges

Dean Ferguson, General Manager, Infracorr Consulting  
Ian Godson, Director and Principal Engineer, Infracorr Consulting  
Scott Gleason, Materials Engineer, Infracorr Consulting

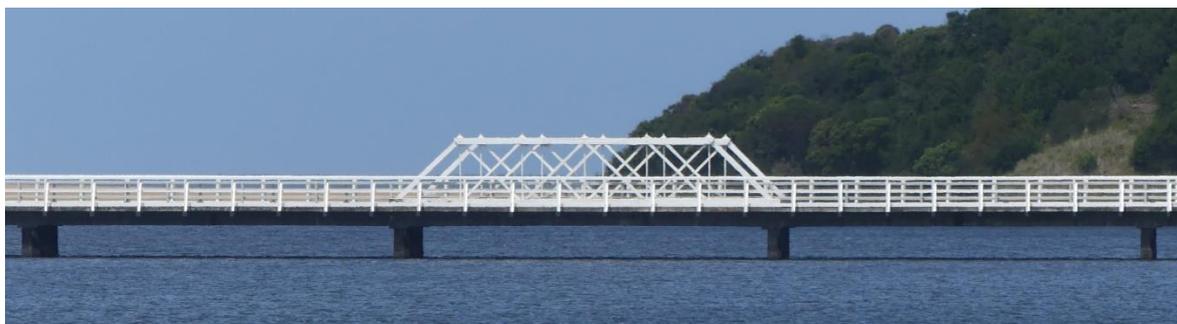
The bridge traverses its 160 m length in 12 spans, with 10 piers and two abutments. At each pier the bridge is supported by a precast headstock beam and five prestressed piles. Between each of the piers and abutments the deck is supported by five prestressed beams, see Figure 1 and Figure 2.

Figure 1 – Road Bridge overall structure

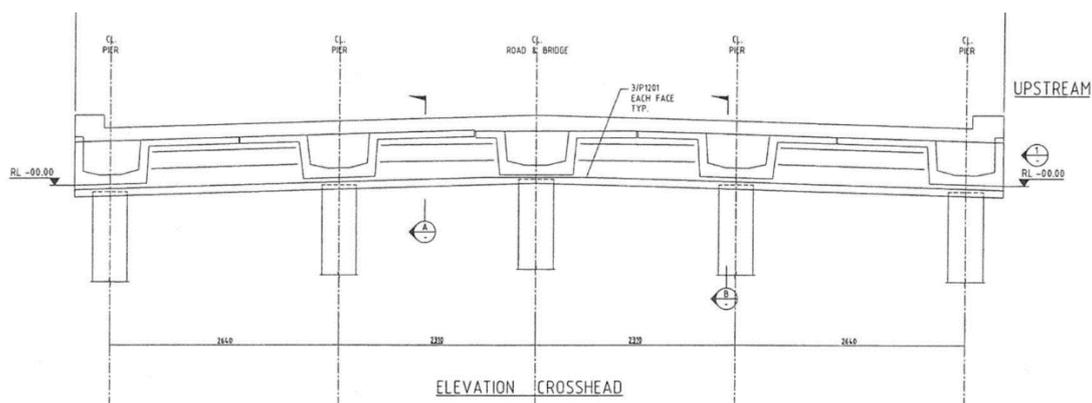
Figure 2 – Bridge cross-section

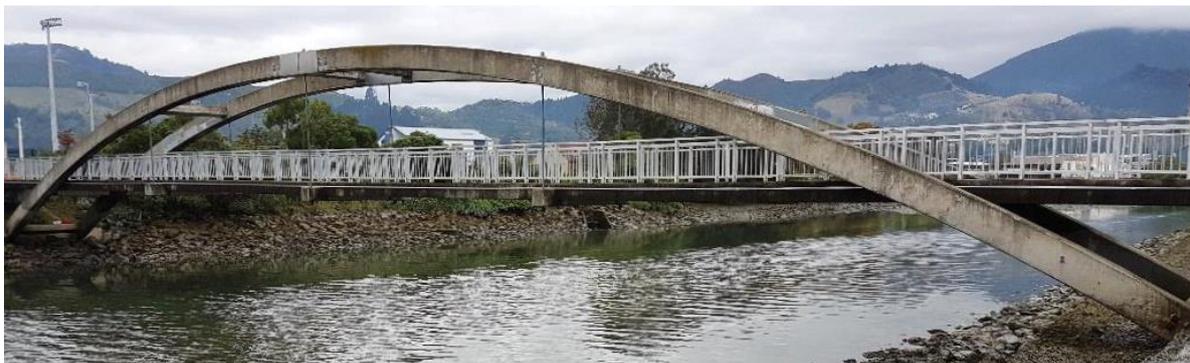
The footbridge is a 63 m single-span arch bridge, across a sheltered tidal river approximately 200 m from its mouth. The bridge is predominantly constructed from precast reinforced concrete elements with two reinforced concrete arches tied together with six cross-tie beams and supported at their base by reinforced concrete pile caps, see Figure 3.

Figure 3 – Pedestrian footbridge overall structure at low tide

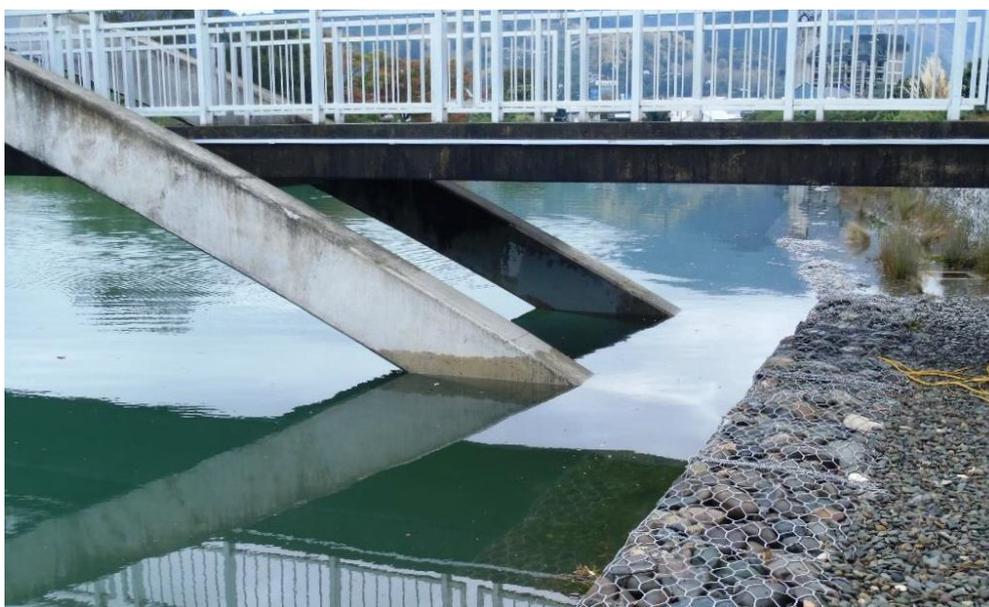
When inspected, the bridge was showing little-to-no visual evidence of concrete degradation. However, a detailed investigation identified that localised active reinforcement corrosion was occurring in the tidal and splash zone elements of the bridge, e.g. the arch footings, pile caps, and bottom two cross-tie beams (see Figure 4). This degradation was attributed to chloride-induced reinforcement corrosion by the investigative engineer. Other elements of the bridge were not considered to be subject to a short- or medium-term corrosion risk.

Figure 4 – Close up of deteriorating concrete elements at high tide: arch footings, submerged cross-tie beam, and submerged pile caps.

The bridge protection was achieved by applying targeted hybrid CP to the reinforcement of the arch footings, pile caps, and bottom two cross-tie beams. The system was designed to provide a 50 years life extension for these elements.

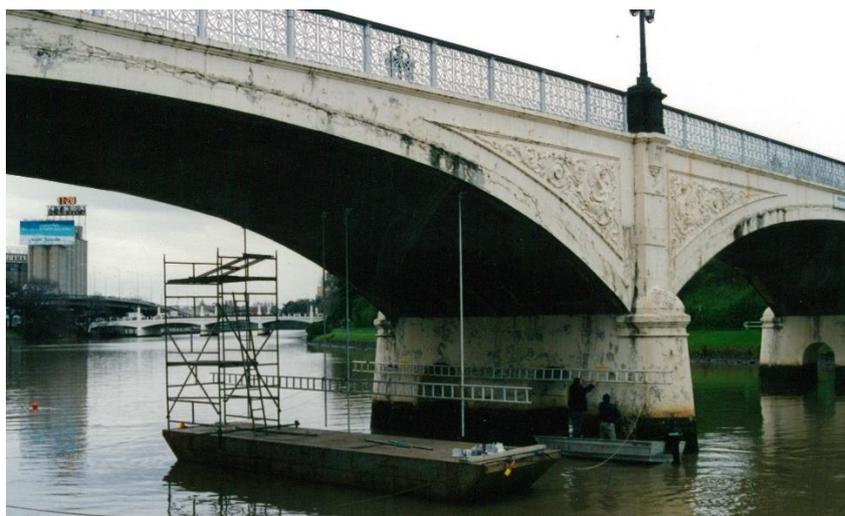
In 1993, almost 100 years after it was constructed, evidence of concrete spalling and outward movement of the side walls (see Figure 5) instigated a detailed investigation which found the entire lower mat of reinforcement was actively corroding, due to carbonation of the concrete surrounding the reinforcement.

Figure 5 – Morell Bridge general condition, circa 1993

Owing to the bridge's unique earth filled construction, a soil anode impressed current corrosion prevention (ICCP) system was installed below the footpath, passing protective current through the soil and 0.5 m thick concrete to protect the reinforcement. Reference electrodes were used to monitor the system performance/reinforcement protection and to ensure stray currents were not adversely affecting surrounding services, e.g. water mains, cable ducts, etc.

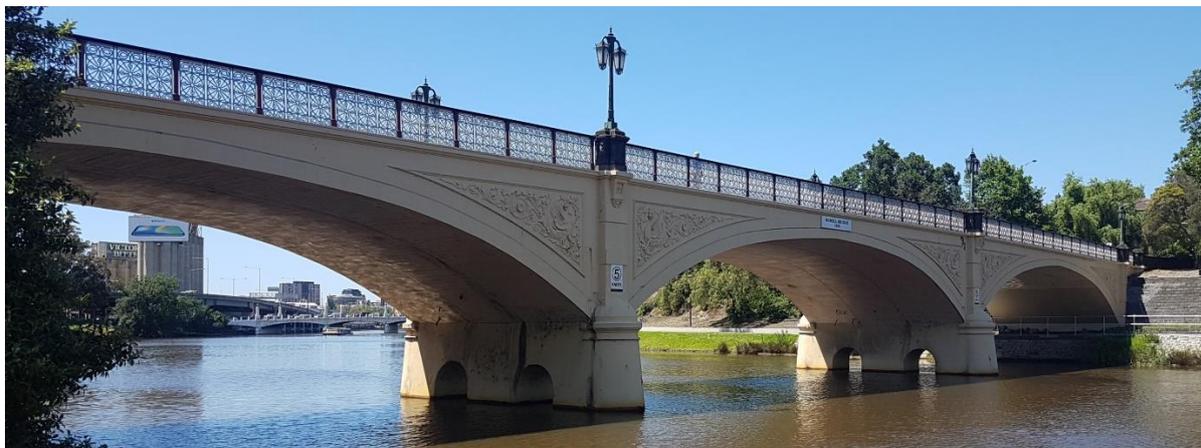
Figure 6 – Fully restored Morell Bridge overall structure, circa 2017
