Load Transfer Sequencing for Maintenance of Lift Span Bridges

D. Fryirs, *BG&E Pty Ltd, Sydney, NSW*, J. de Burgh, *BG&E Pty Ltd, Perth, WA* and S. Millie, *NSW Roads and Maritime Services, Wagga Wagga, NSW*

ABSTRACT

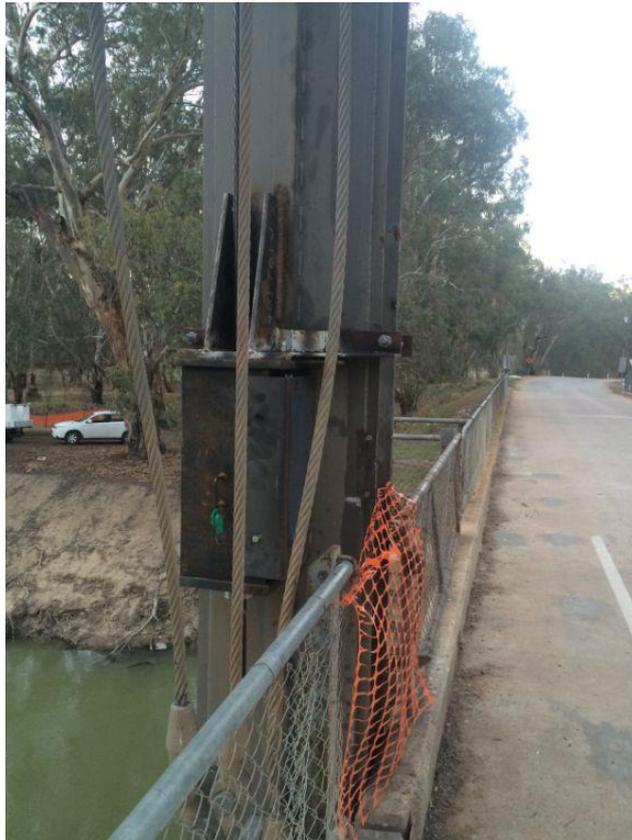
Figure 4 - Bracket and jacking assembly welded to the existing column on the Nyah Lift span bridge

The design intent of the chosen method, shown in Figure 3, was to use the existing structure where possible. The counterweights were lifted at each end by stressing strands draped over an available width in the existing pulley system. This maintained the existing load paths that the original structure was designed for. A bracket was welded to the side of the column, near deck level, to act as the anchorage point for the stressing strand. Hollow core jacks could then be attached to the base of the welded bracket and used to lift the counterweights. A stool was designed to be inserted around each jack after the jacking process so that the counterweights were not held under hydraulic pressure which would have been a significant safety risk. This also protected the jacks from vandalism during the replacement procedure. Due to the eccentric loading, small additional loads were applied to the column. The capacity of the column was checked for these additional loads and found to be sufficient.

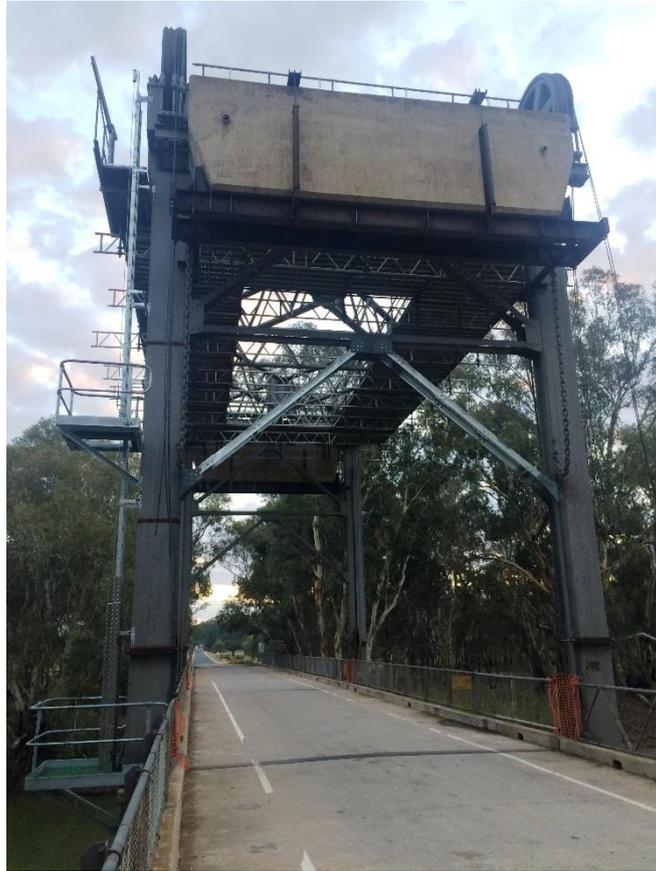
Figure 5 –Support cradle attached to raised counterweight

The existing counterweight support brackets were investigated and it was deemed impractical and unsafe to utilise them for the temporary support. A custom cradle was designed for the counterweight to improve the safety of the process and provide solid support points for the stressing strands. In order to maintain the balance of the pulley system, when the cradles were attached to the counterweights it was anticipated that additional weight needed to be added to the lift span. The planned approach was to place plastic barriers on the lift span prior to installing the cradles and filling them with water after the installation to balance the weight and allow seamless use of the lifting mechanism. This would have reduced the bridge width, however one lane could remain open allowing access and it was the cheapest solution for the client. The barriers would also help to improve the safety of the works being undertaken. On site it was found that this was not required, and that the additional weight of the cradles did not impact the use of the lifting mechanism.

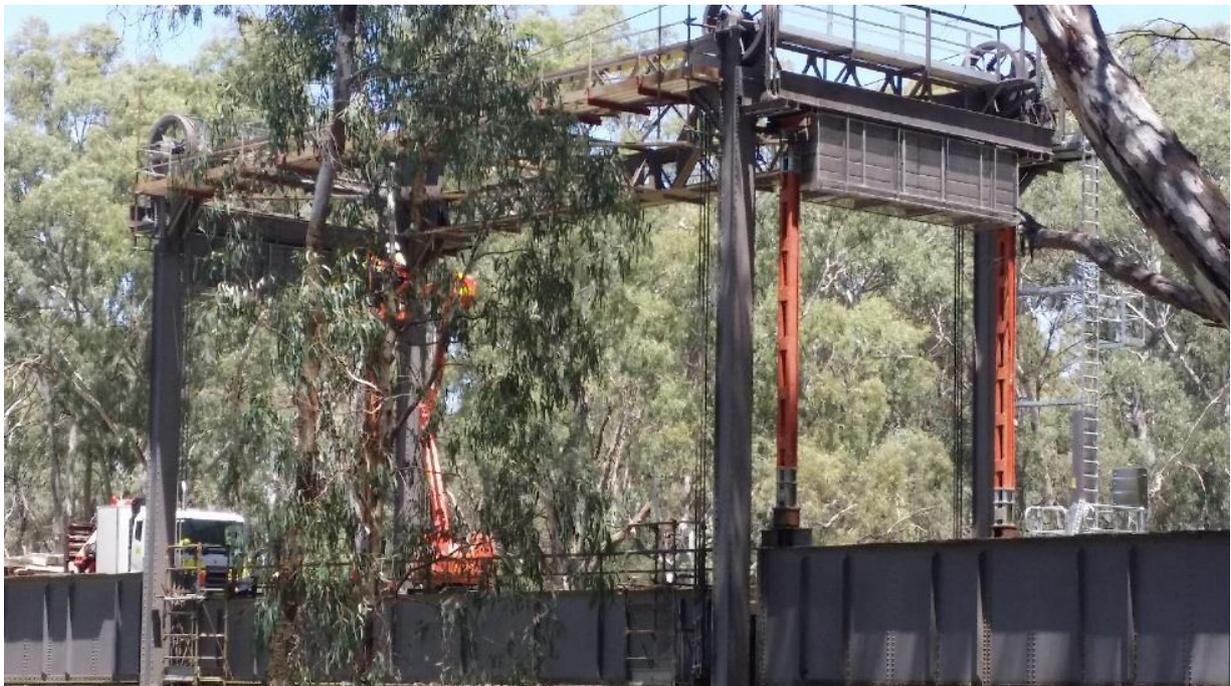
Figure 6 - Photo showing the counterweight support design implemented on the Gonn Crossing Bridge

The design methodology devised aimed to simplify the procedure used on the Nyah lift-span bridge and use proprietary products where possible. In this instance, the bridge geometry could readily accommodate direct support of the counterweights on

Megashor 1000kN support struts, braced to the existing columns. The struts were each raised by a hydraulic jack to lift the counterweights and remove tension in the steel cables in order to limit manual labour and improve efficiency. The lift needed to be carried out in synchronisation between all four points due to the articulation of the wire cables. The support struts were supported on top of the approach span girders, applying additional load to this structure that would need to act in combination with existing road traffic. Having originally been designed for rail traffic, the affected components were found to be sufficient for this application.

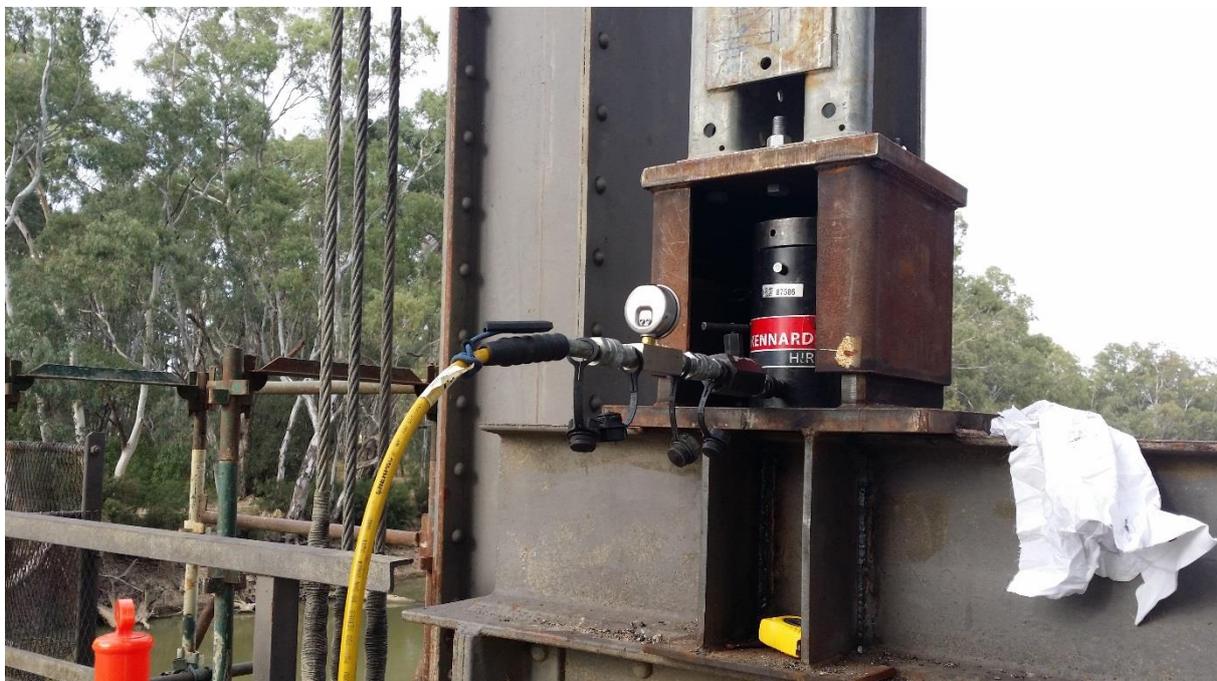
Figure 8 - Jacking stool installed underneath the Megashor struts used to lift the counterweight

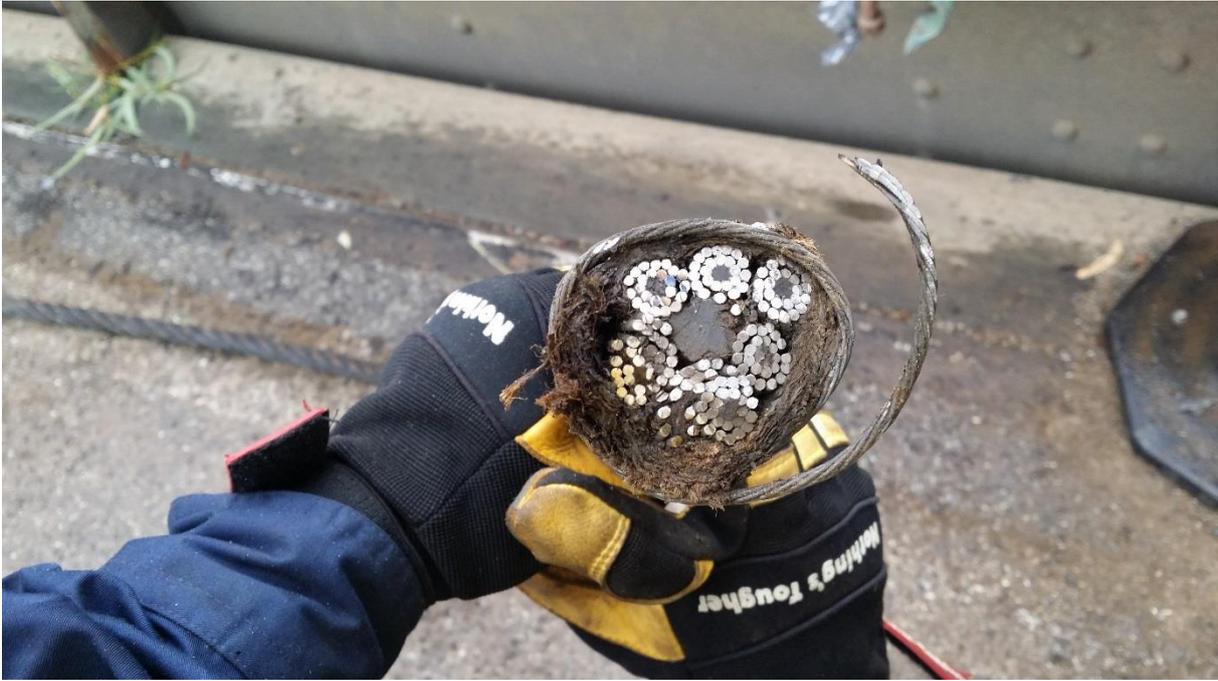
Figure 9 – Cross section through the old steel wire rope removed from the Gonn Crossing Bridge

Gonn Crossing Bridge is located on Murrabit Road and carries traffic over the Murray River between the township Murrabit to the south in VIC and the locality of Gonn Crossing to the north in NSW. The bridge was opened on July 1, 1926, and was the first all-steel construction lift span across the Murray between Victoria and New South Wales. The bridge was originally designed to carry both road and rail traffic, and includes a central span (17.7m, 58ft) able to be lifted by a winch along with six additional approach spans totalling approximately 103m in length [6]. The bridge lies on a north/south axis and consists of 7 structural steel spans with timber decks. The bridge is supported on concrete pile caps founded on concrete piles. The central lift span is balanced by means of a counterweight system to facilitate lifting by manual means. Steel cables provide the link over a pulley system between the lift span and two concrete counterweights, one at either end of the lift span [7]. Similar to the Nyah Bridge, the steel cables connecting the lift span to the counterweights had deteriorated over time and required replacement.
