# Condition Assessment of Installed Nuclear Power Plant (I&C) Cables

**K. Anandakumaran,  
D. Marttila, and A. Ghaforian**

**EQ Technical Meeting  
Clearwater, Florida  
November 4, 2015**

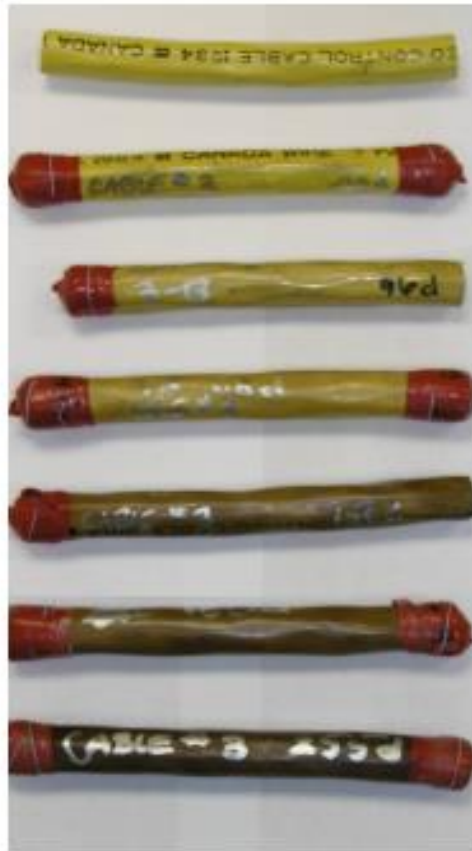
# Visual Inspection – PVC Jacket Aging

As Received

40 days @ 110°C

96 days @ 110°C

110 days @ 110°C

150 days @ 110°C

180 days @ 110°C

255 days @ 110°C

**255 days @ 110°C = 40 years @ 65°C**  
**Exposure to >100 Mrad needed for PVC jacket color change**  
**Qualitative indicator of thermal aging**

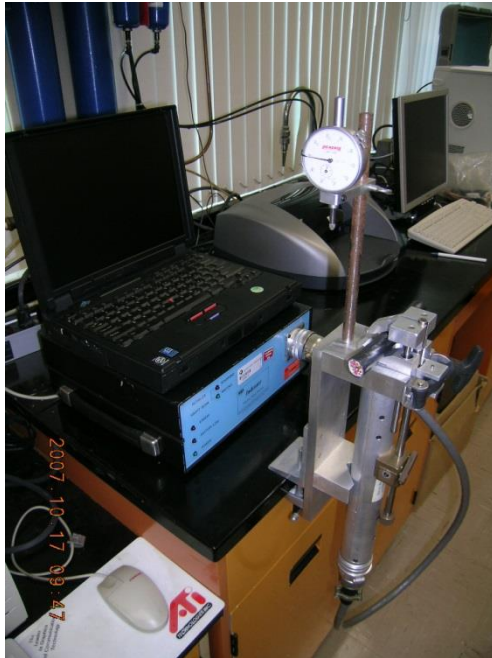
The Indenter Tool as used in the lab

**Suitable for: Thermal aging of PVC, Neoprene & Hypalon materials**

**Not Suitable for Radiation: >100 Mrads required for indication**

**Quantitative indicator of thermal aging**

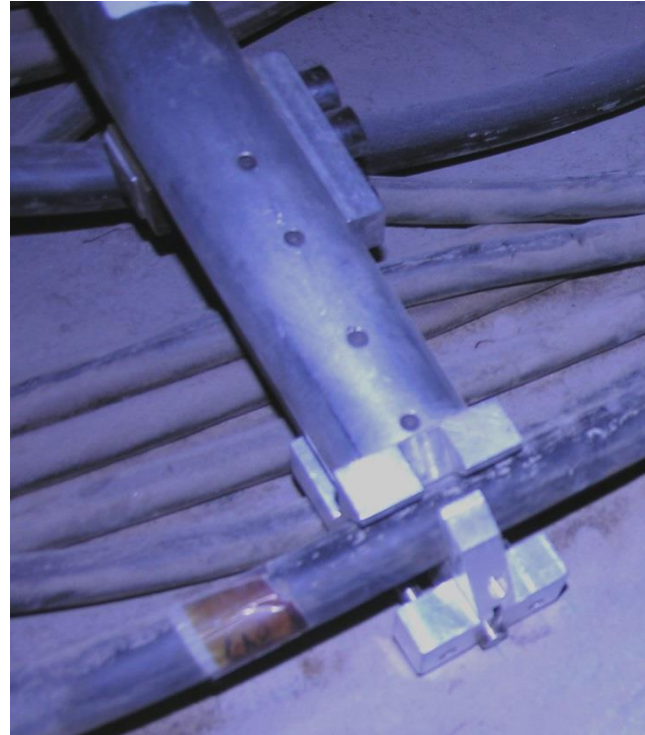
The Indenter Tool in a cable tray as used in the field

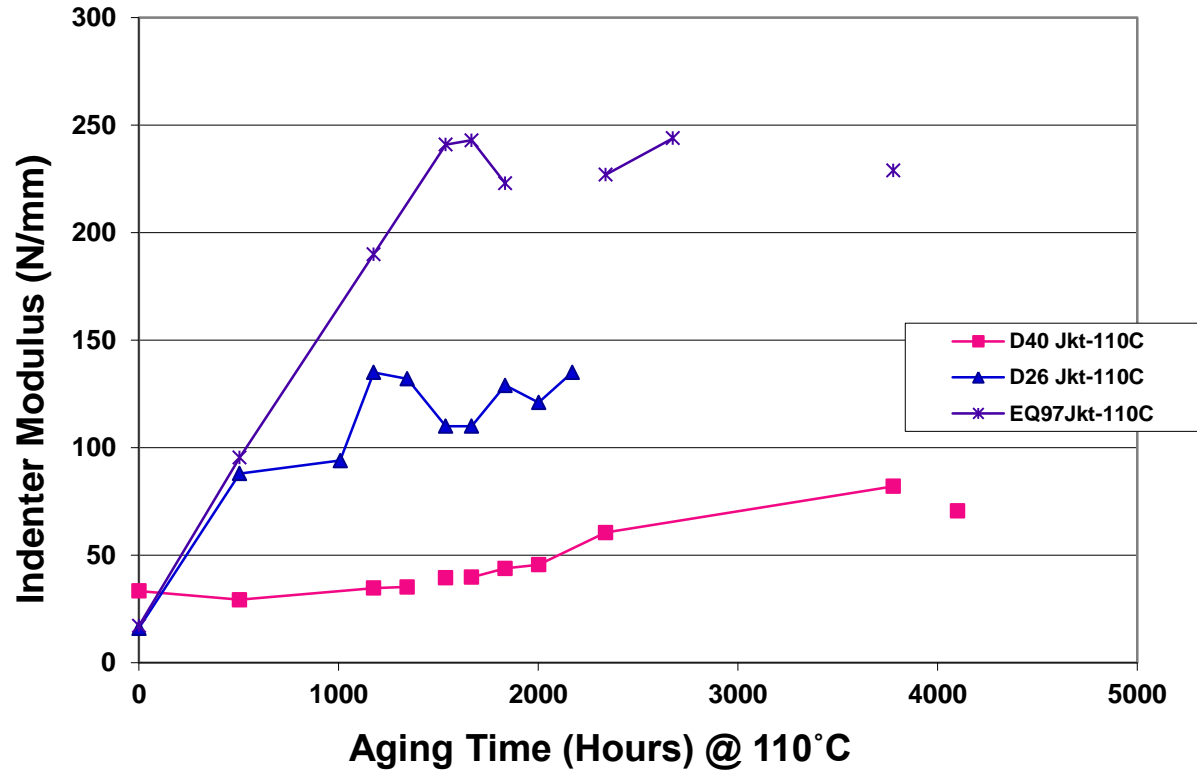
# Indenter Modulus of 3 Yellow PVC Jackets

- Indenter Modulus > 100 N/mm = Hot Spot (Insulation must be checked)
- Modulus increase correlates with aging time
- Good indicator of the condition of PVC cables used outside containment
- Eg.: Cable EQ97 ages rapidly i.e., If it shows minimal or no aging then other cables in that location must be ok (thermally)

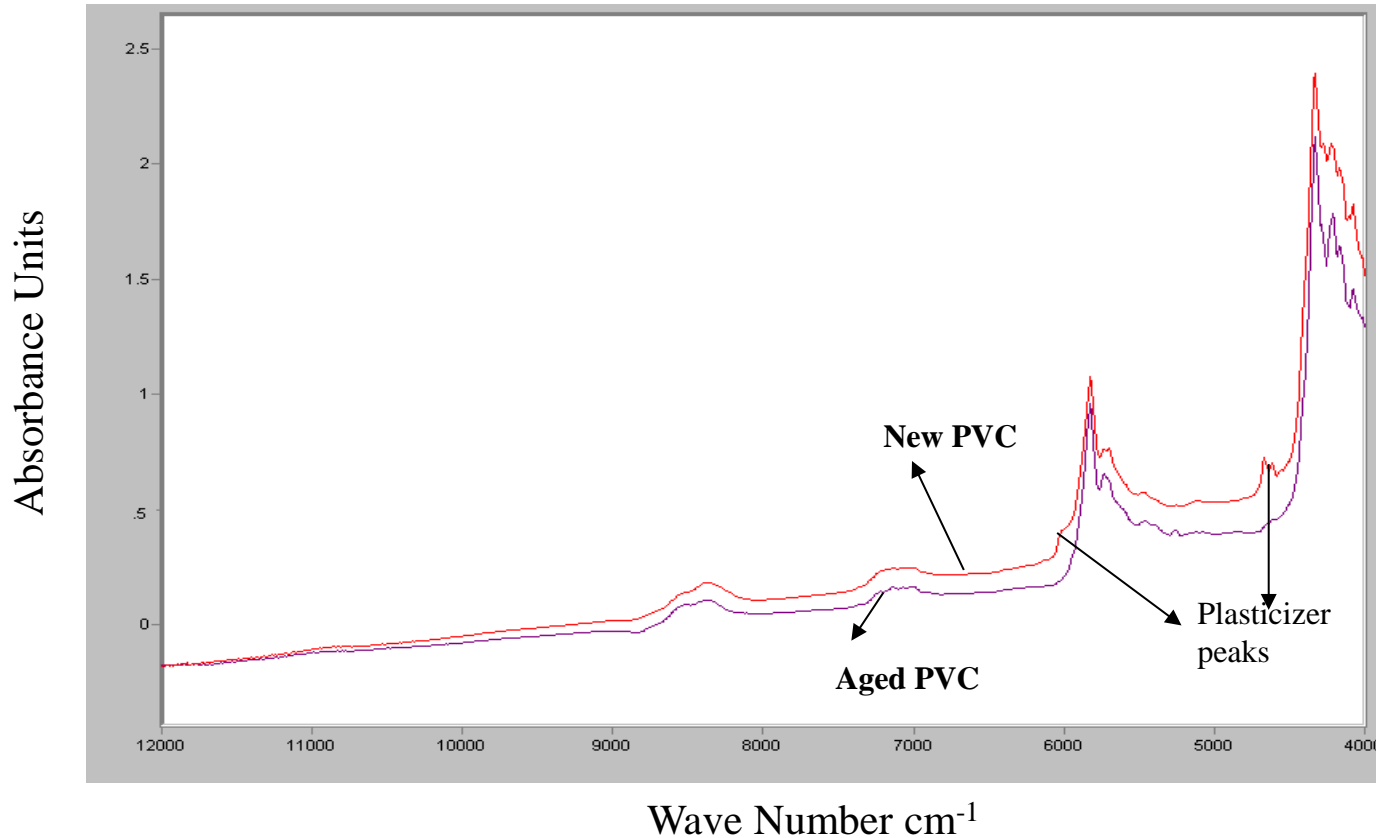
## NIR Change with Thermal Aging for PVC

**Intensity of the plasticizer peaks decrease with aging**

(Normal plasticizer content >30% by weight)

**NIR technology monitors loss of plasticizers – Primary thermal aging mechanism for PVC**

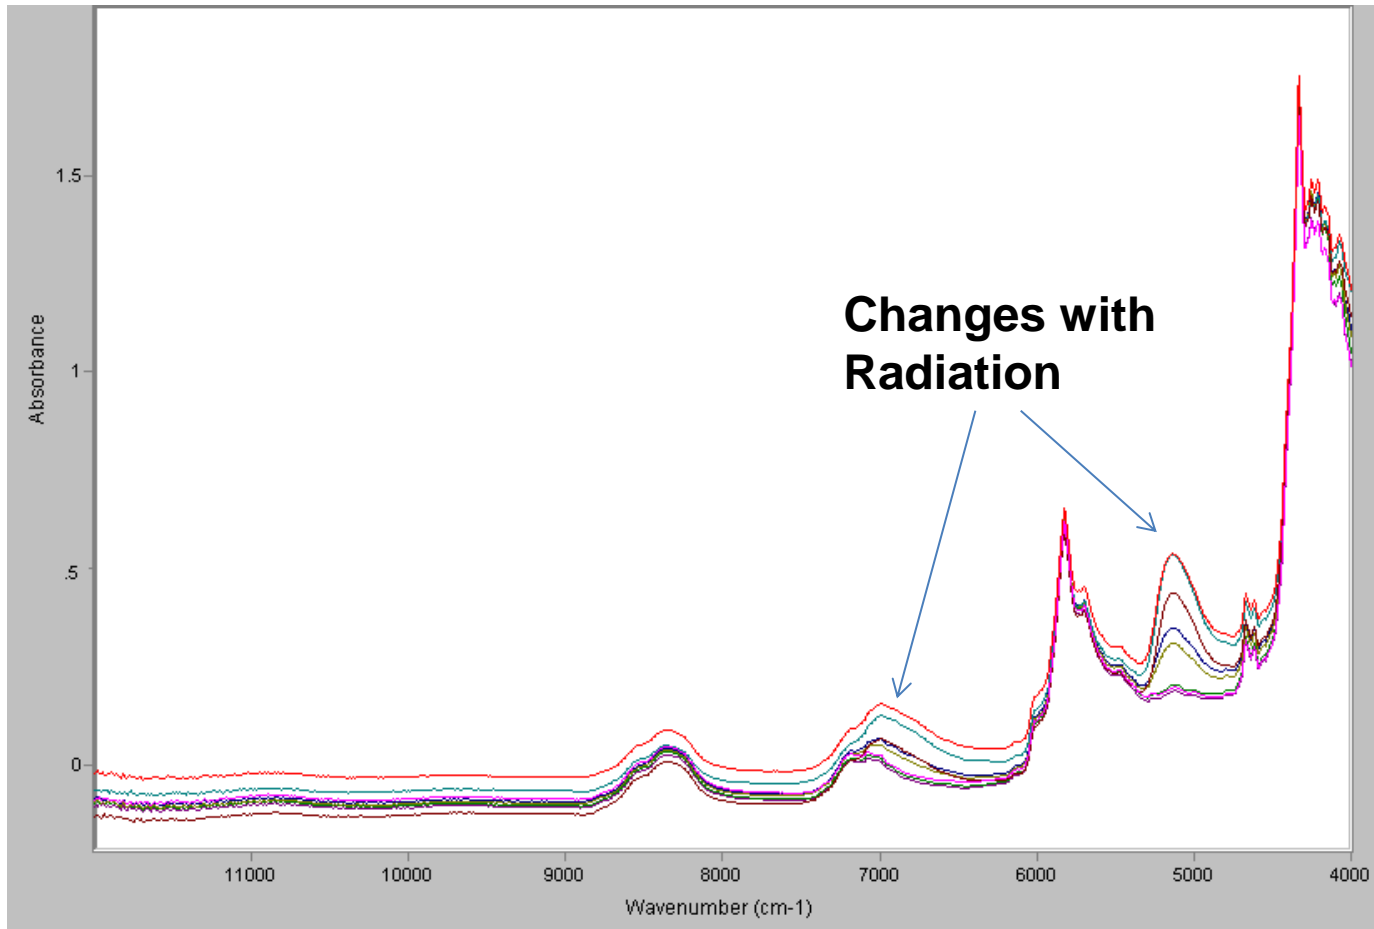
# NIR Change with Radiation Aging for PVC (0 to 60 Mrad)

NIR monitors degradation due to exposure to radiation

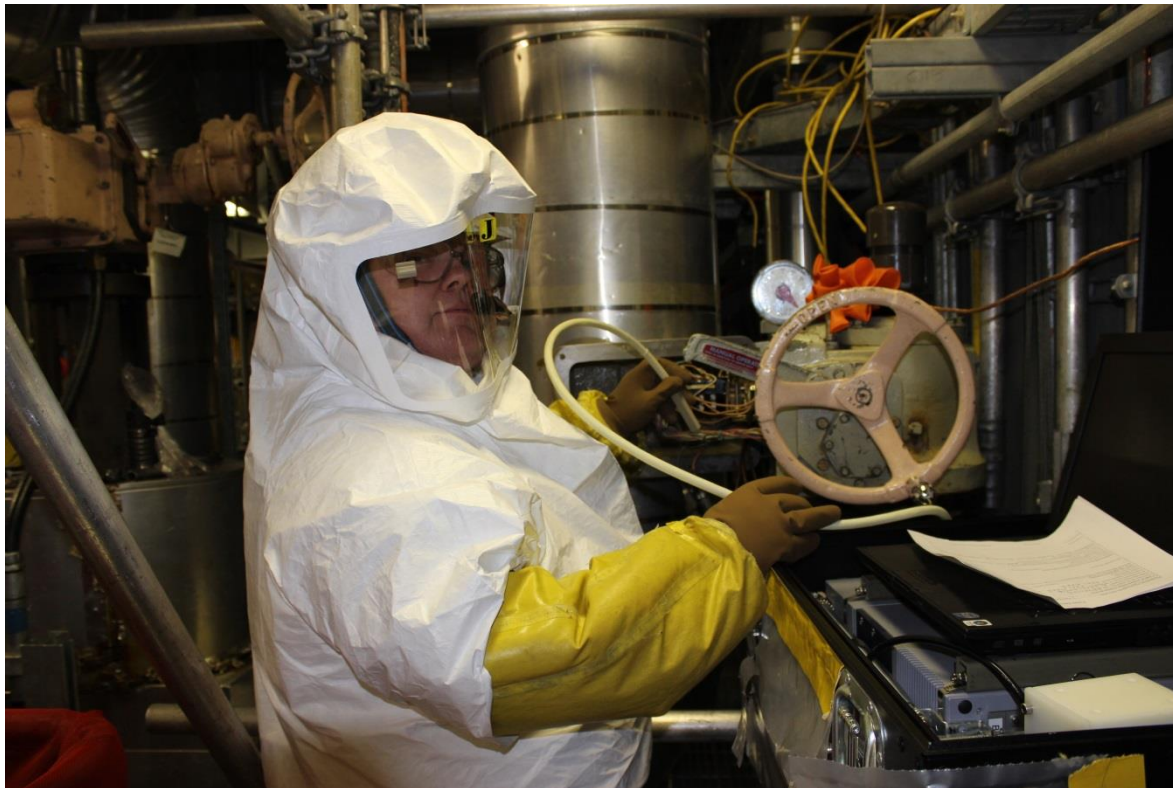
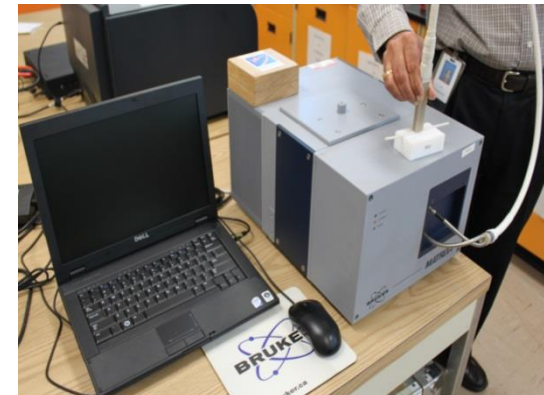
# NIR (Near Infrared) Technology

- Non-destructive – *Light Colors only*
- Materials absorb IR at characteristic frequencies
- Capable of discriminating between formulations
- NIR is field proven technology in CANDU plants
  - Rugged instrumentation
  - Flexible, fiber-optic probe for easy access to cables
  - Used on > 10,000 in-service cable insulations in CANDU plants

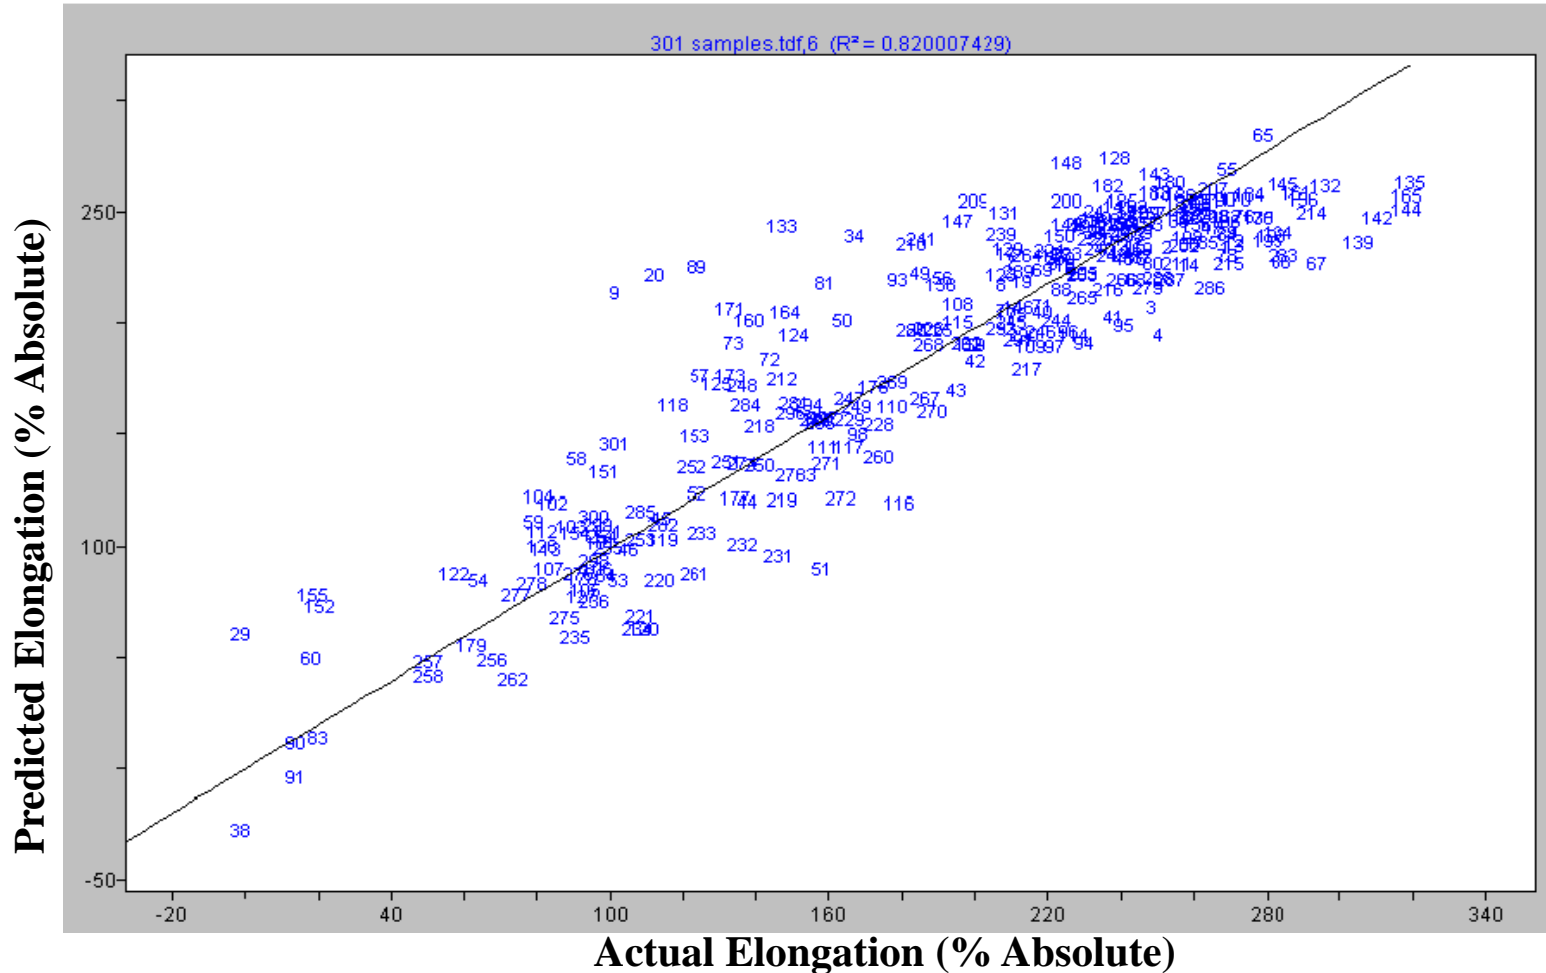
# NIR Prediction Model – EPR 3,4,5 Insulation

Actual elongation values Vs predicted for thermal, radiation, and radiation plus thermal aged EPR 3,4,5 insulated wires (removed 13 outliers out of 301 samples)  $R^2 = 0.82$

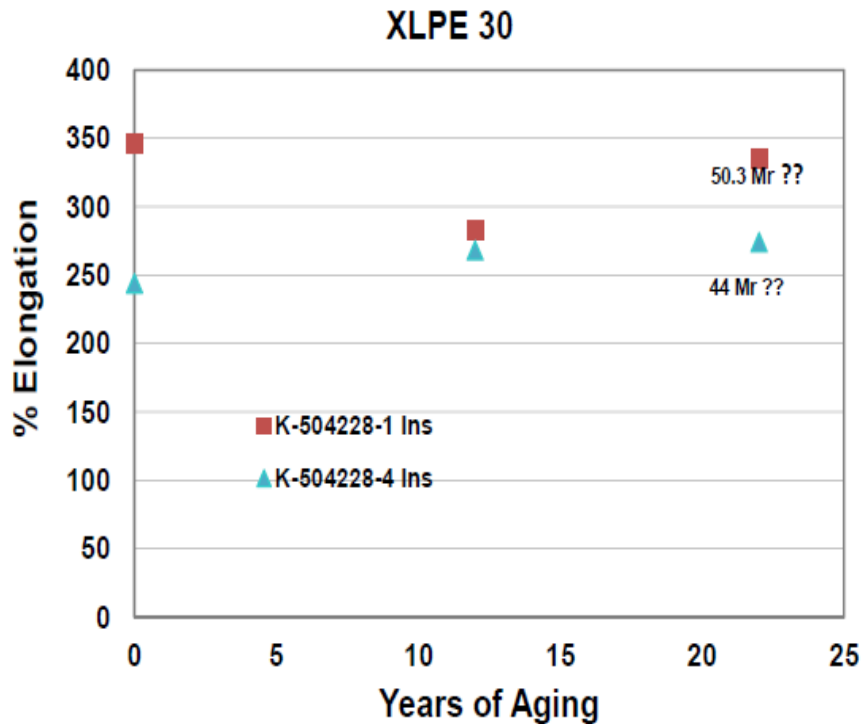
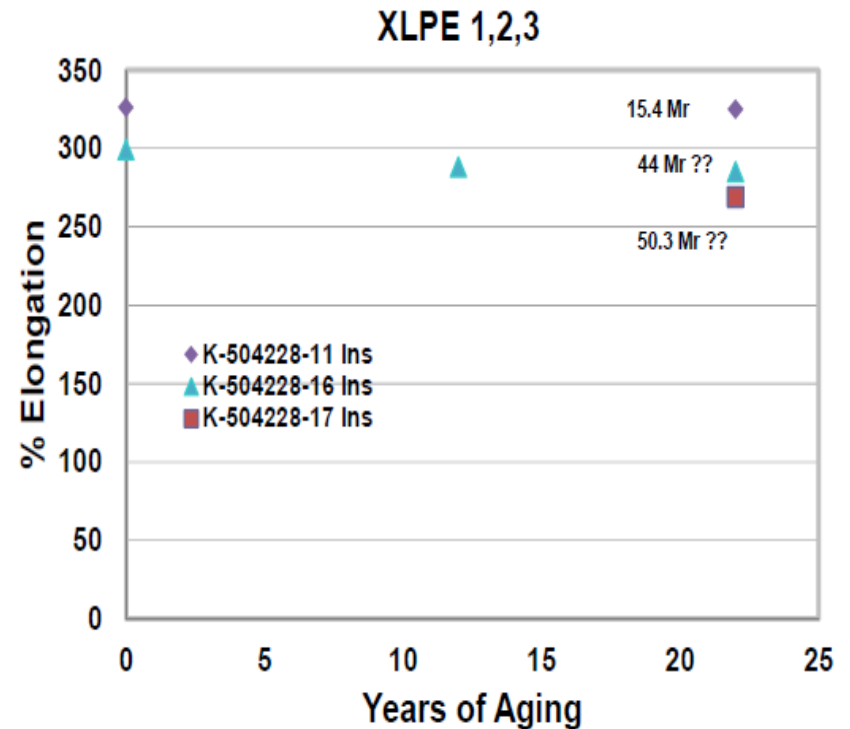
# Elongation at Break Values of XLPE 30 & XLPE 1,2,3 Insulations (New, 12-Yr Aged and 22-Yr Aged)

Estimated Radiation Dose (in Mrads) ?? from EQ Room Condition Manual  
 ?? At this level of irradiation Elongation values should have dropped to ~100%

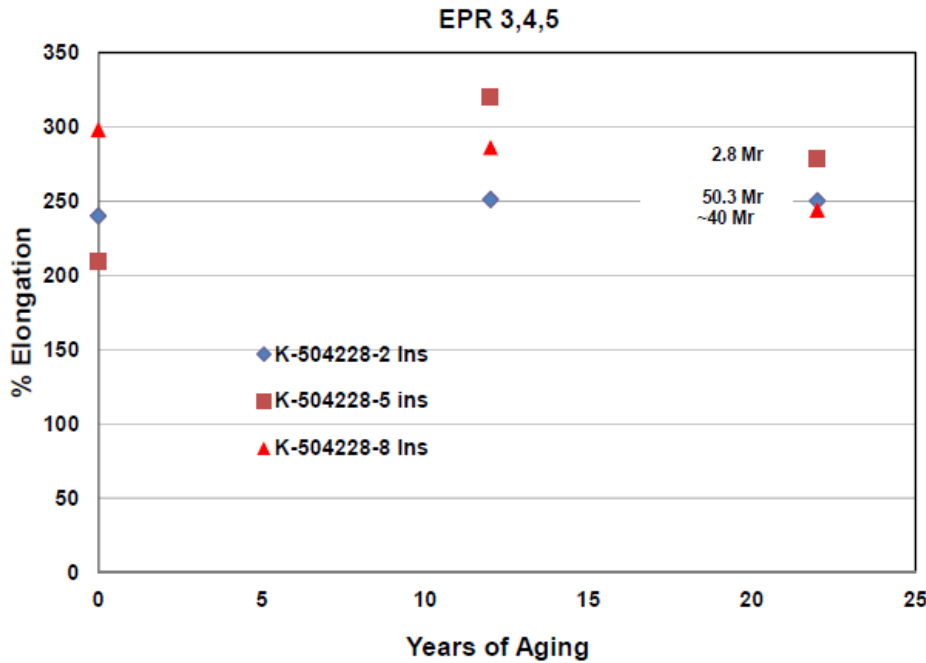
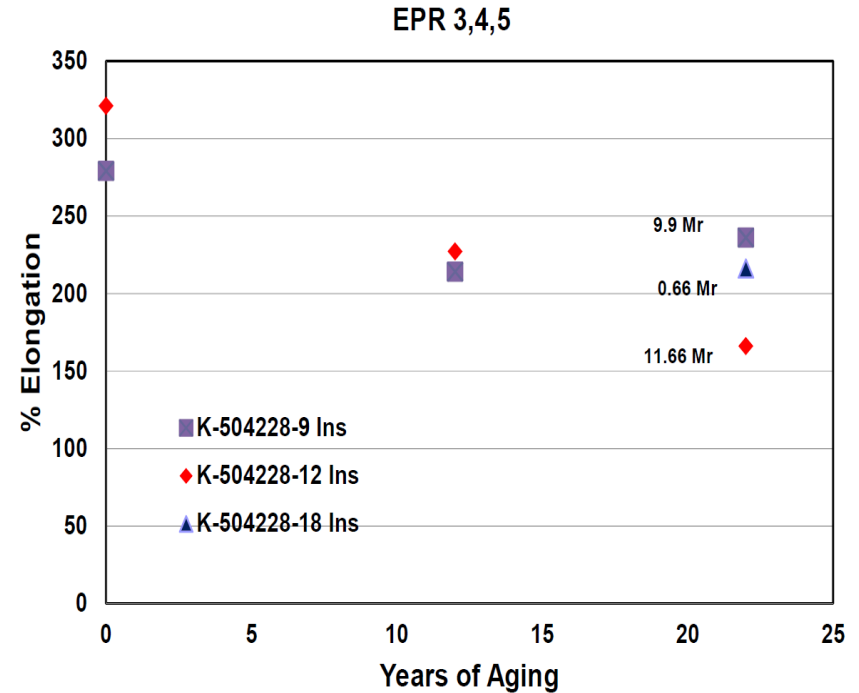
# Elongation at Break Values of EPR 3,4,5 Insulations (New, 12-Yr Aged, and 22-Yr Aged)

Estimated Radiation Dose (in Mrads) ?? from EQ Room Condition Manual  
 ?? At this level of irradiation Elongation values should have dropped to ~100%  
 K-504228-12 Ins - Elongation reduction due to composite insulation
