# Emergency Bridging Strategy

Peter Newhouse, Asset Manager Structures, Main Roads WA

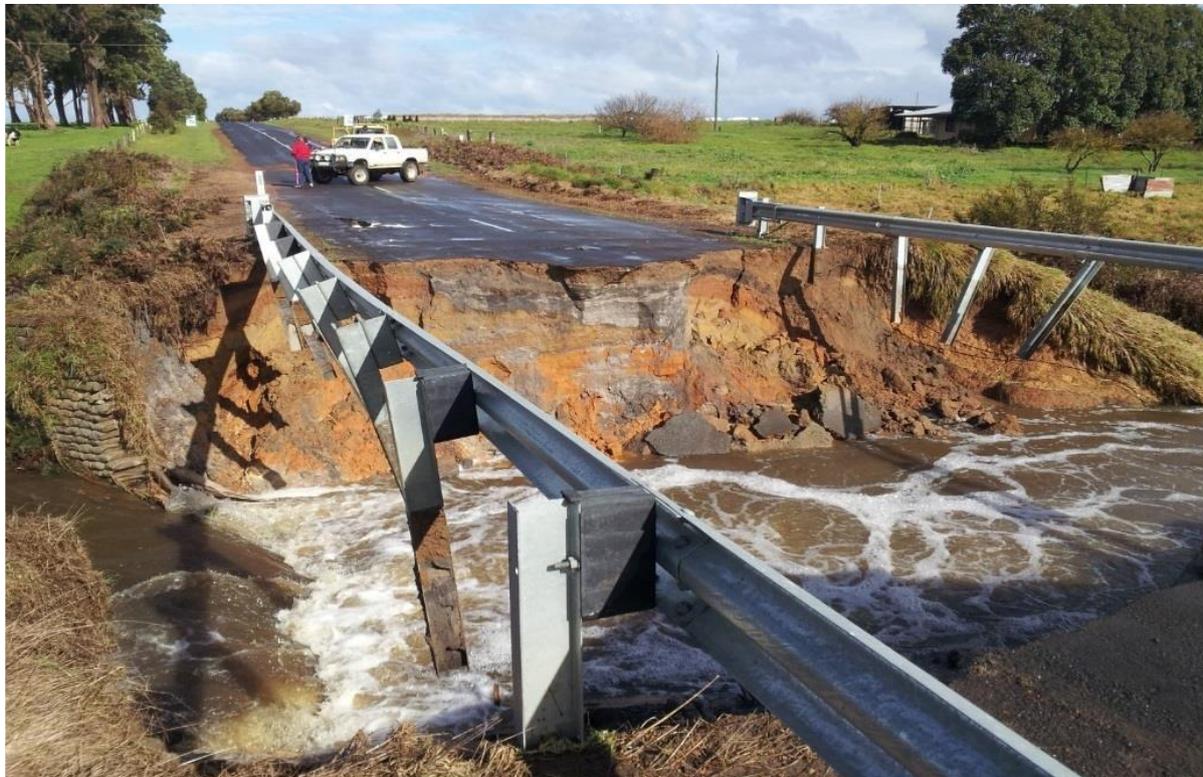
By way of example, in July 2013 following heavy rainfall, the Shire of Augusta Margaret River lost a significant culvert on Warner Glen Road. The culvert pipes were washed downstream leaving the guardrail suspended over the river (refer to Figure 2). The Shire requested MRWA to install a Bailey bridge to keep the road open. Although MRWA had a number of Bailey bridge components at that time, the condition and load carrying capacity of these components was unknown. Accordingly, MRWA had to decline the request.

**Figure 2: Washed out culvert – Warner Glen Road, Shire of Augusta/Margaret River July 2013.**

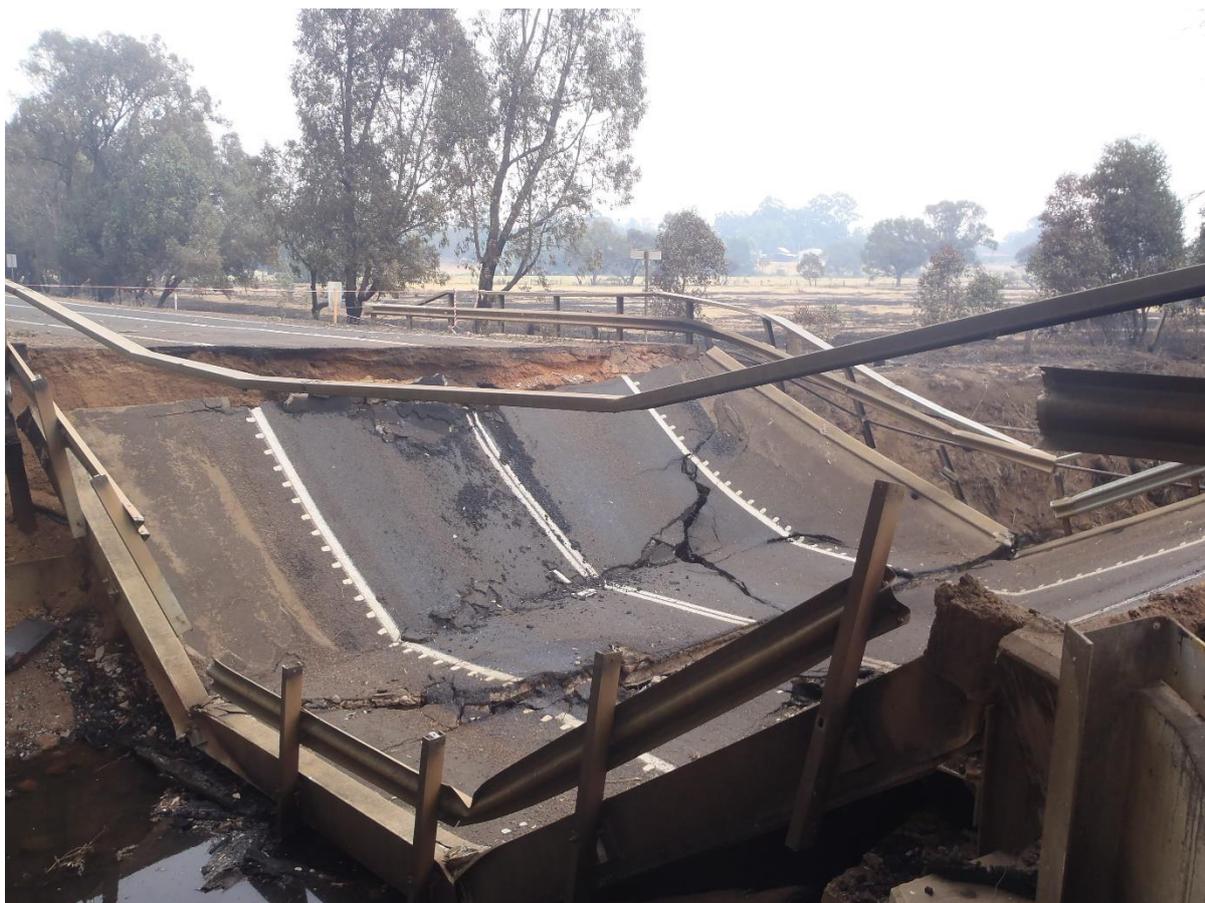
As a result of the Waroona bushfires in February 2016, the Samson Brook bridge (Bridge 0149) on the South Western Highway was destroyed (refer Figure 3) and the Harvey town bridge (Bridge 0170) was treated with fire retardant as fire threatened to enter the town.

**Figure 3: Bridge 0149 on South Western Highway destroyed by the Waroona bushfires in 2016**

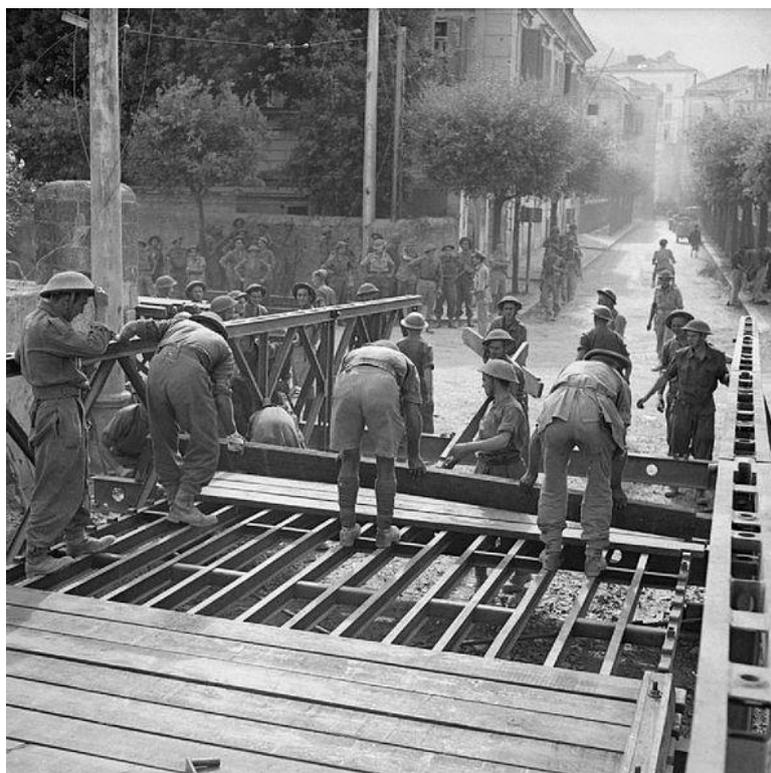
**Figure 4: Royal Engineers construct a Bailey bridge in Italy, September 1943. Timber planks are being laid over the stringers to construct the deck.**

MRWA has a significant number of Bailey bridge components and has used Bailey bridges in the past for emergency and semi-permanent applications. Originally the Bailey bridging system used timber chesses (planks) supported by steel stringers for the deck (refer to Figure 4). As MRWA did not have

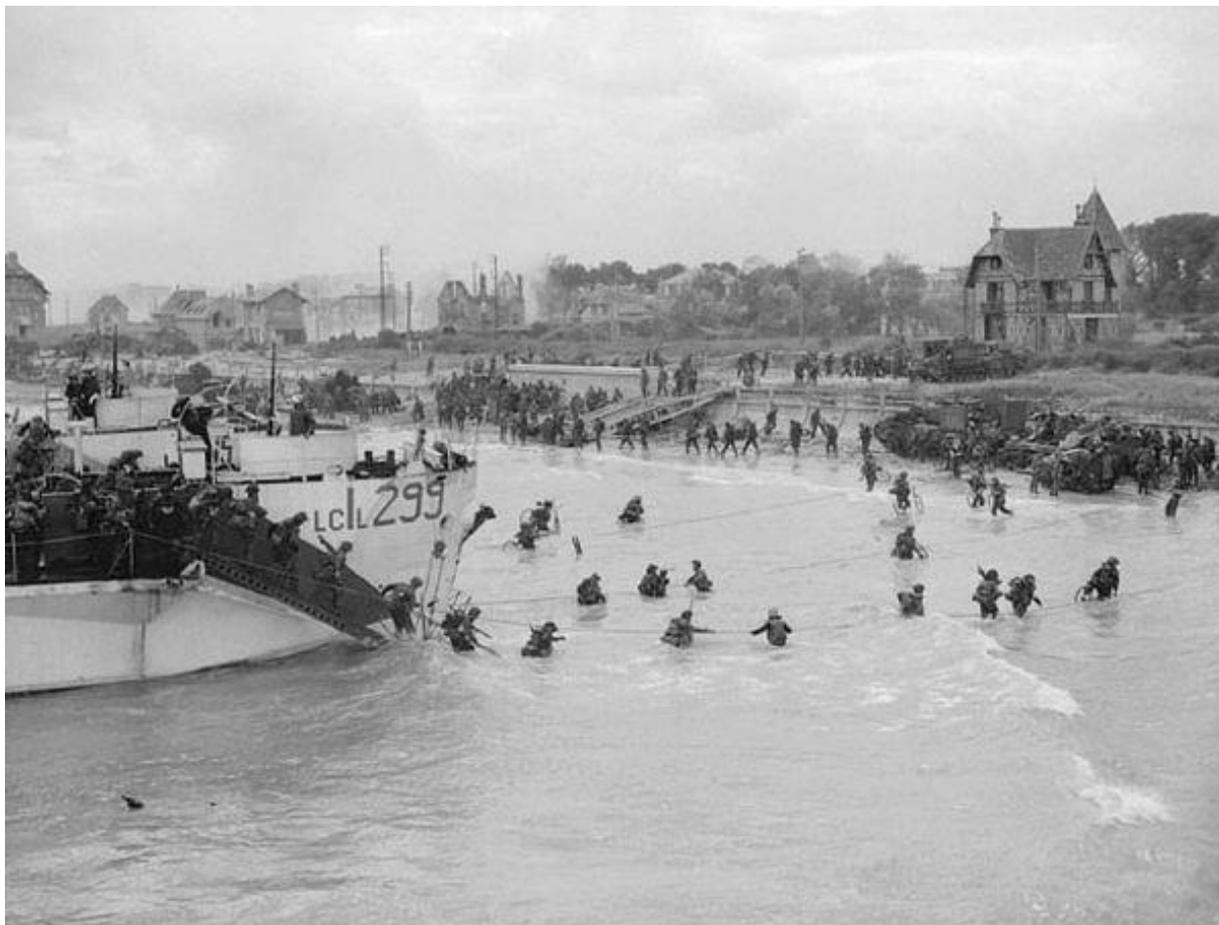
The **Small Box Girder bridge** (SBG) was a small assault bridge that could be used to span gaps of up to 30 feet. It was typically carried on a tank, such as the Churchill Armoured Vehicle Royal Engineers (AVRE) or something similar, and could be deployed without engineers having to expose themselves to enemy fire. The design had been formally adopted by the British Army in 1932. Refer to Figure 5 showing the use of the SBG bridge during World War 2.

**Figure 5: A Small Box Girder Bridge (used as ramp, centre) at 'Nan White' Beach at Bernières-sur-Mer.**

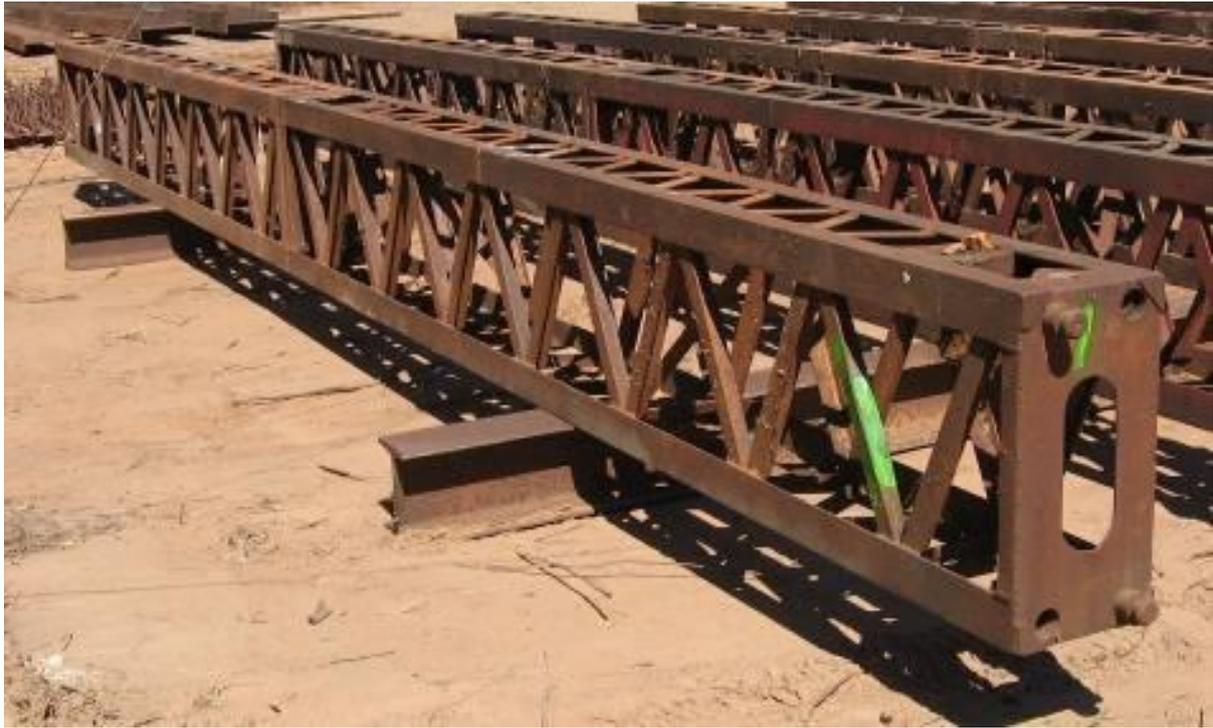
The Australia Army designed its own version of the SBG bridge and it is this type that MRWA owned. The small welded box girder is a robust under bridge girder. It comprises of end and intermediate trusses (refer to Figures 6 and 7). The intermediate trusses are 355mm wide, 670mm deep, and 4.24m in length. The tapered end trusses are 355mm wide with the depth ranging from 200mm to 670mm over a length of 4.24m. The Australian Army Museum at Holsworthy in NSW agreed it is almost certain to be ex-Army as it very closely resembles a slightly larger under-truss they produced in the 1940s.

**Figure 6 – SBG Intermediate Truss**

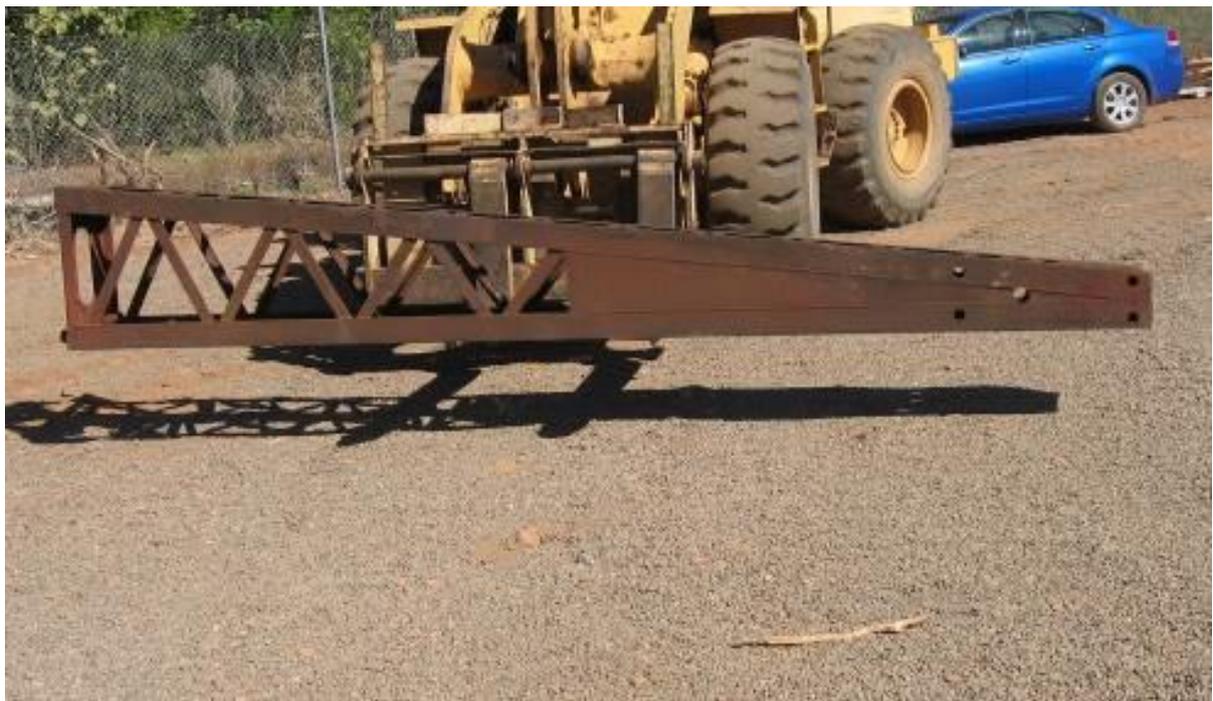
**Figure 7 – SBG End Truss**

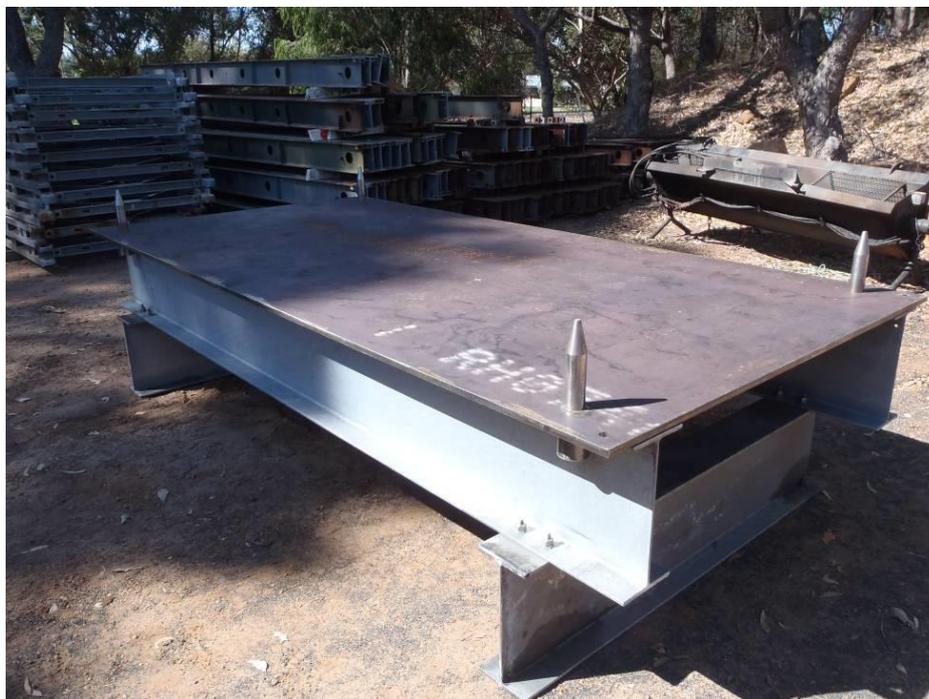
MRWA supplied a template table for checking warping of the Bailey panels and the reinforcing chords (refer Figures 9 and 10).

**Figure 9 – template table used for checking warping of the panel and reinforcing chords.**

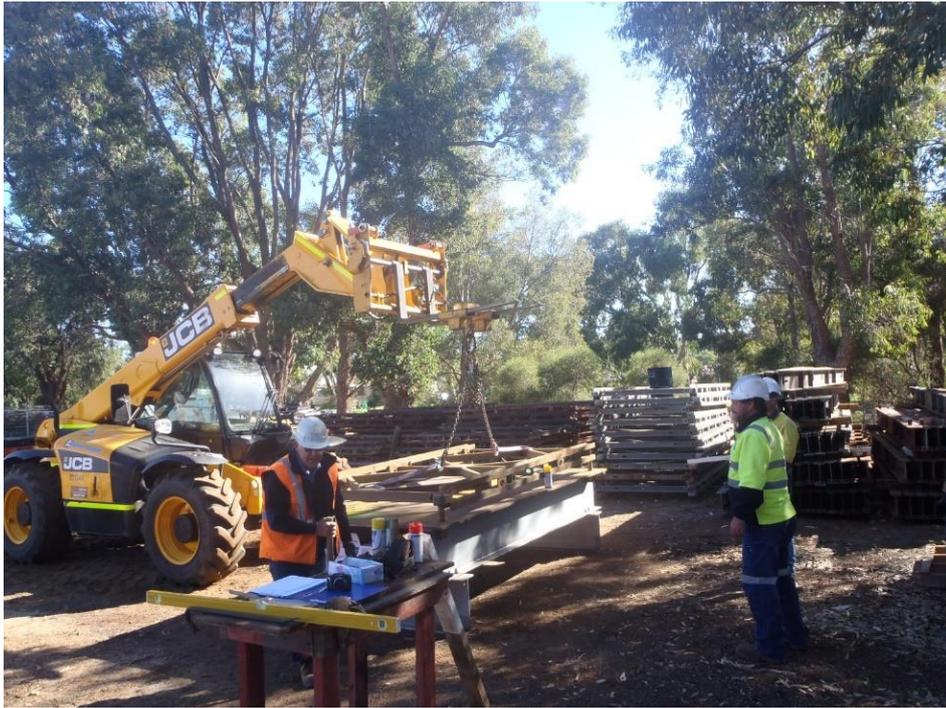
**Figure 10 – a panel being placed on the template table in readiness for condition assessment**

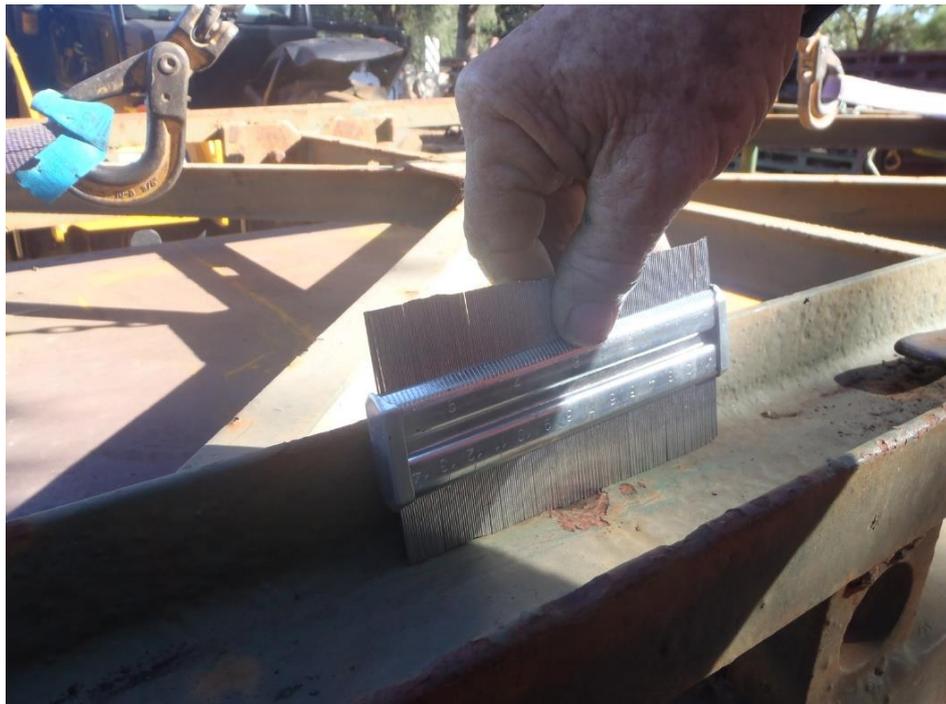
**Figure 11 – measuring the depth of corrosion on a panel chord**

A profile gauge was used to assess the depth of corrosion on components (refer to Figure 11) while a purpose-made gauge was used to check pin hole wear in the panels (refer to Figure 12).

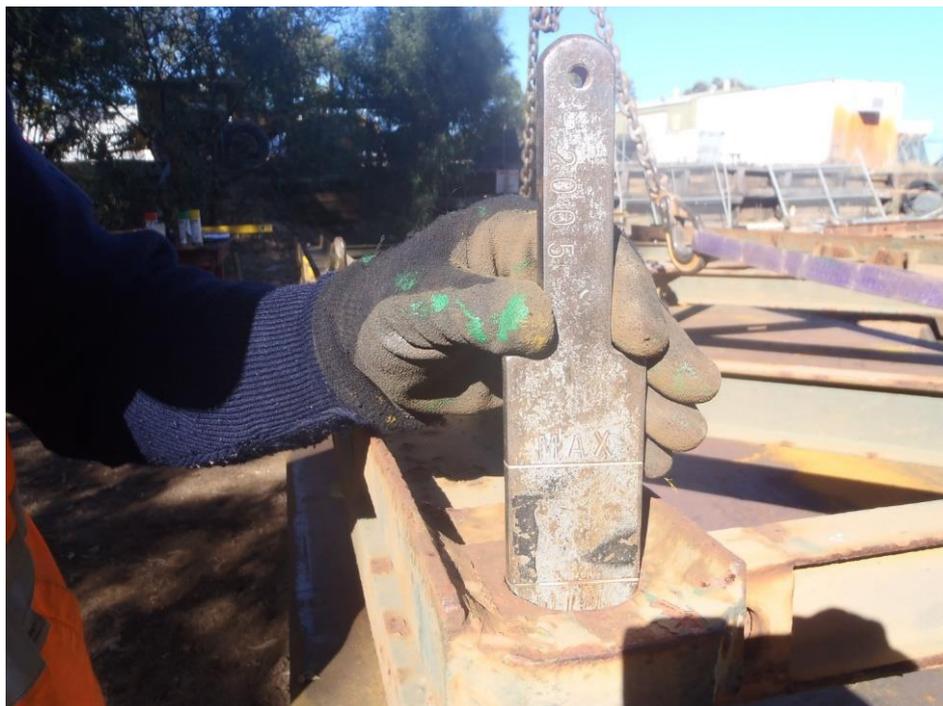
**Figure 12 – Measuring pin hole wear in a panel**

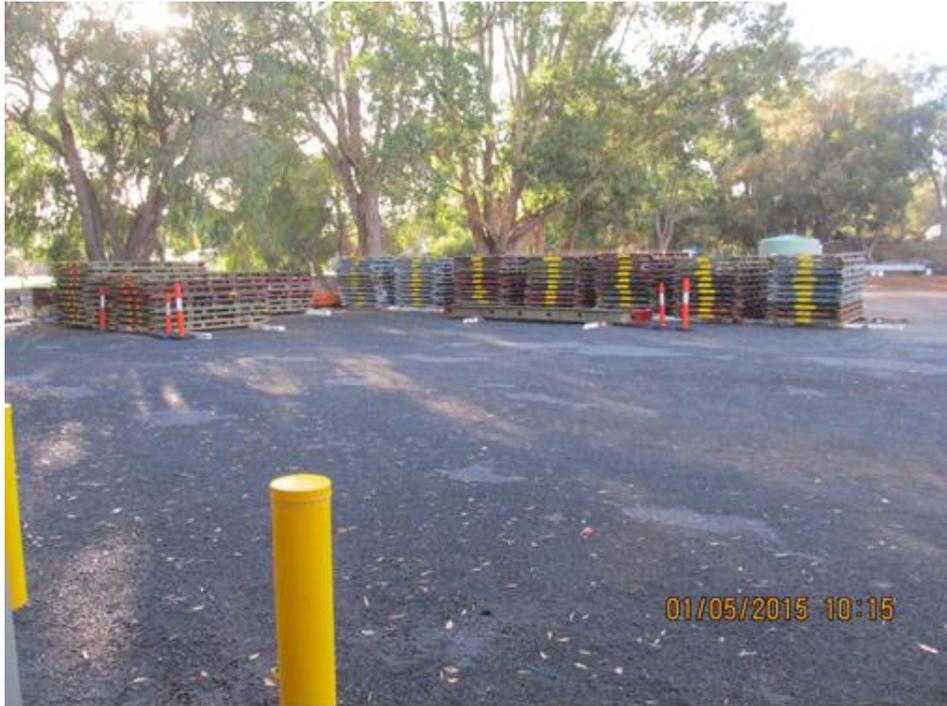
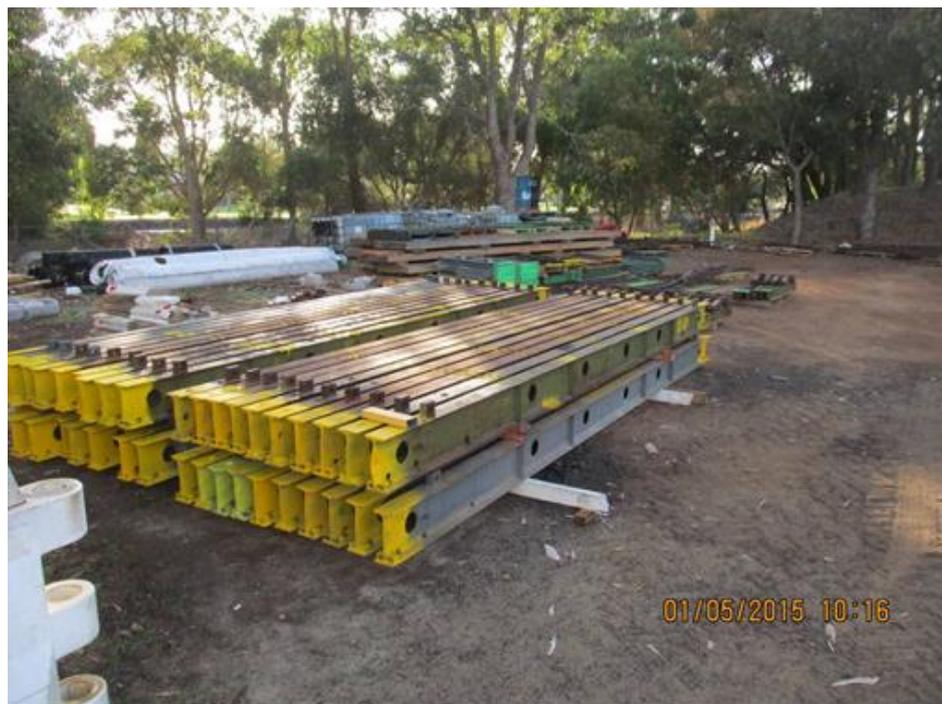
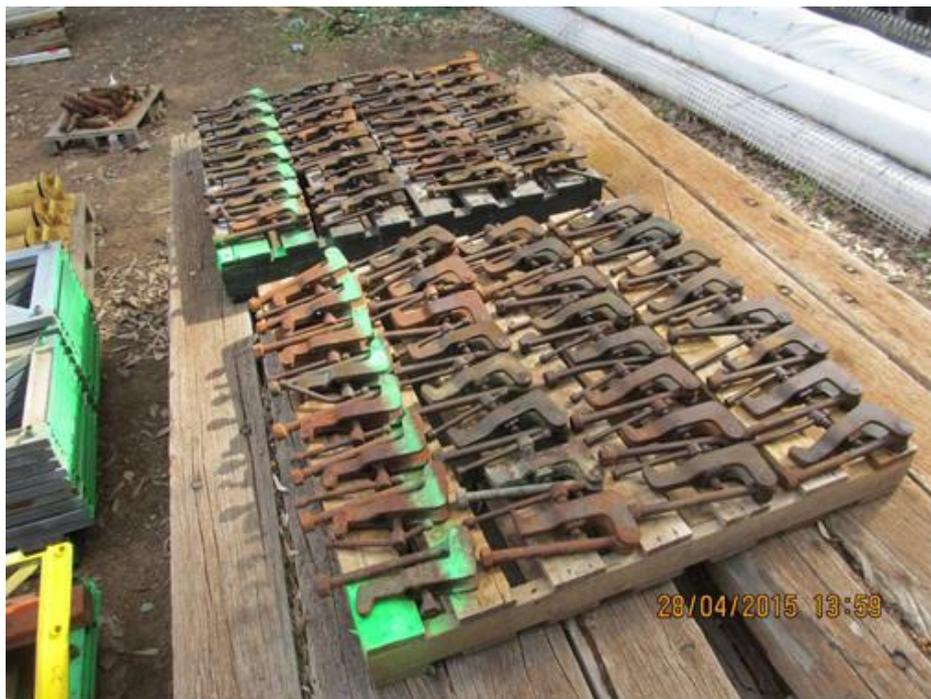
Every component was colour coded as follows:

- **green** – good condition
- **yellow** – required repair
- **red** – to be scrapped or “cannibalized” for repair of other similar components.

**Figure 13 – Colour coded sorted stacks of panels**

**Figure 14 – transoms requiring repair**

**Figure 15 – transom clamps in good condition**

Refer to Figures 13, 14 and 15 for typical colour coding of the Bailey bridging components.

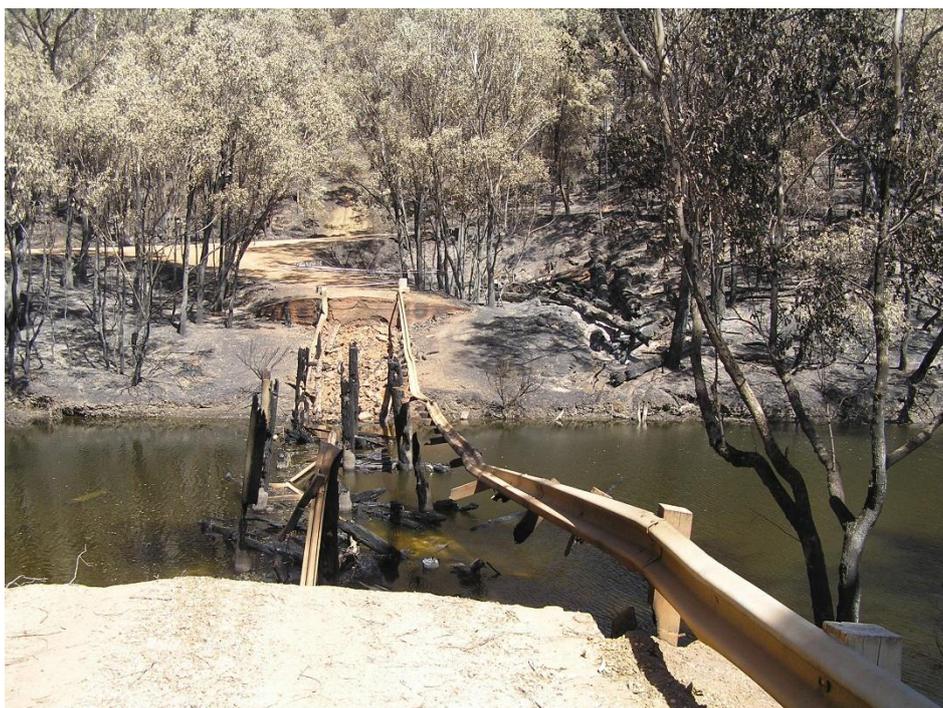
In 2013 a bushfire in the Shire of Donnybrook/Balingup destroyed Bridge 3291A on Southampton Road over the Blackwood River (refer to Figure 16). This was a significant bridge approximately 60m in length and provided access for the management of State forest, access for private landowners and

**Figure 16 – Bridge 3291A on Southampton Road over the Blackwood River in the Shire of Donnybrook/Balingup destroyed by a bushfire in 2013**

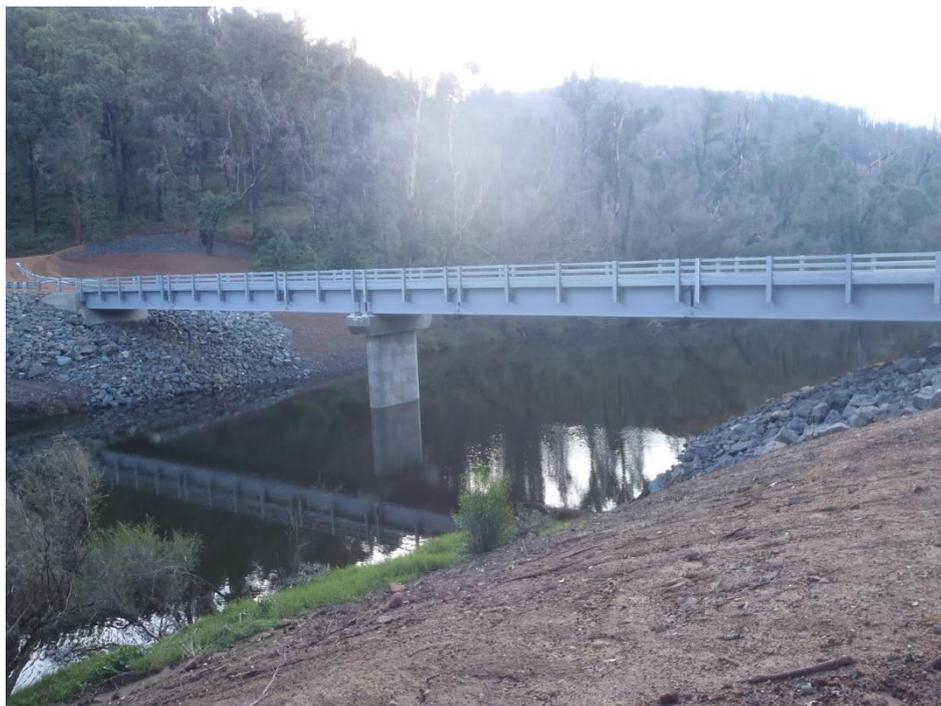
The replacement bridge was 57m long, 2 spans, 4.7m wide and supported on reinforced concrete abutments and pier. The main justification for using the Unibrige was the pressure to reinstate a bridge at this crossing within a tight timeframe.

The Unibrige was successfully installed within the required timeframe (refer to Figure 17). The Unibrige superstructure took only one week to assemble and place. However, given the length and weight of the steel girders, a 220 tonne crane was required to place the girders (refer to Figure 18).

**Figure 17 – Bridge 3291B completed using the Unibridge superstructure**

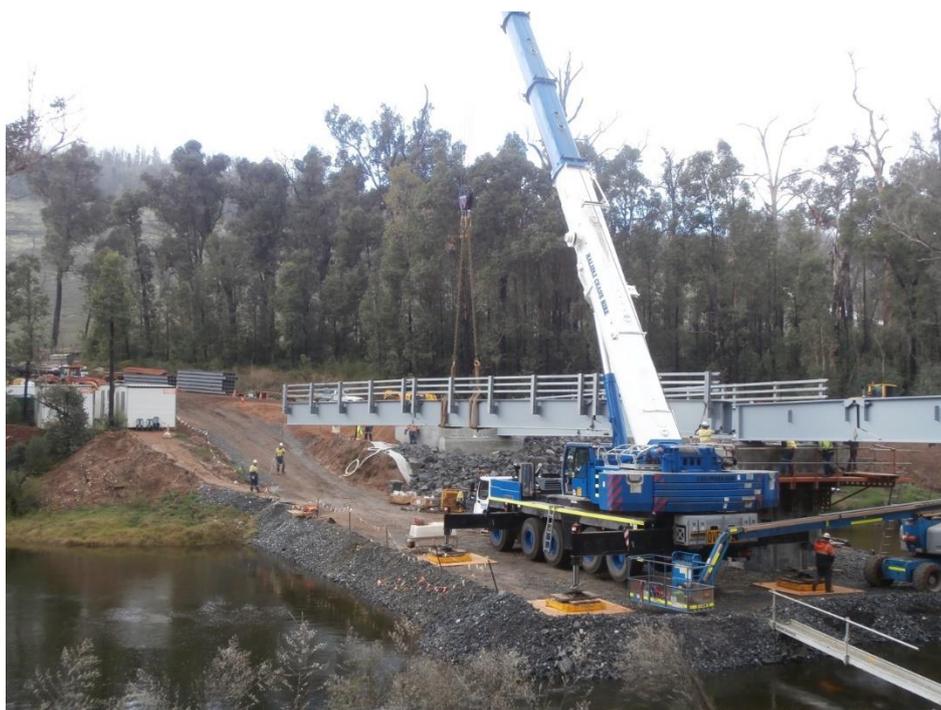
**Figure 18 – a 220 tonne crane being used to place the Unibridge steel girders**

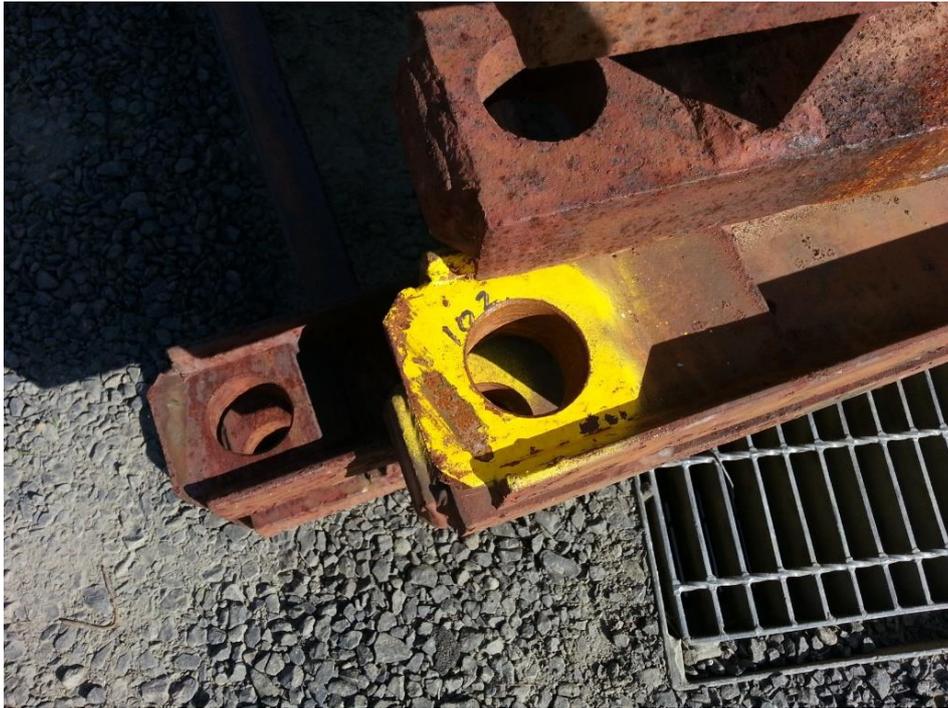
Local engineering fabrication company Spurling Engineering was engaged to undertake the structural repairs to the Bailey bridging components including arranging the sandblasting and galvanizing of these components. Figure 19 shows a pin hole reamed out so that the pins can be installed correctly. Figure 20 shows a previously damaged gusset plate on a panel having been straighten out.

**Figure 19 – pin hole reamed out**

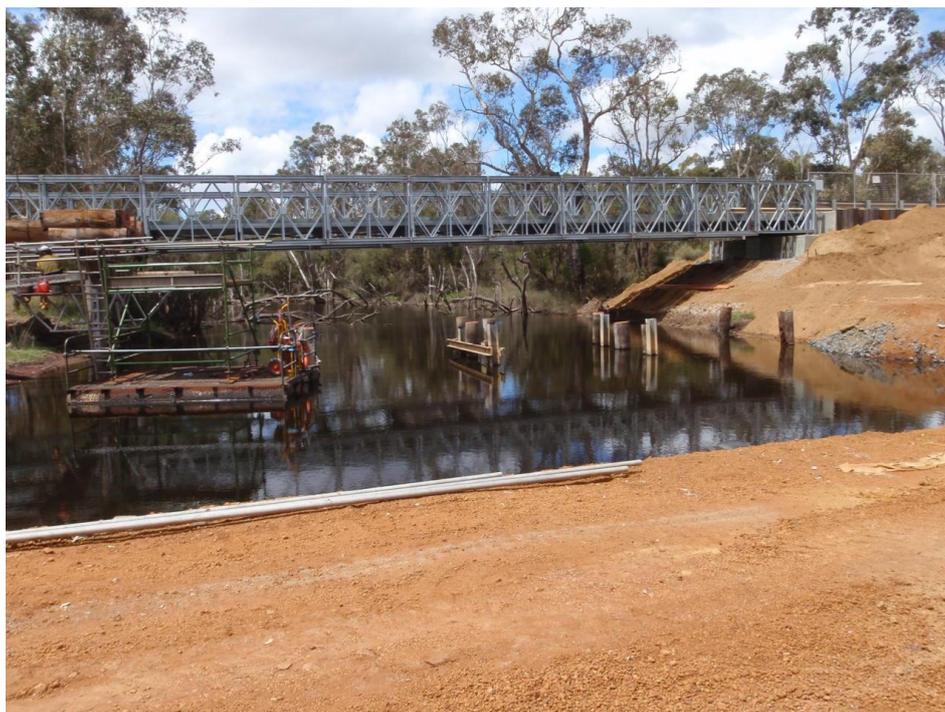
In 2018, MRWA purchased a 40m long Mabey Compact 200 bridging system. In the first instance, it was used on a sidetrack for the replacement of Bridge 0270 on the Boyup Brook Cranbrook Road over Tone River. The 40m configuration used provided a load capacity of 100% T44. Refer to Figure 21 showing the Mabey Compact 200 bridge installed on the side track alongside the original Bridge 0270 which was being demolished.

**Figure 21 – 40m long Mabey Compact 200 bridge installed on Boyup Brook Cranbrook Road over Tone River**

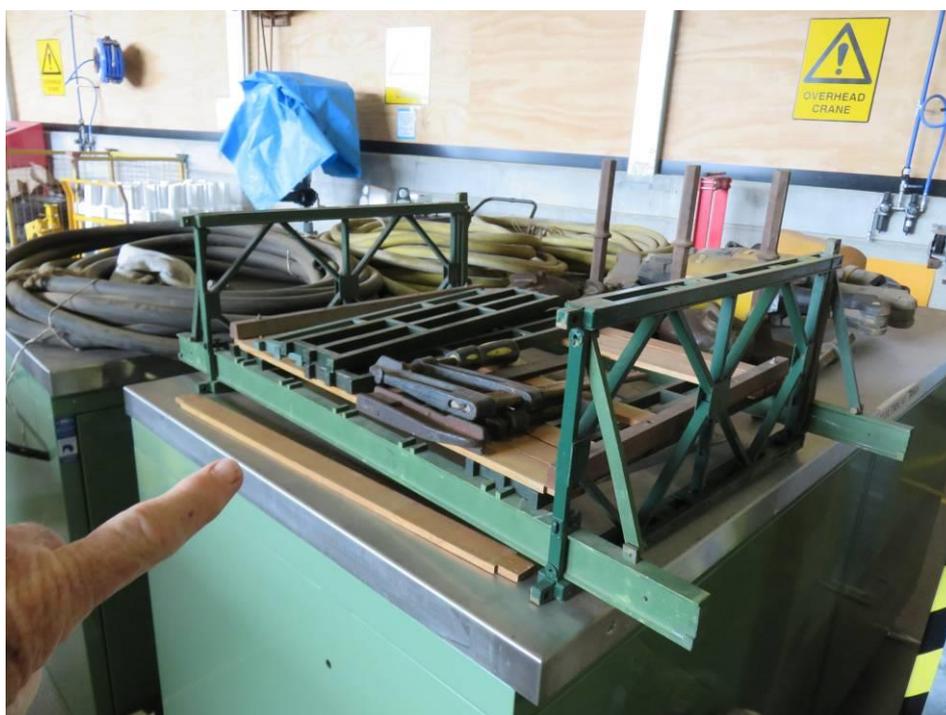
The Bailey bridging system training will include theoretical training and onsite practical training. The theoretical training will help staff understand the function of each component, the correct naming of the components, and how to determine what configurations are required for various spans. To assist in this aspect of the training, it is planned to use a scale model kit from the Army Museum in Holsworthy, NSW. Figure 22 shows some of the scale model components.

Figure 22 – Model Bailey Bridge Set Type A

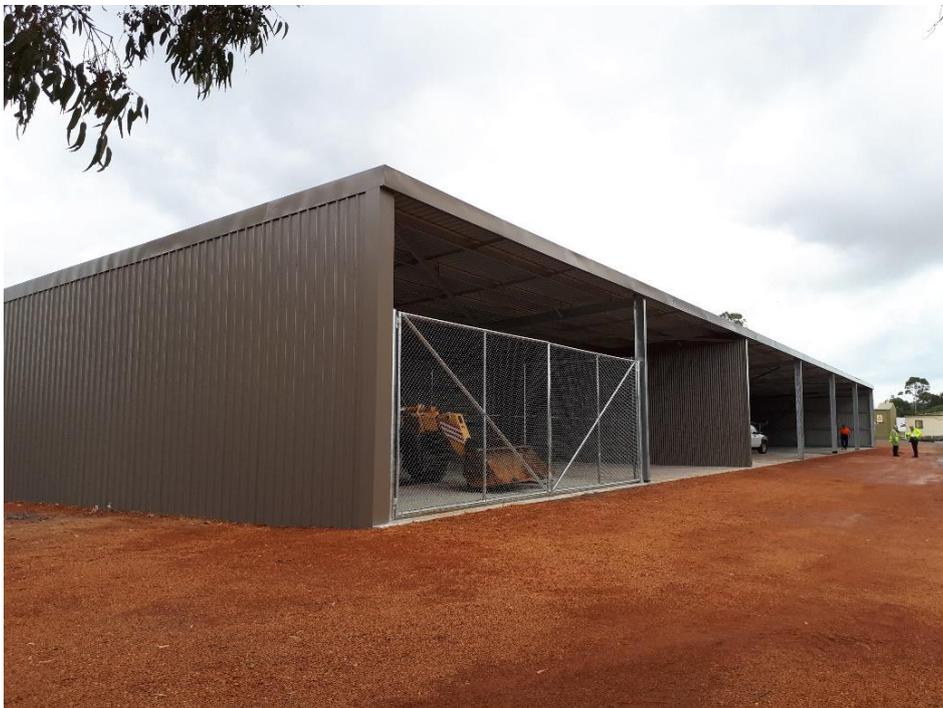
The storage shed is 60m long by 10m deep comprising six 10m x 10m bays. Refer to Figure 23 for the storage shed layout and Figures 24, 25 and 26 for the complete storage shed and some of the Bailey bridging components stored in the shed. The shed is big enough to house both the Bailey and Mabey Compact 200 bridging systems.

Figure 24 – Completed storage shed for emergency bridging systems

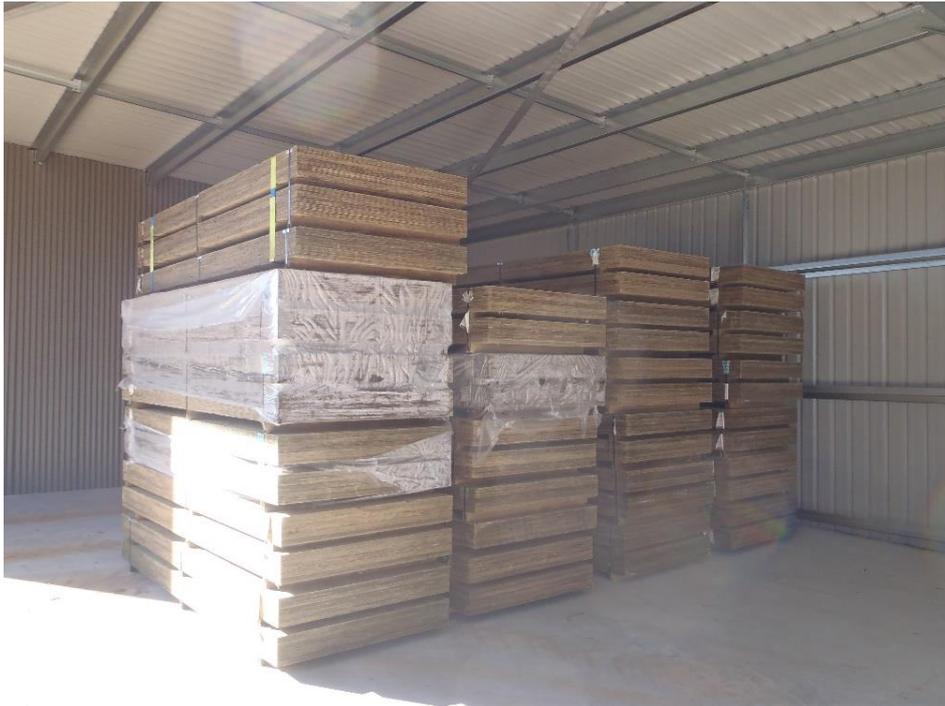
New decking was purchased from Big River Group. The decking is 170mm thick cross-laminated plywood (“Bridgeply”). These decking panels are 3.048m long to match the length of the truss panels. The panel width is 1.2m and the stress grade is F17. Three panels are used side by side to provide the required deck width (3.6m) and the outer panels have timber kerbs attached. The panels have been designed to support T44 loading (minimum required was VSR) with a maximum span between transoms of 1.5m.

**Figure 25 – Bridgeply decking for Bailey bridging system**

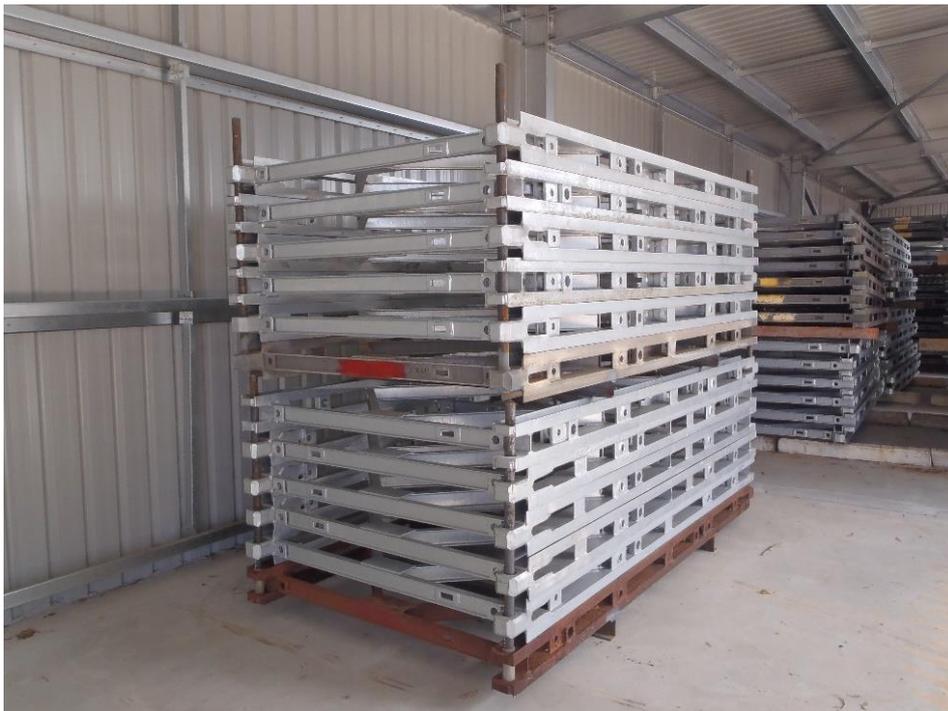
**Figure 26 – Bailey bridge panels stacked on purpose made pallets**
