# Strategic Management and Rehabilitation of an Aging Road Bridge Asset Portfolio

Matt Duncanson, Senior Engineer – Materials Technology, SMEC Australia Pty Ltd (Co-Presenter)  
Tiffany Parker, Senior Structural Engineer, City of Gold Coast (Co-Presenter)  
Dr. Luke Menefy, Team Leader – Materials Technology, SMEC Australia Pty Ltd  
Yvonne Ulas, Senior Project Manager, City of Gold Coast

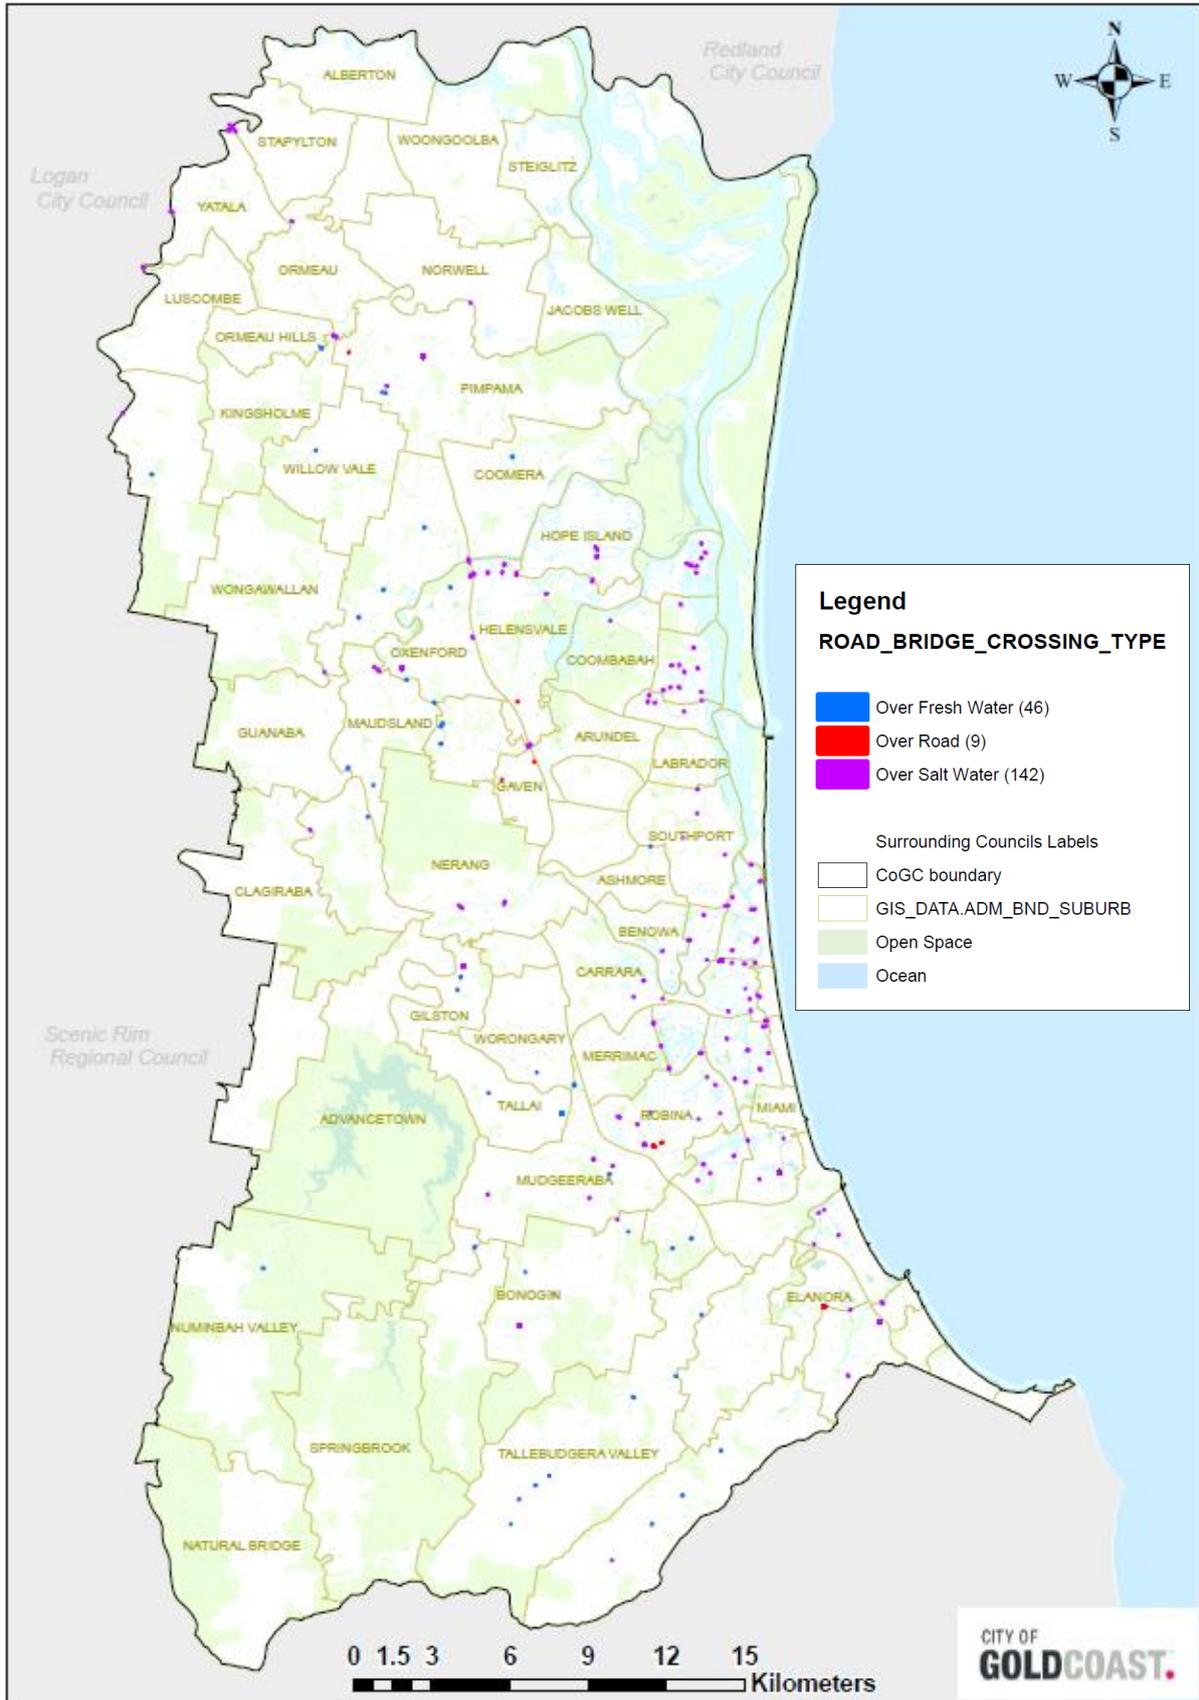
Figure 1: Road Bridge Location Map

(refer **Table 1** and **Figure 1** Location Map). The earliest concrete bridges date back to 1950's and are approaching 70 years old.

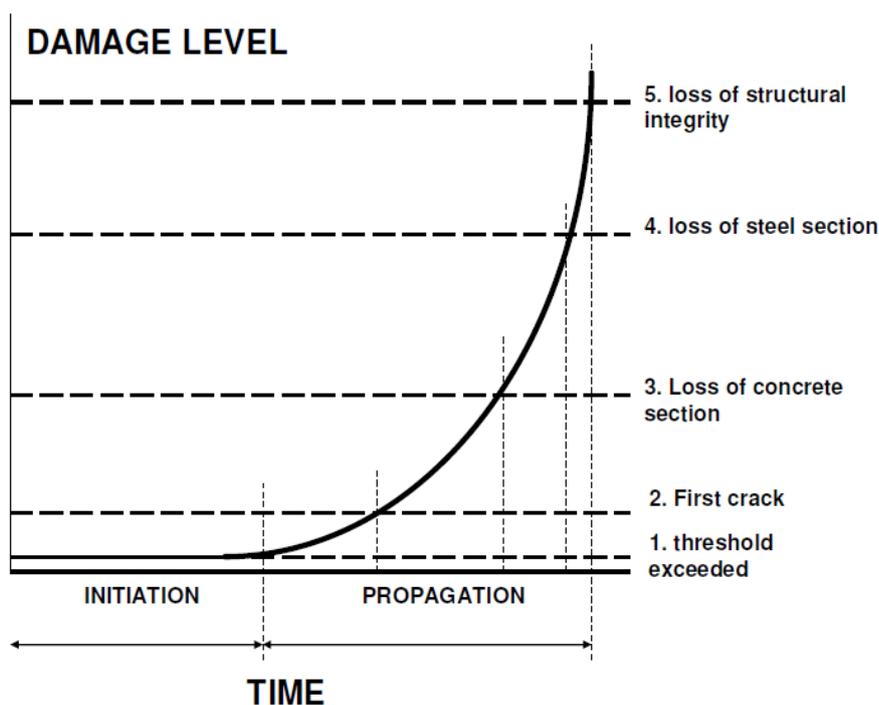
**Figure 3: Typical Stages of Corrosion (Chirgwin, G. et al, 2009)**

The long term goal, however, is to transition from the corrective (reactive) interventions to preventative (proactive) maintenance. With reference to the “Law of Fives” (as described in SA HB84, 2018) and shown in **Figure 3**, the aim is for the works to be scheduled prior to the corrosion initiation and before the deterioration occurs. This approach offers the best value over the lifecycle of the asset.

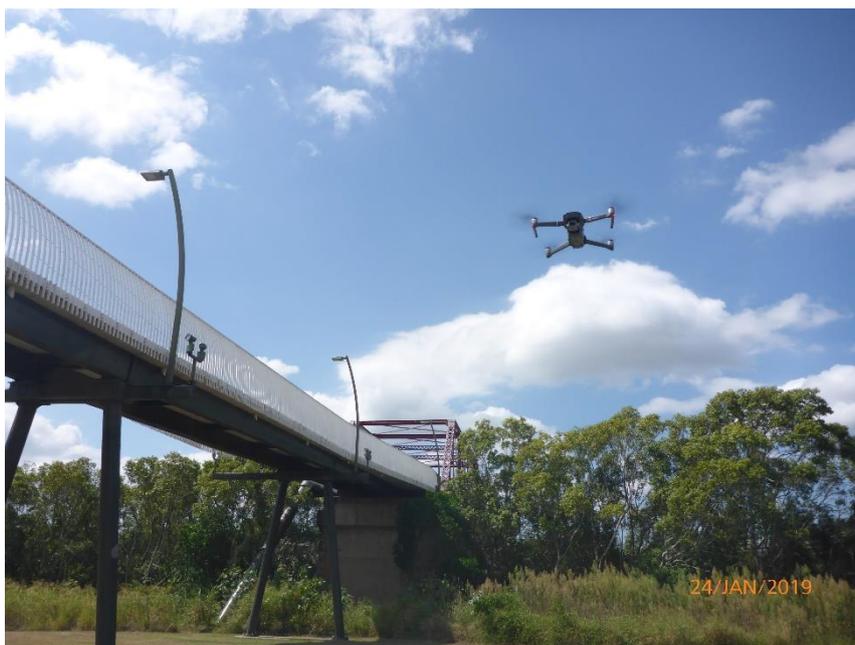
**Figure 4: RPA (drone) Bridge Inspection**

- High zoom cameras/binoculars – can be very effective, will generally require a tripod at high zooms to ensure clarity of images.
- Remotely piloted aircraft (i.e. drones as shown in **Figure 4**) – this is a rapidly emerging market with an abundance of technologies available. The primary considerations are safety of the public during drone use (generally by abiding by Civil Aviation Safety Authority’s requirements) and having a highly skilled operator with experience in bridge inspection.
- Borescopes/videoscopes – very useful for cavities or other tight areas (e.g. bridge bearings).
- “Camera on a stick” – a rudimentary technique; however, it can be very cost effective and provide good outcomes. Most useful when live viewing (e.g. on a tablet computer connected via WiFi).

It is important to highlight the limitations of remote inspection techniques, such as their inability to accurately quantify the size of defects requiring repair. In some instances, this project risk can be managed accordingly when procuring the repair works.

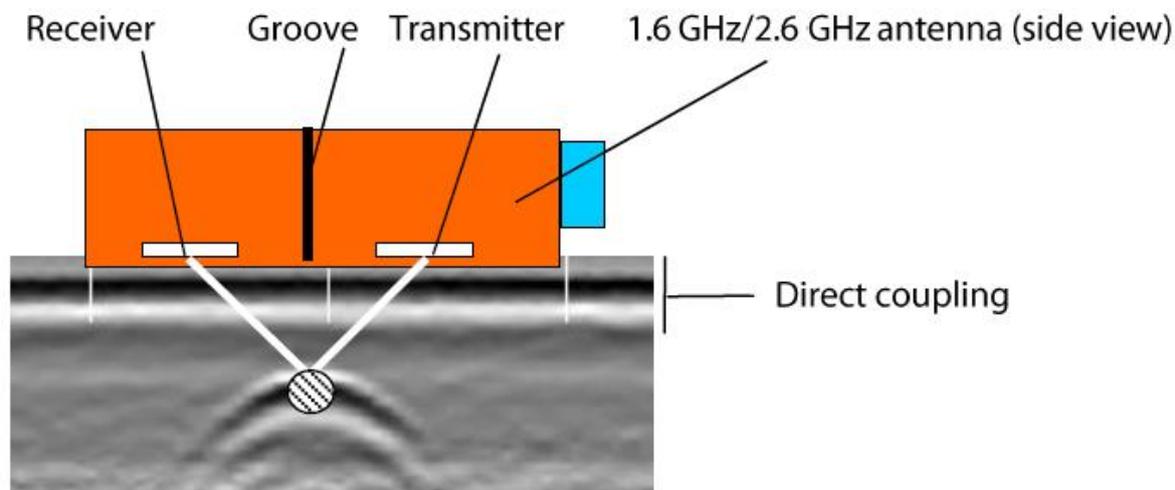
**Figure 5: GPR Locating Reinforcement (source: GSSI Structure Scan Mini II manual)**

GPR's use radio to send a signal into the concrete, and the reflection is received and interpreted by the device (**Figure 5**). The principal of GPR relies on variance in density of the media undergoing scanning; for example, steel reinforcement is approximately three to four times denser than concrete. The primary limiting factor of GPR is the susceptibility to the moisture content of the concrete which

can largely affect the readings. It must be verified the dielectric setting on a GPR correlates to the moisture content of the concrete, which will often necessitate exposing the reinforcement to calibrate the readings. This is of particular difficulty when the moisture content varies within a structural element, such as a bridge pile (tidal, splash and atmospheric).

In an idealised scenario, both devices are used in conjunction to supplement each other. For example, the GPR can be used to initially determine the reinforcement layout, and then the cover meter is used to determine the cover (including a drill hole or breakout if the bar size is not known).

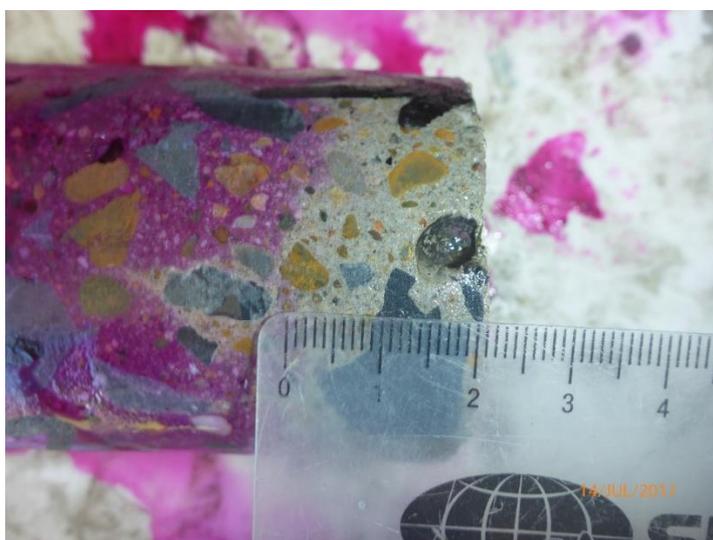
**Figure 6: Neutralisation (Carbonation) Depth Testing**

Neutralisation depth testing (commonly referred to as carbonation testing) is a quick and simple test conducted on site (can be conducted in laboratory on core samples). Freshly fractured concrete (i.e. core sample or breakout) is sprayed with a solution of phenolphthalein, ethanol and water (**Figure 6**). The phenolphthalein is a pH indicator which will turn magenta in contact with alkaline concrete (where the pH is commonly around 12). If the pH has dropped to below approximately 9 due to carbonation or other mechanisms, the solution will remain colourless.

It should be noted only the cement will change colour and the aggregate will always remain colourless. When measuring the neutralisation depth, it is important to ensure the aggregate is not included.

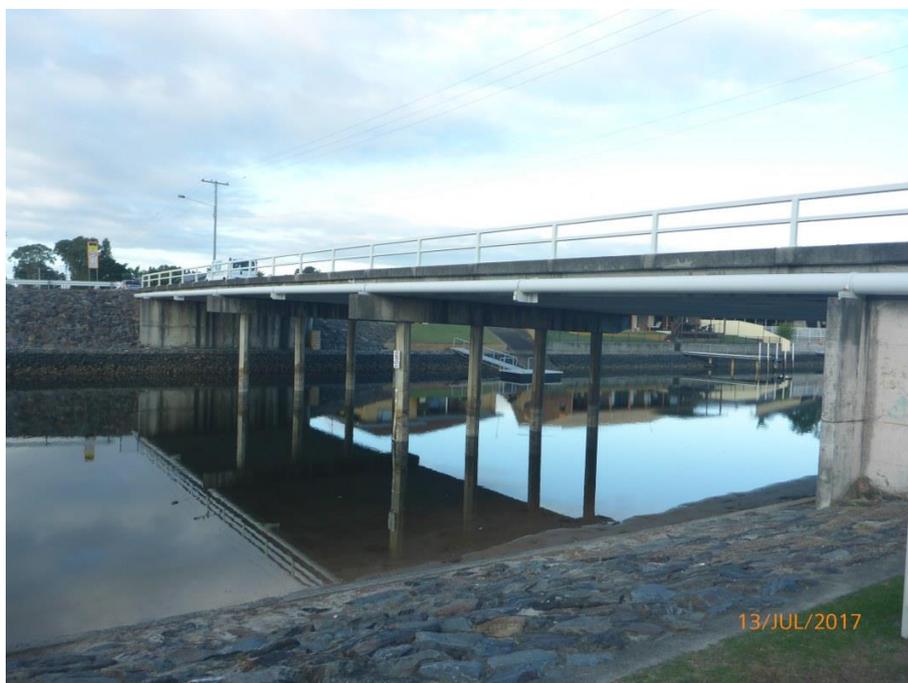
**Figure 7: Hollywell Bridge**

A Level 2 (visual only) condition assessment was undertaken in May 2014. Whilst the bridge was rated in Condition State 2 overall, the City had concerns with the defects noted in the report. These defects included horizontal and vertical cracking on the abutment walls and pier headstocks, and localised minor spalling.

Although there were no defects observed in the pier piles, given they were octagonal prestressed (i.e. steam cured), there were residual concerns of internal expansion as a result of AAR/DEF. This risk was considered higher based on the era of construction.

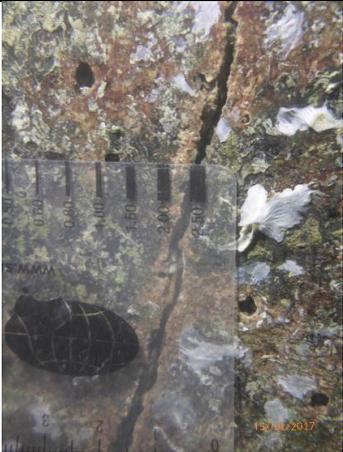
Bridge Element	Key Findings	Image
Pier piles	<p>- 50% (i.e. 4 of 8) were found to have severe vertical cracking between mean water surface and riverbed level.</p> <p>Petrographic analysis confirmed the cracking to be a result of internal expansion due to delayed ettringite formation (DEF).</p> <p>- Very high chloride concentrations in the tidal zone were present at the depth of reinforcement, which exceeded the industry accepted corrosion initiation threshold (although corrosion induced damage was not observed)</p>

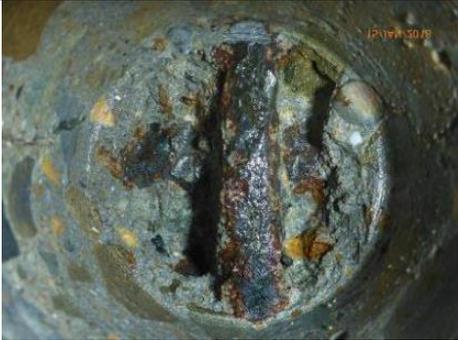
Bridge Element	Key Findings	Image
Pier headstocks	<ul style="list-style-type: none"> <li>- Extensive corrosion induced delamination and cracking with a total area measured at approximately 12m<sup>2</sup></li> <li>- Up to 40mm of concrete carbonation (with 45mm cover)</li> <li>- High chloride concentrations at depth of reinforcement (which are suspected to include a high level of cast in chlorides)</li> <li>- Confirmed reinforcement corrosion at concrete breakout locations</li> <li>- Erroneous steel-to-concrete potential findings due to heavy carbonation</li> </ul>

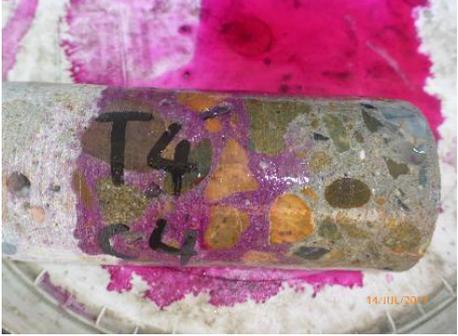
Abutment walls and wingwalls	<ul style="list-style-type: none"> <li>- Very similar condition to pier headstocks</li> <li>- Approximately 34m<sup>2</sup> of corrosion induced delamination and cracking</li> <li>- Carbonation depth of 42mm exceeding the minimum measured cover of 34mm</li> </ul>

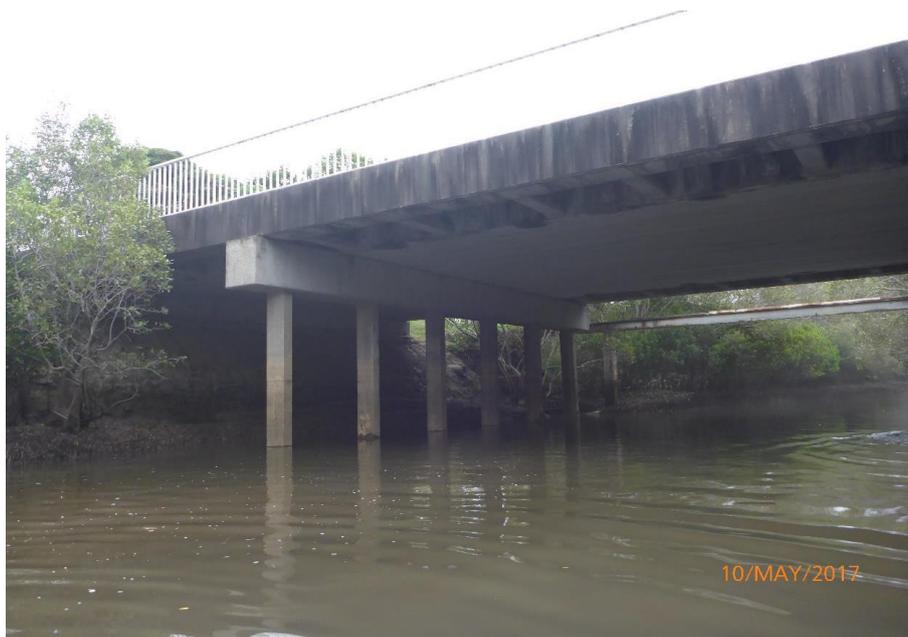
**Figure 8: Southport Bridge**

The bridge was constructed circa 1968 and consists of three spans with transversely post tensioned prestressed deck units, and cast in-situ pier and abutment headstocks supported on precast prestressed octagonal concrete piles (**Figure 8**).

A Level 2 (visual only) condition assessment was undertaken in June 2014. The only observed notable defects were cracking in the pier and abutment headstocks, and cracking/spalling of the concrete service supports. The piles were rated in Condition State 1 with no defects observed at the time of inspection.

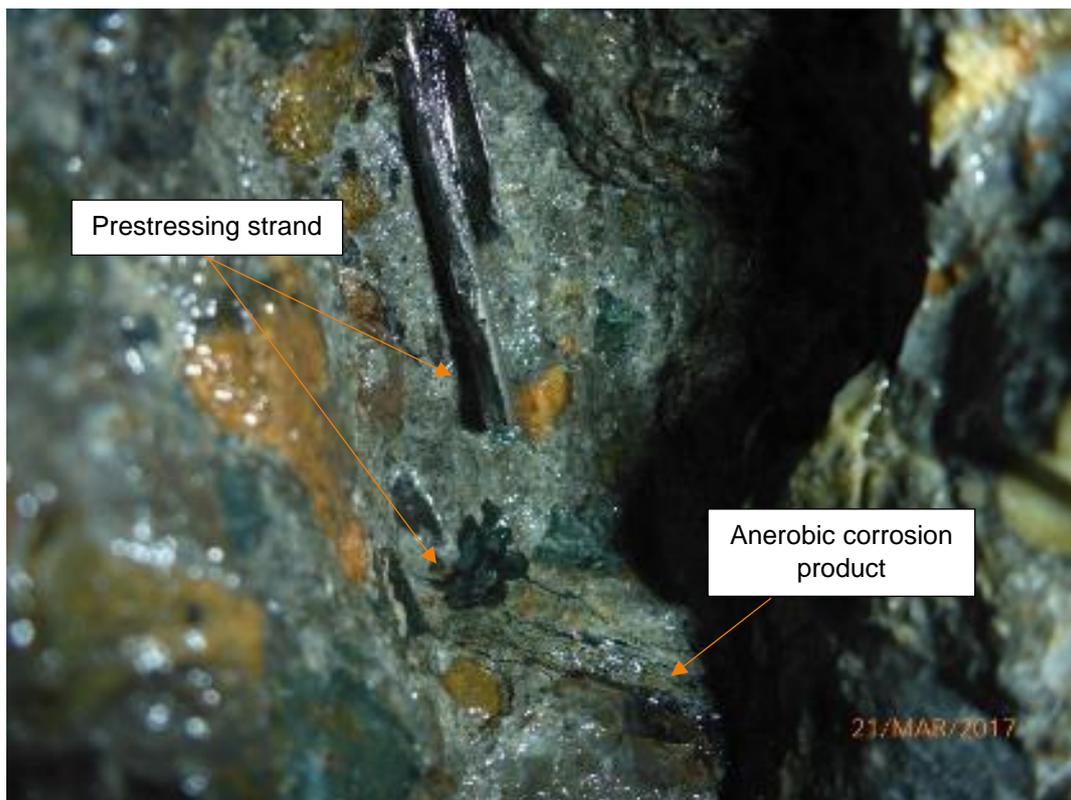
**Figure 9: Anerobic Corrosion to Prestressing Strands**

This project demonstrates how a simple task such as cleaning the piles, can result in uncovering defects which require immediate rectification to ensure the structural integrity of the bridge is maintained.

As a result of the investigation, structural encasements were designed and constructed for the 5 piles experiencing DEF induced expansion and anaerobic corrosion.

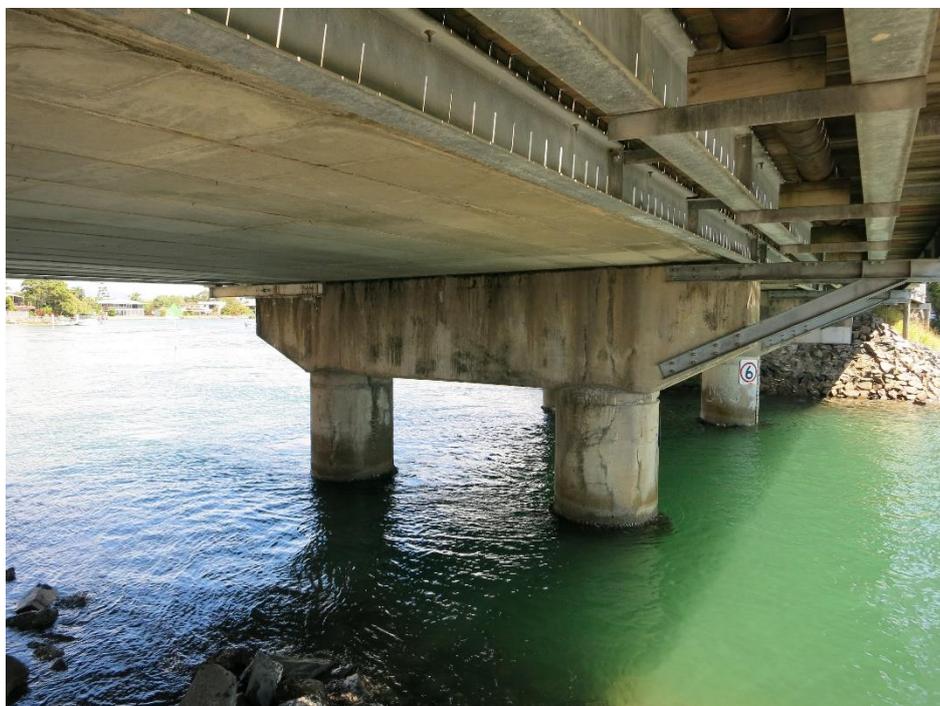
**Figure 10: Biggera Waters Bridge**

The bridge was constructed circa 1960 and consists of three spans with transversely post tensioned prestressed deck units, and cast in-situ pier and abutment headstocks supported on cast in-situ piles. The cast in-situ piles utilised precast concrete cylinders (i.e. pipes) as a permanent formwork (**Figure 10**).

A Level 2 (visual only) condition assessment was undertaken in 2014 and rated the bridge in CS4, primarily due to severe cracking to the pile cylinders and headstocks. A Level 3 Engineering investigation and assessment was required to identify the failure mechanism and rehabilitation options.

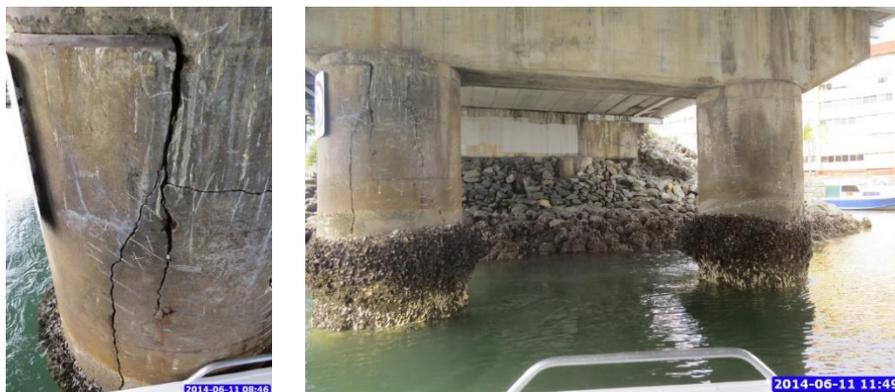
**Figure 11: Vertical Cracking to Piles**

It was concluded the observed vertical cracking to the existing cylinders was a combined consequence of two issues. The first being the result of the outward expansion force induced by AAR and the second being the presence of cast in chlorides, believed to be a result of seawater being used in mixing. Without sufficient confining reinforcement in both the parent pile and the cylinder, concrete expansion was inevitable.

A load capacity assessment was undertaken on the piles based on full removal of the damaged cylinders to ensure ongoing structural integrity during installation of new structural encasements around all four piles. The bridge had to remain open to traffic throughout the entire construction period, and the assessment had confirmed no temporary load limit was necessary. However, strict construction sequencing had to be followed.

The new structural pile encasement consisted of a galvanized reinforcement cage designed to withstand AAR bursting pressures, and a high strength concrete with suitable cover due to exposure to an aggressive marine environment. A bespoke self-compacting micro concrete mix was designed which was pumpable and could be placed underwater using a tremie. A proprietary glass fibre reinforced polymer (GFRP) permanent form was specified.

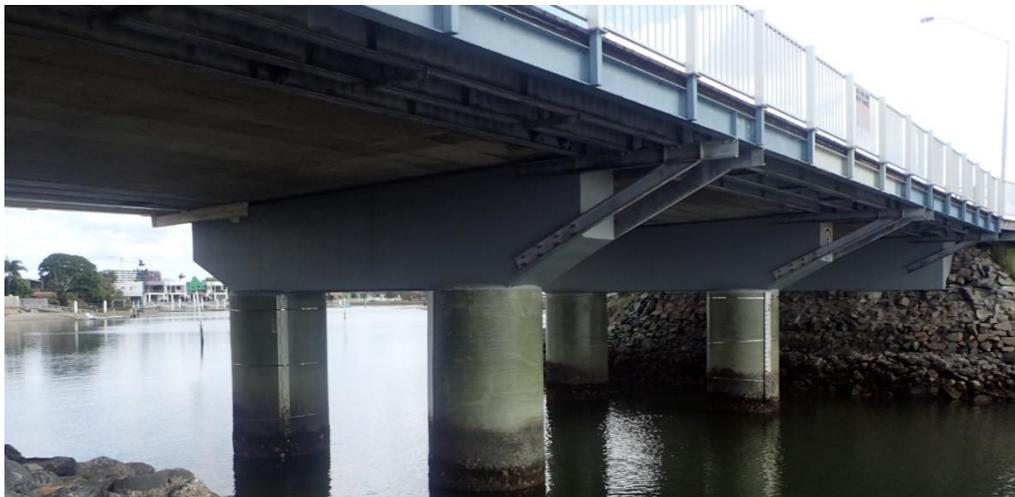
**Figure 12: Completed Structural Pile Encasements**

The remaining three pile encasements were installed successfully as shown in **Figure 12**.
