# Behaviour of Round Notched Timber Sections

JUSTIN DEWEY, *College of Science* and RABIN TULADHAR, *Engineering, JCU, Townsville, Australia*

## ABSTRACT

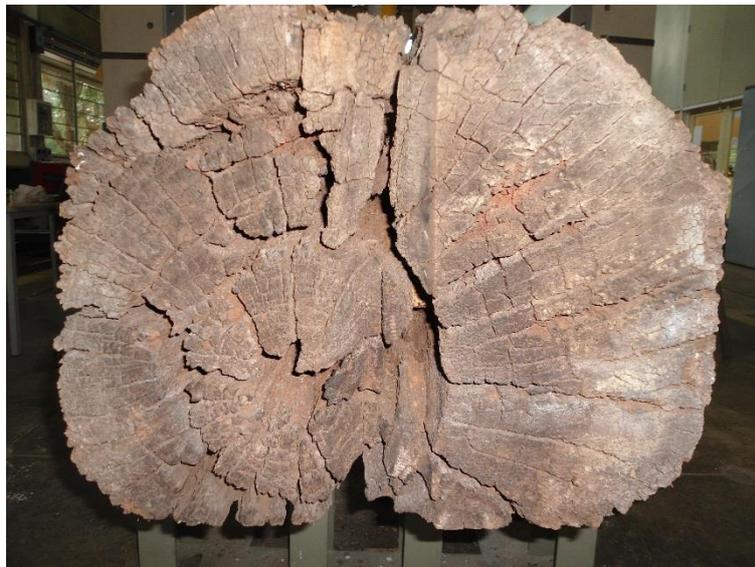
*Figure 3 Radial drying cracks*

It has been noted by researchers that cracking at the internal corner cannot be stopped. This occurs when the end grain is exposed to the environment. Due to the capillary action encountered at the cut face, an uneven distribution of drying may occur leading to additional stresses at this point due to cycles of shrinkage and swelling. Shrinkage in timber can cause tensile failure across the grain. In round members, due to the radial grain profile this can occur in any direction (*Figure 3*).

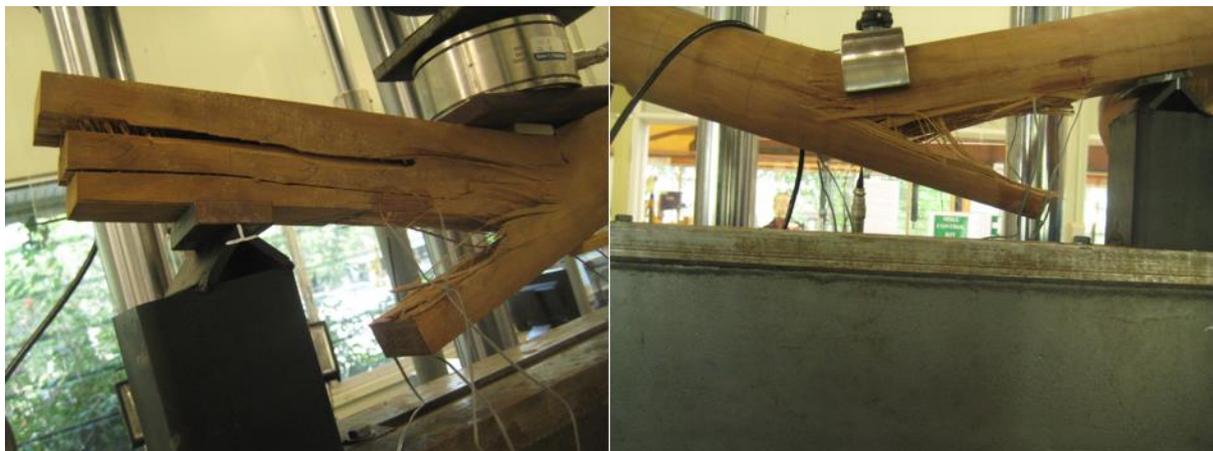
*Figure 7 typical experimental failure*

Nearly all failures in the stepped notched specimens initiated due to mode 1 tension perpendicular to the grain at the re-entrant corner. Mode 2 shear failure would happen in a sudden brittle manner with the crack propagating from the initial mode 1 failure site parallel to the grain to below the load point (*Figure 7*). Failure in the tapered notches would generally happen in a sudden brittle manner with mode 1 and mode 2 occurring simultaneously. Another difference was that when mode 1 failure occurred in the stepped notches it would initiate from the re-entrant corner whereas with the tapered notches failure would occur on the sloped face further away from the sharp corner. Often, failure in the tapered notches followed weaknesses in the radial direction creating a failure in the form of a truncated pie slice with the truncation occurring at the re-entrant corner.
