# Snake River Bridge Load Test Addressing Bridge Management Issues WBES 2015 – Reno, NV

### Snake River Bridge – Overall Details

### Snake River Bridge – Initial Load Rating Results

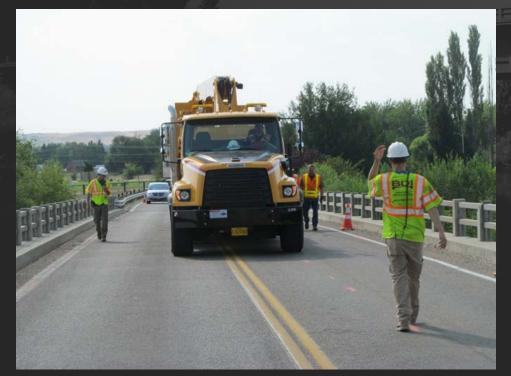
Test along Truck Path Y2

Setup of Tandem Double Truck Test
