Mitigating Grouted Post-Tension Strand Corrosion on Bridges

David Whitmore, P.Eng.
Vector Corrosion Technologies

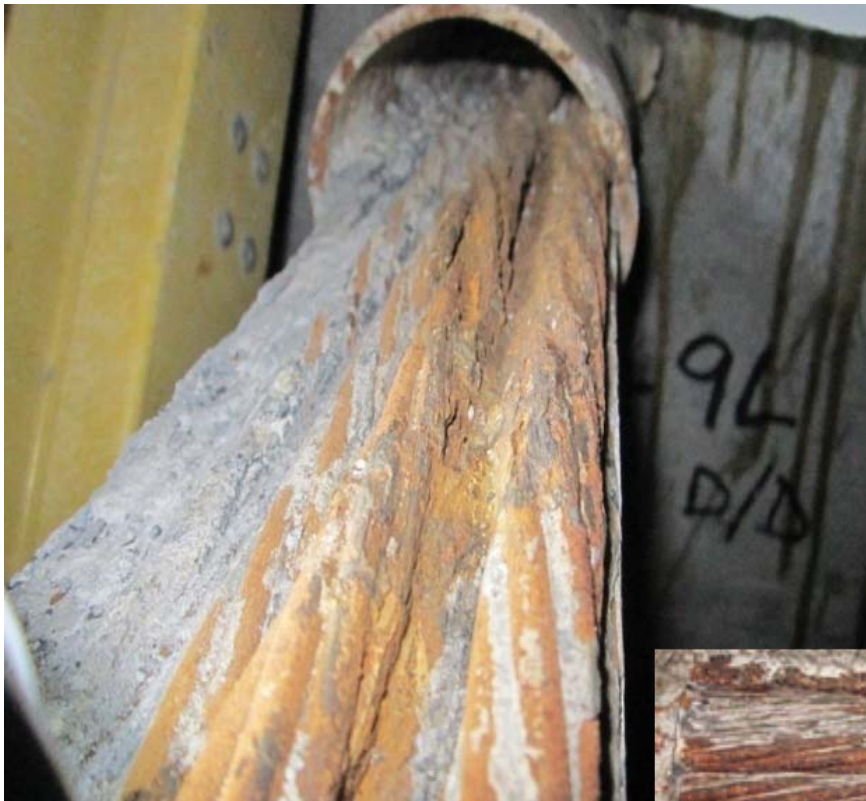
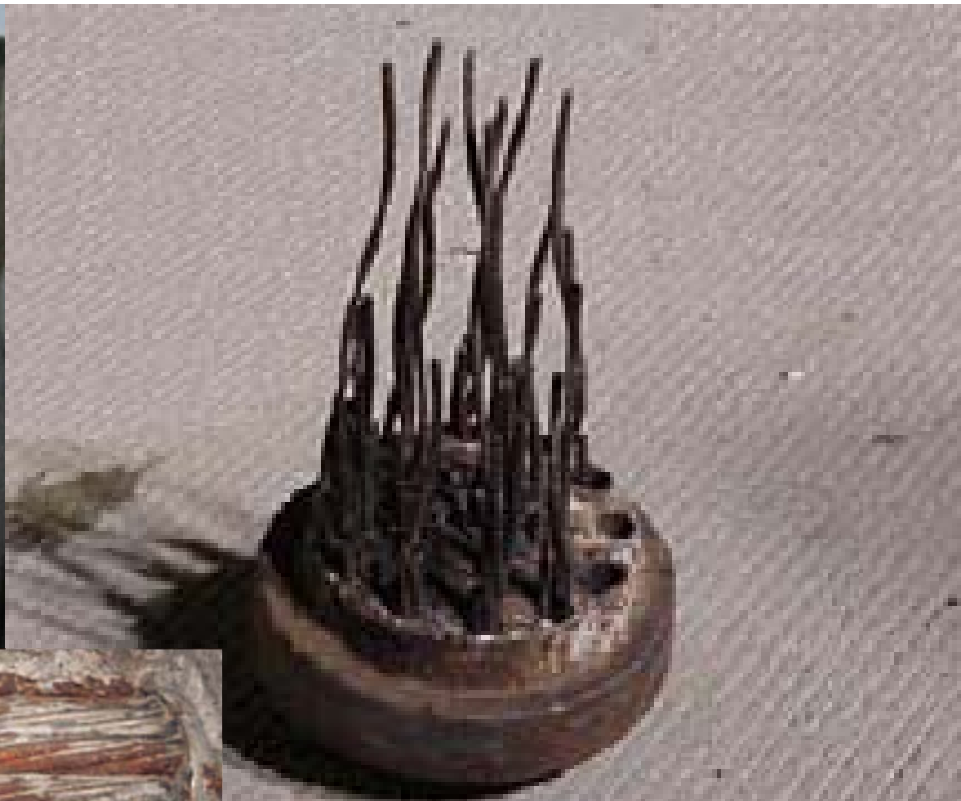
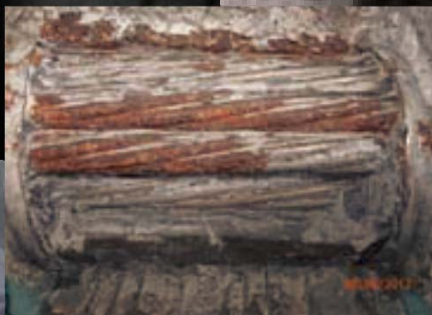
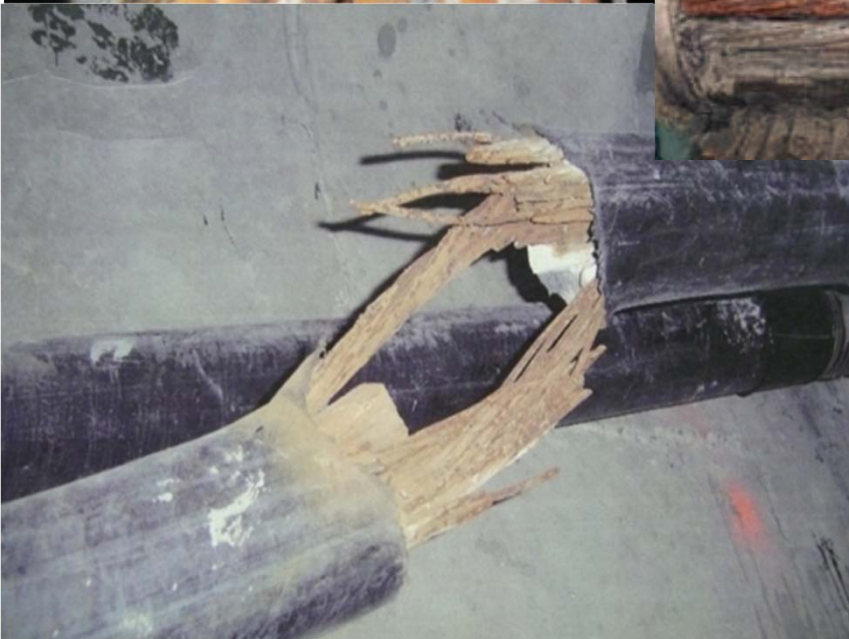
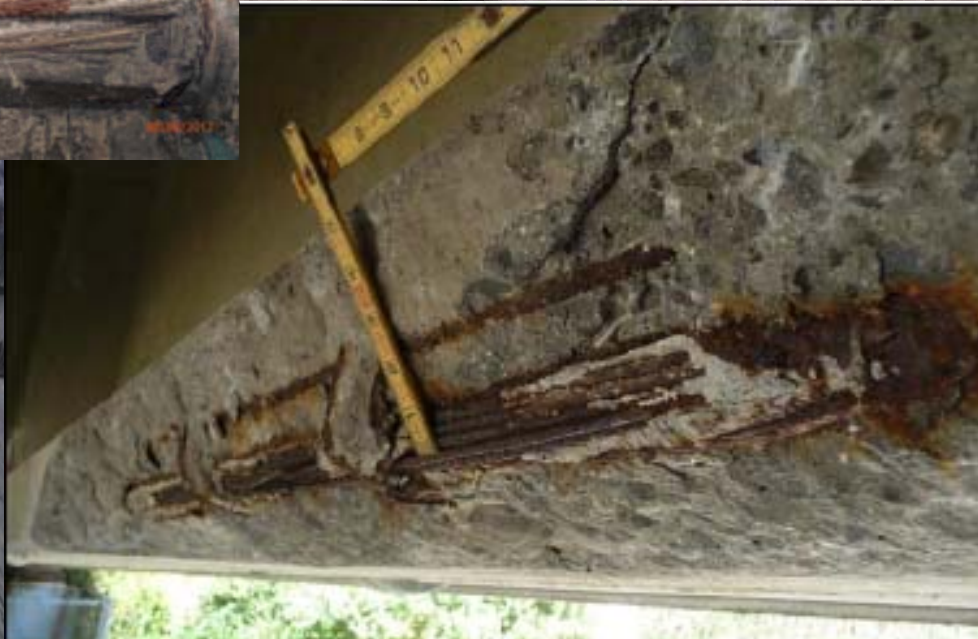
Grout Issues which can lead to Corrosion

- **Voids**

1. Bleed Water
2. Grouting Problems

- **Defective Grout**

1. Segregated
2. Chloride Contaminated
3. Carbonated

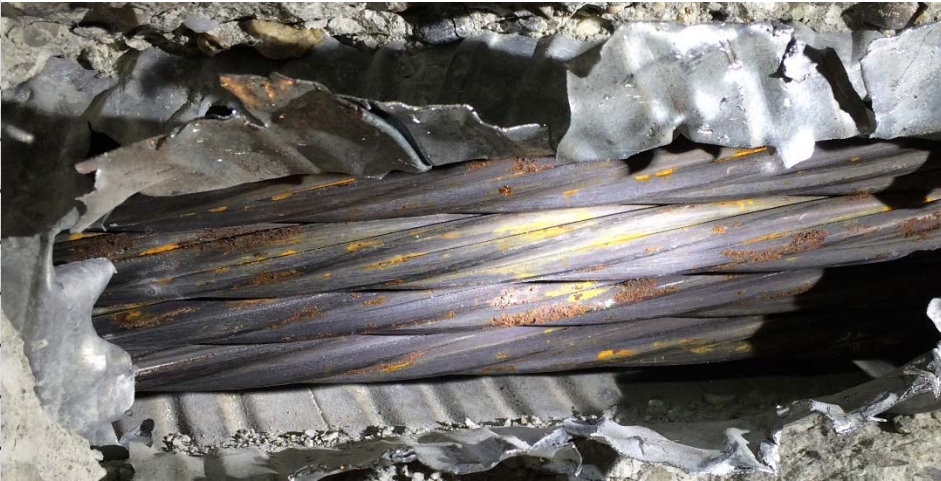
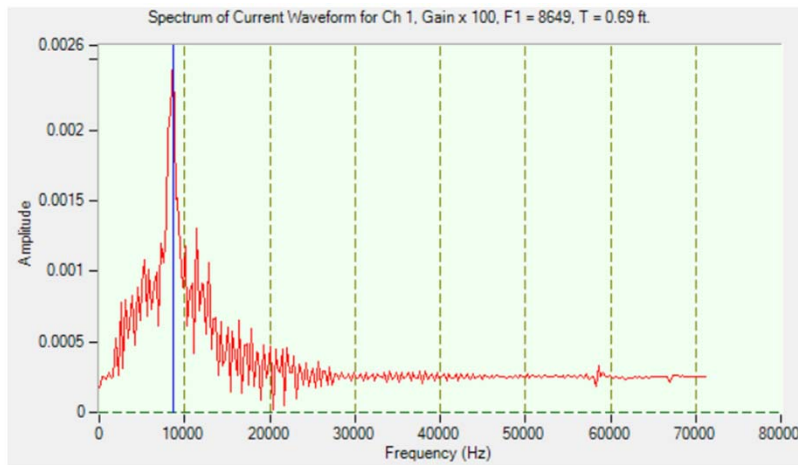
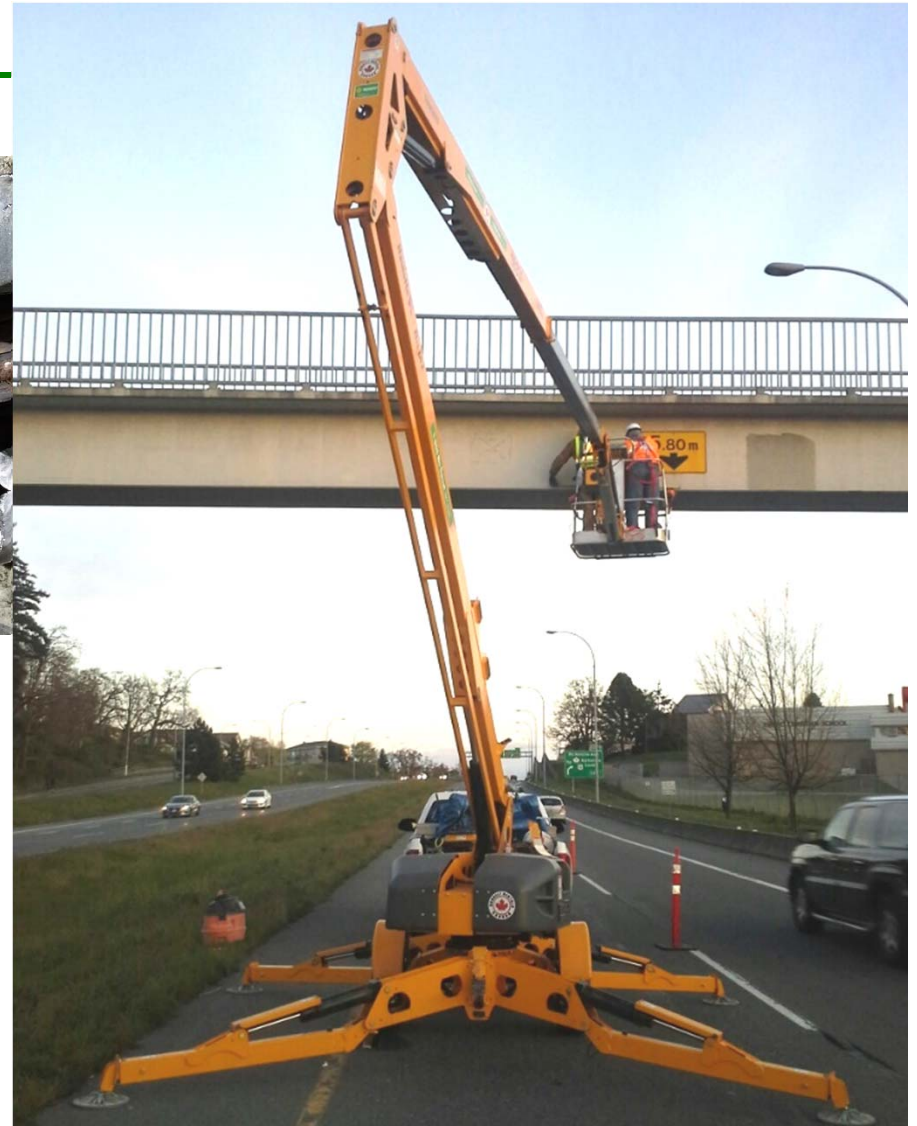
Impact Echo – Rogers Overpass

- Sonic / Ultrasonic Methods
- Borescope
- Magnetic

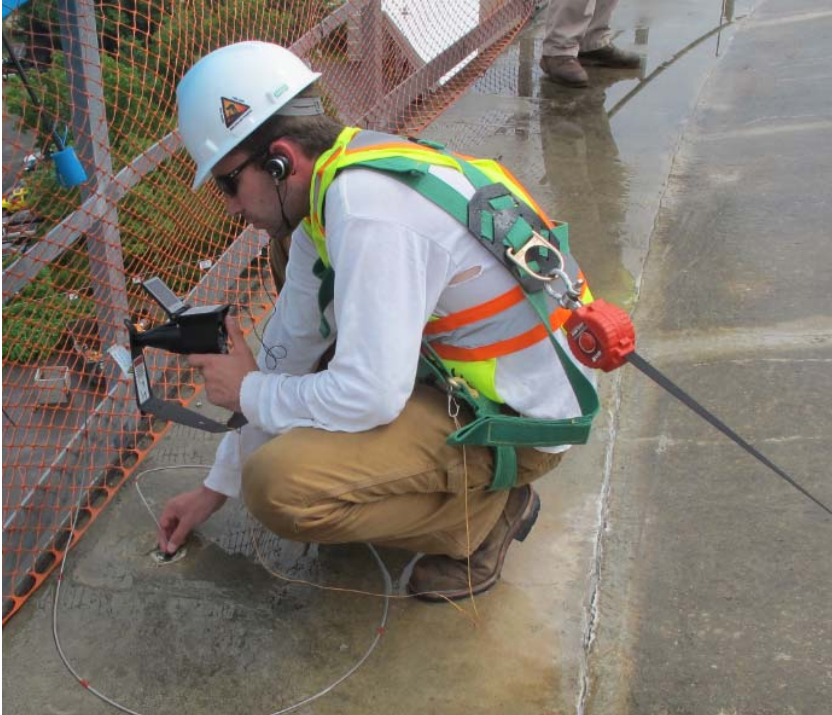
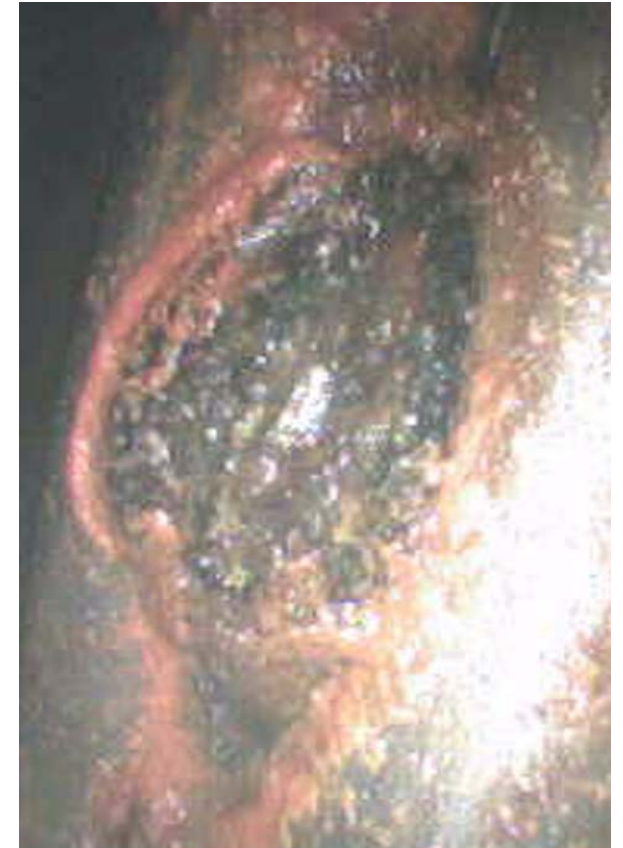
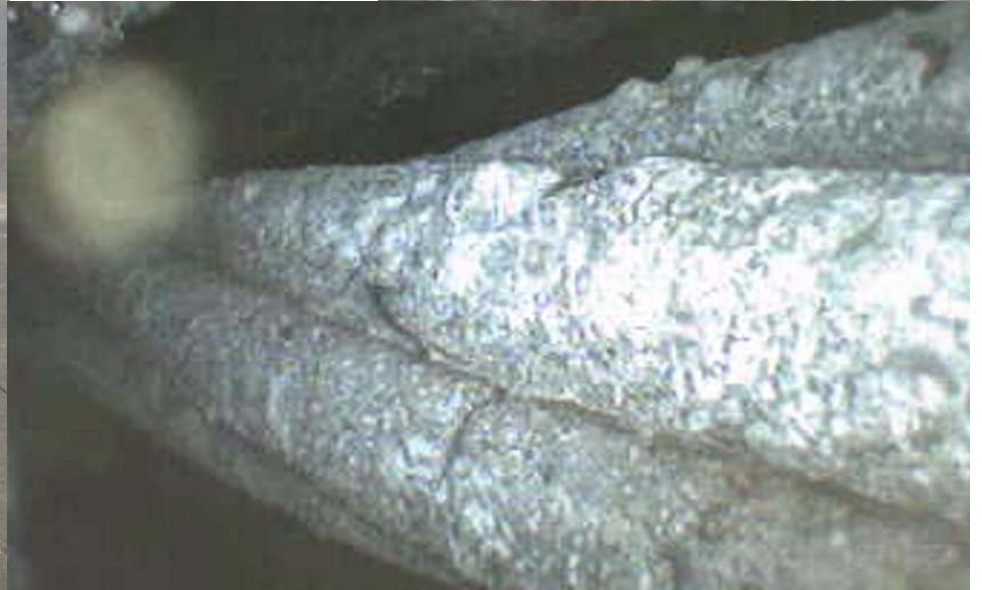
Borescope Inspection

- Visual inspection of voids with minor physical impact
 - Borescope Diam. = 4 mm

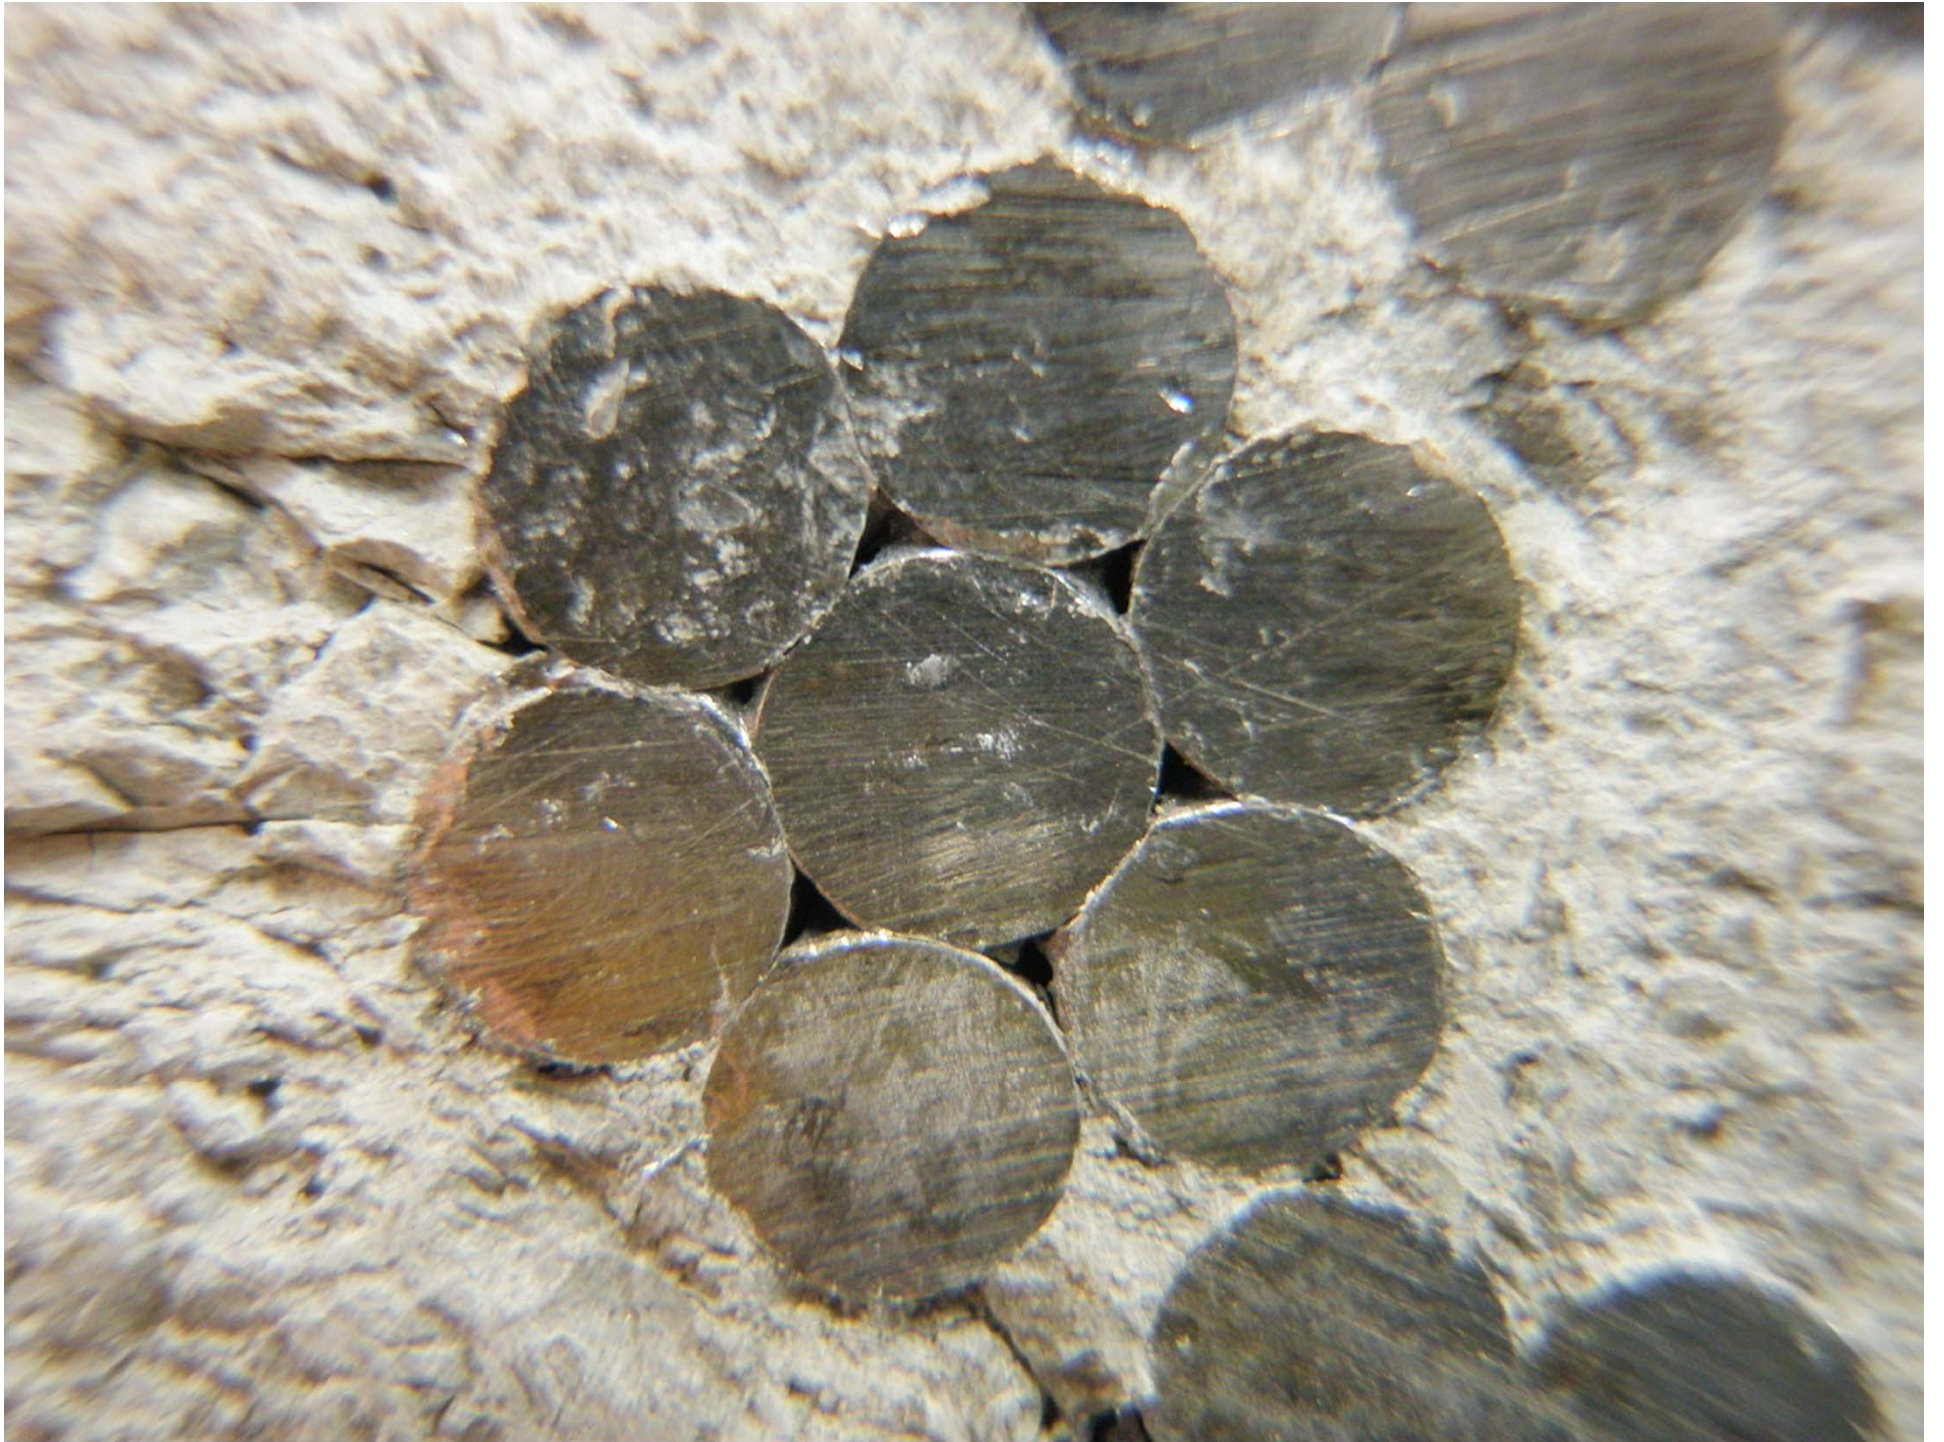
Tendon Impregnation Process

- Corrosion protection process
- Impregnation material transported inside strands full length of tendon
- Impregnation material reduces corrosion by:
 - Coating exposed steel in voids
 - Improving corrosion resistance of grout

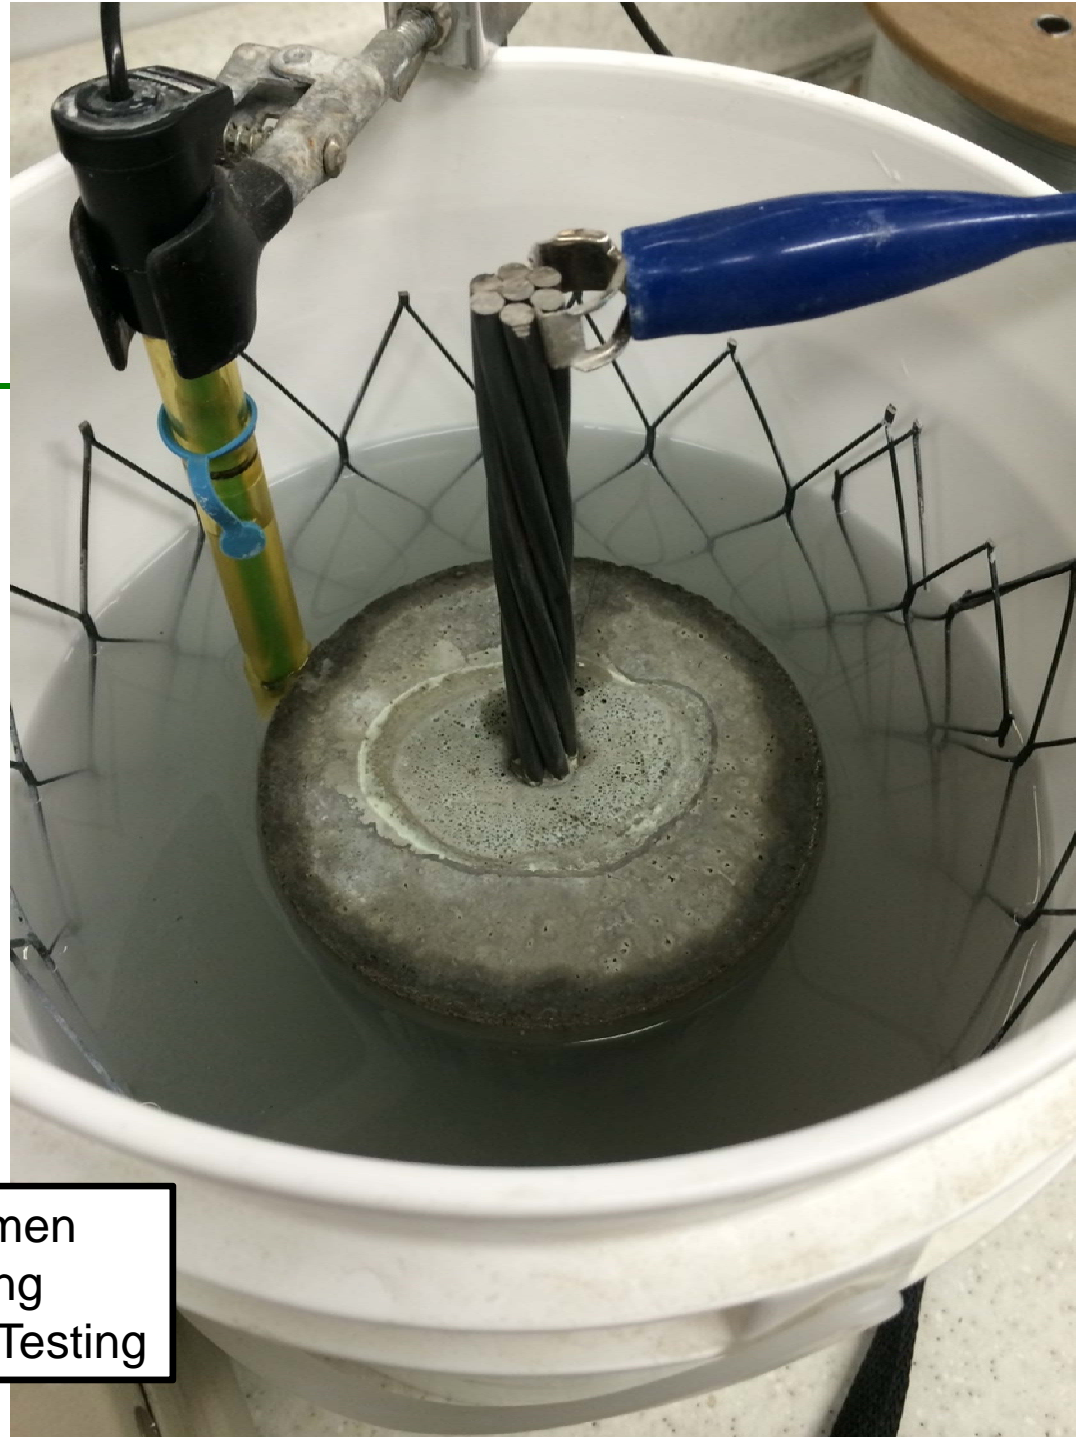
Test Specimen
Undergoing
Galvanostatic Testing

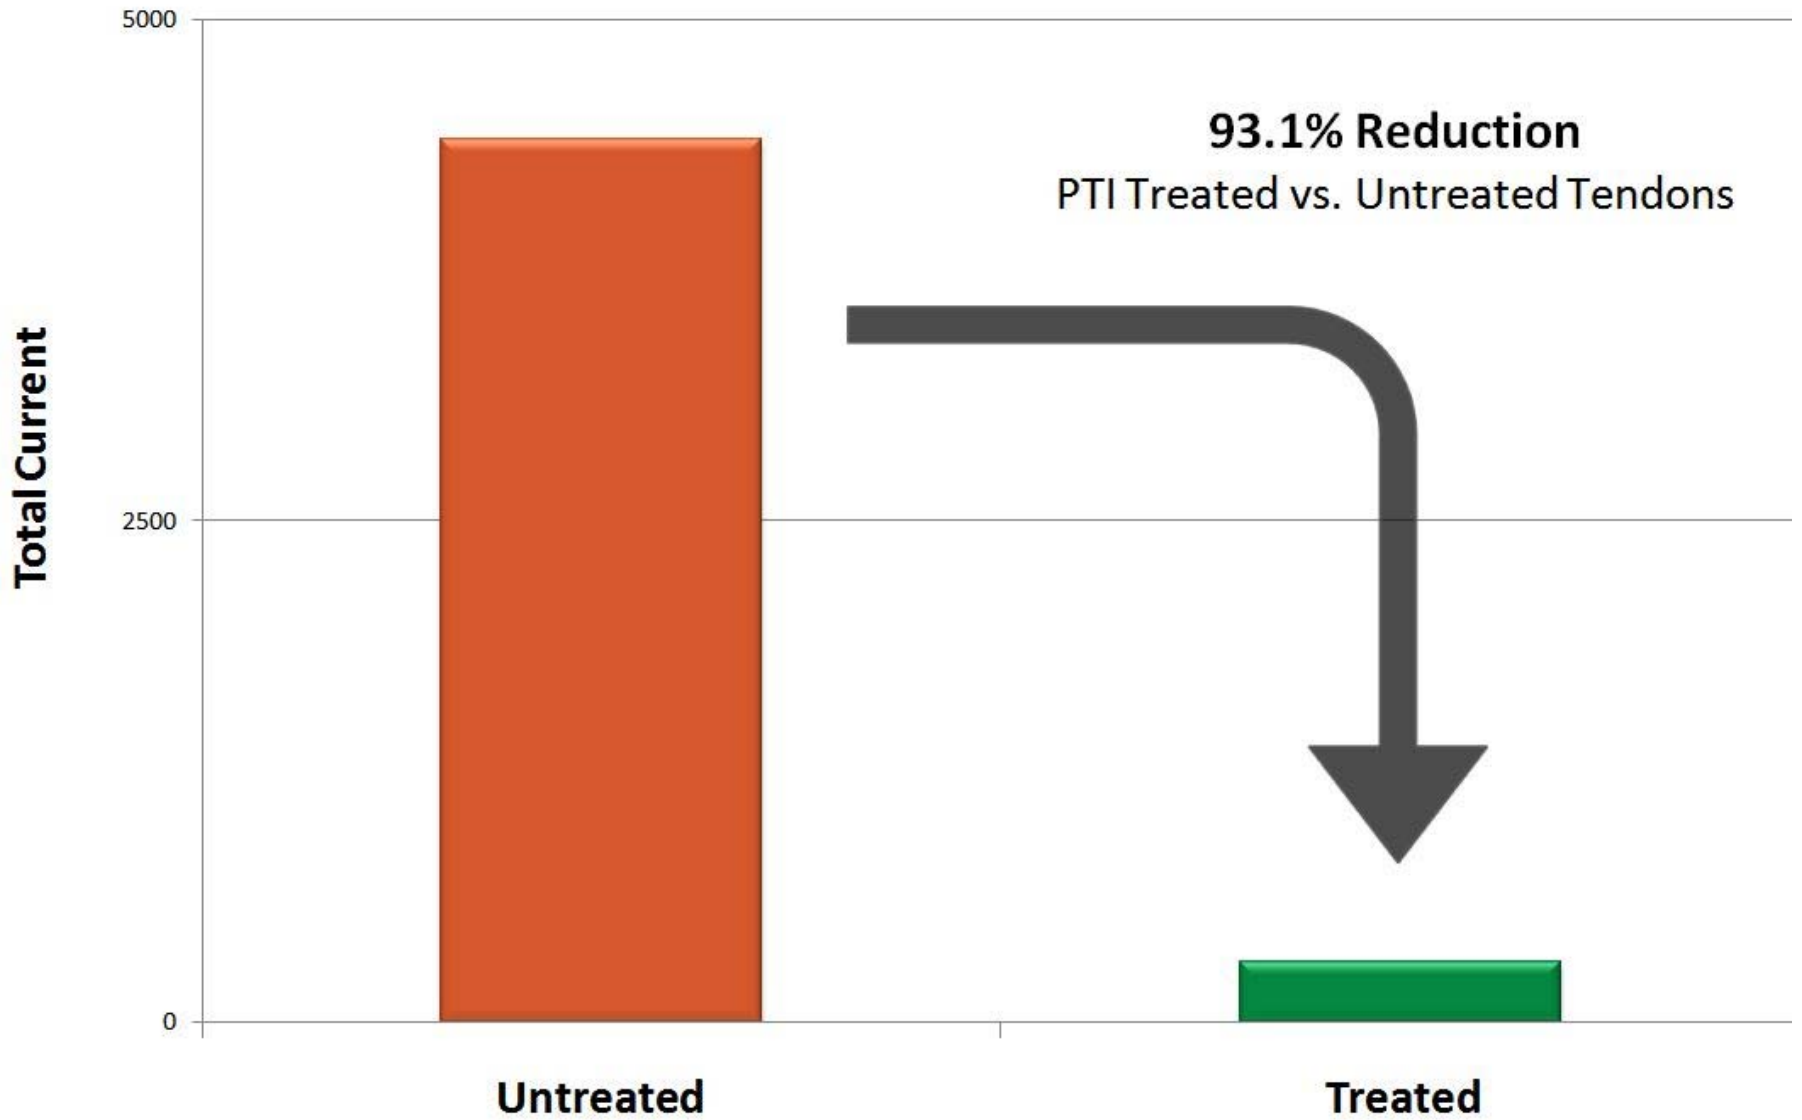
Potentiostatic Testing

Tendons in Chloride-Contaminated Grout (2% Cl⁻)

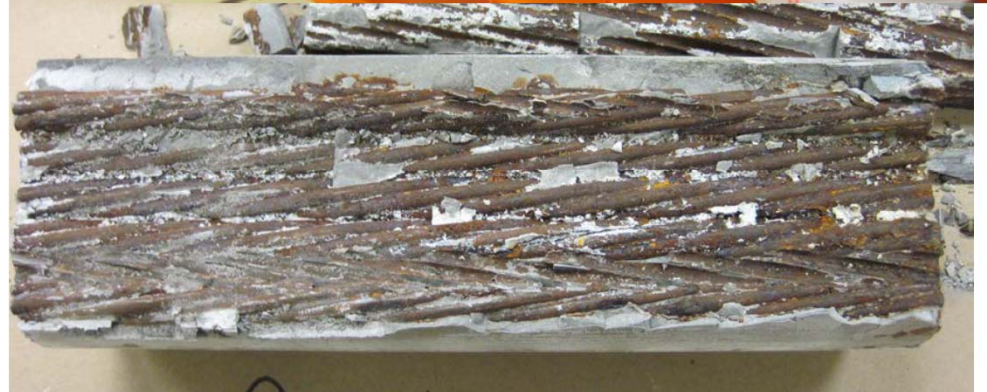
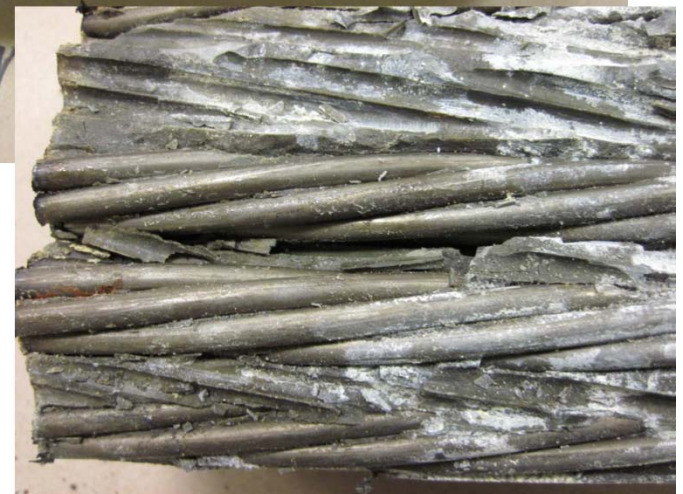
FDOT Testing

Interim Report:

Evaluation of a Silicon Based Polymer
Corrosion Inhibitor for Post-Tensioned
Tendons

K. Bergum
T. Risher
State Materials Office
Corrosion/Durability Laboratory
March 1, 2017

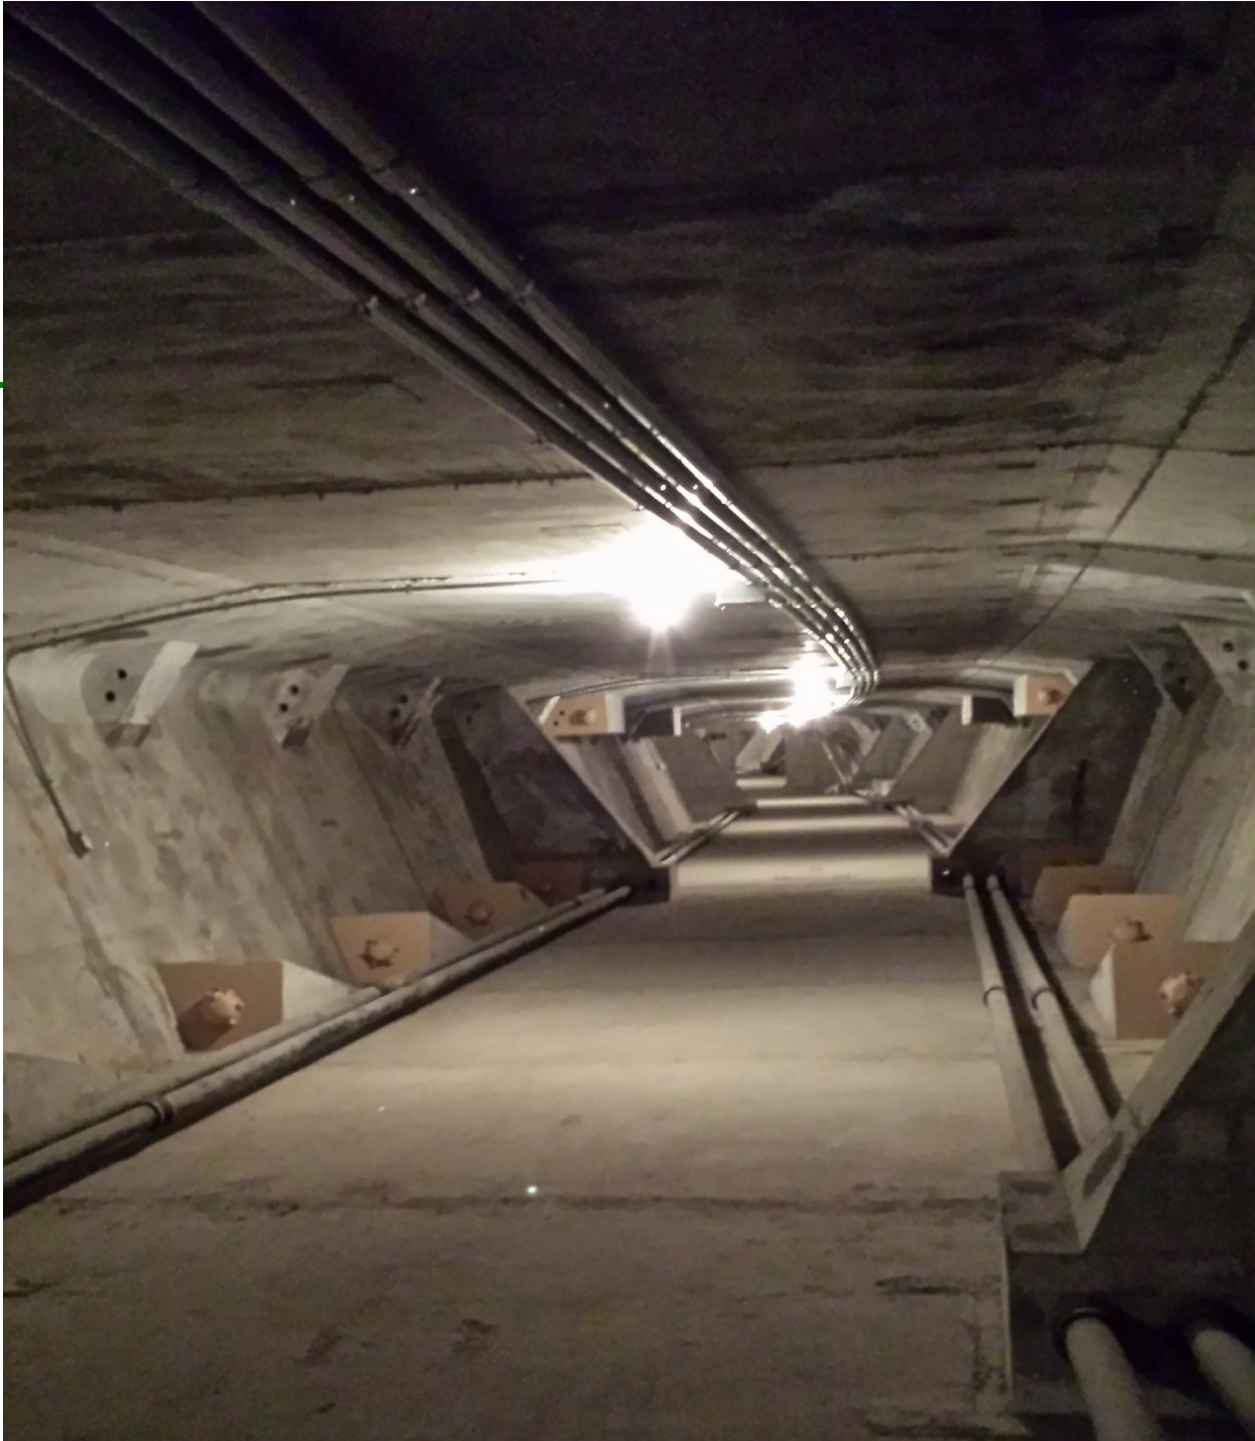
Removal of Anchorage Caps and Grout

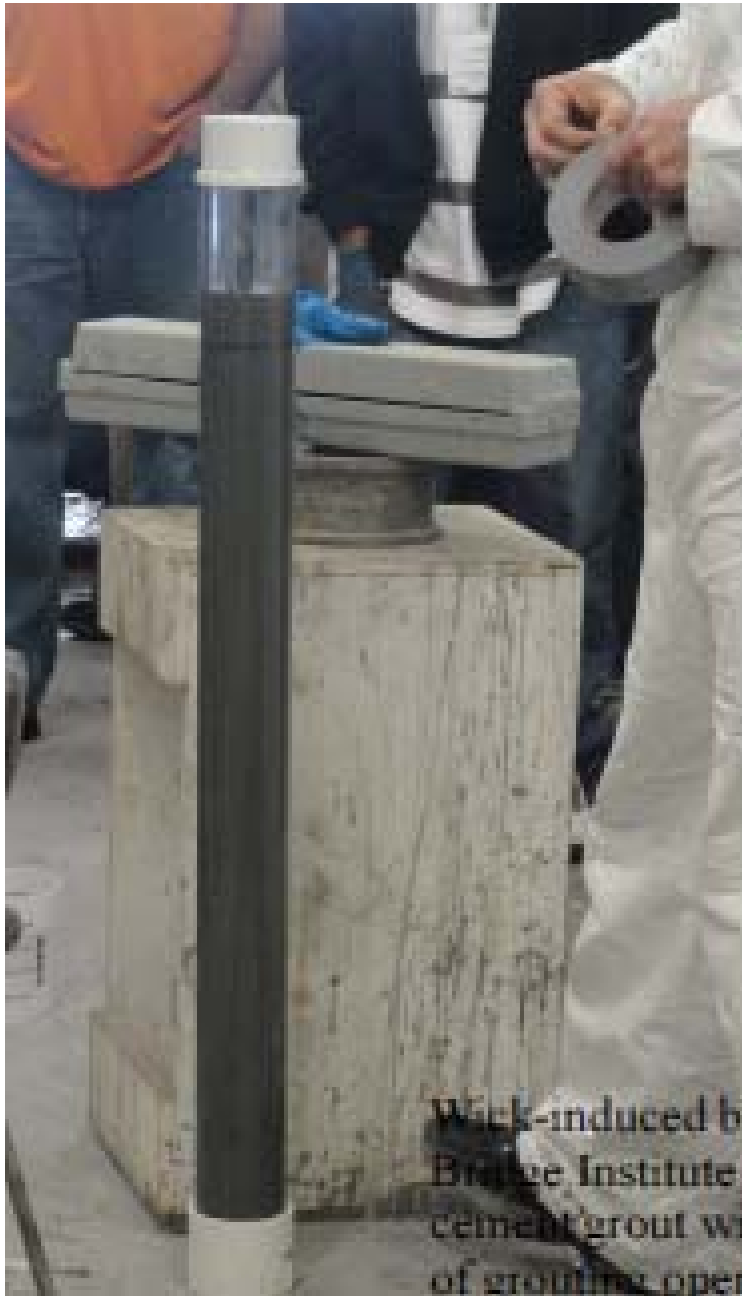
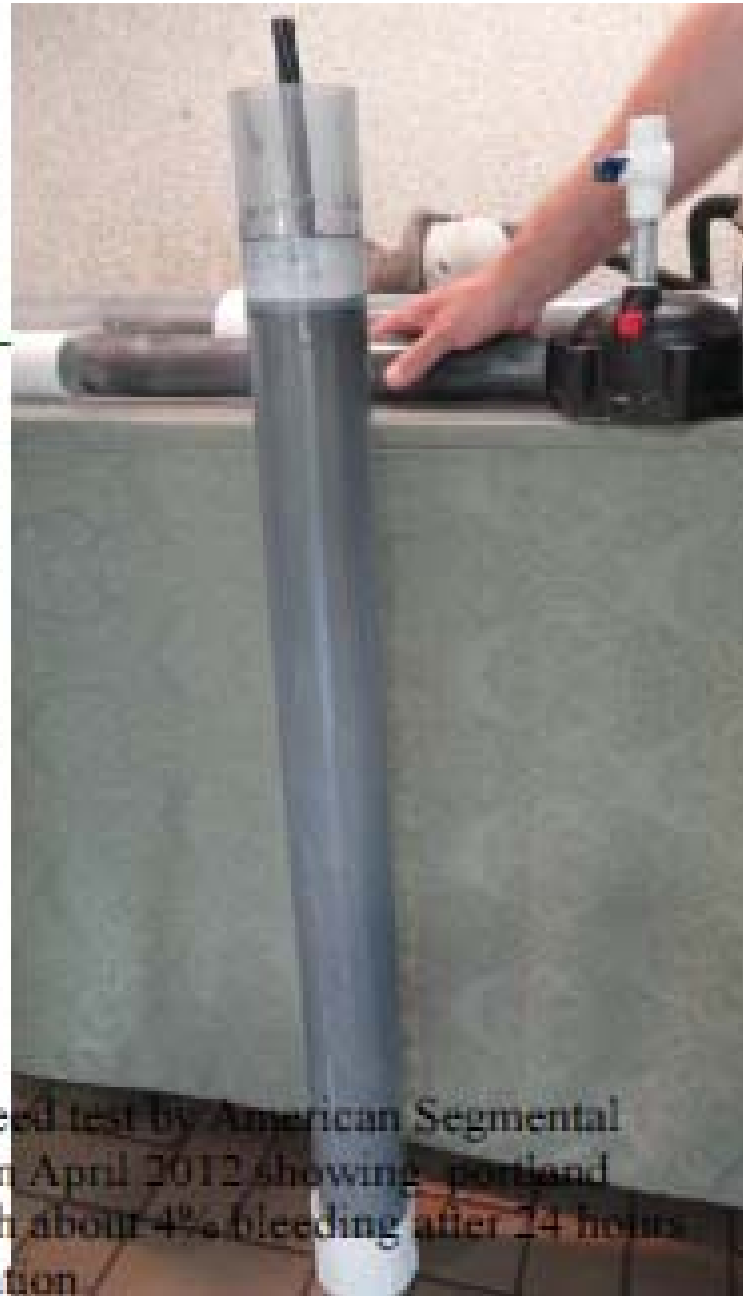
Wick-induced bleed test by American Segmental
Bridge Institute in April 2012 showing portland
cement grout with about 4% bleeding after 24 hours
of grouting operation

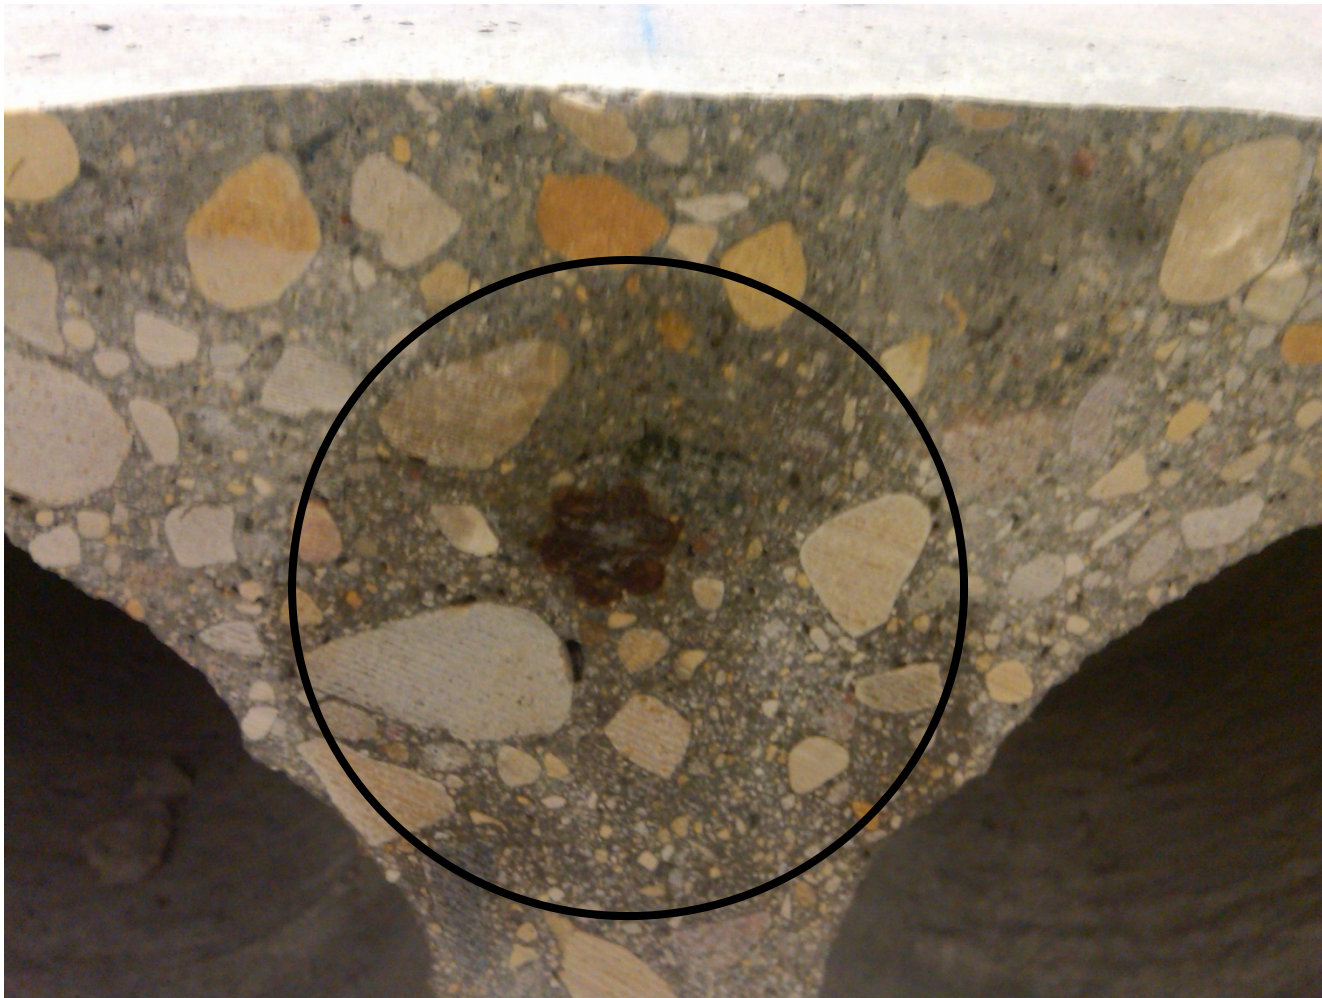
Impregnation of Strands in Prestressed Concrete

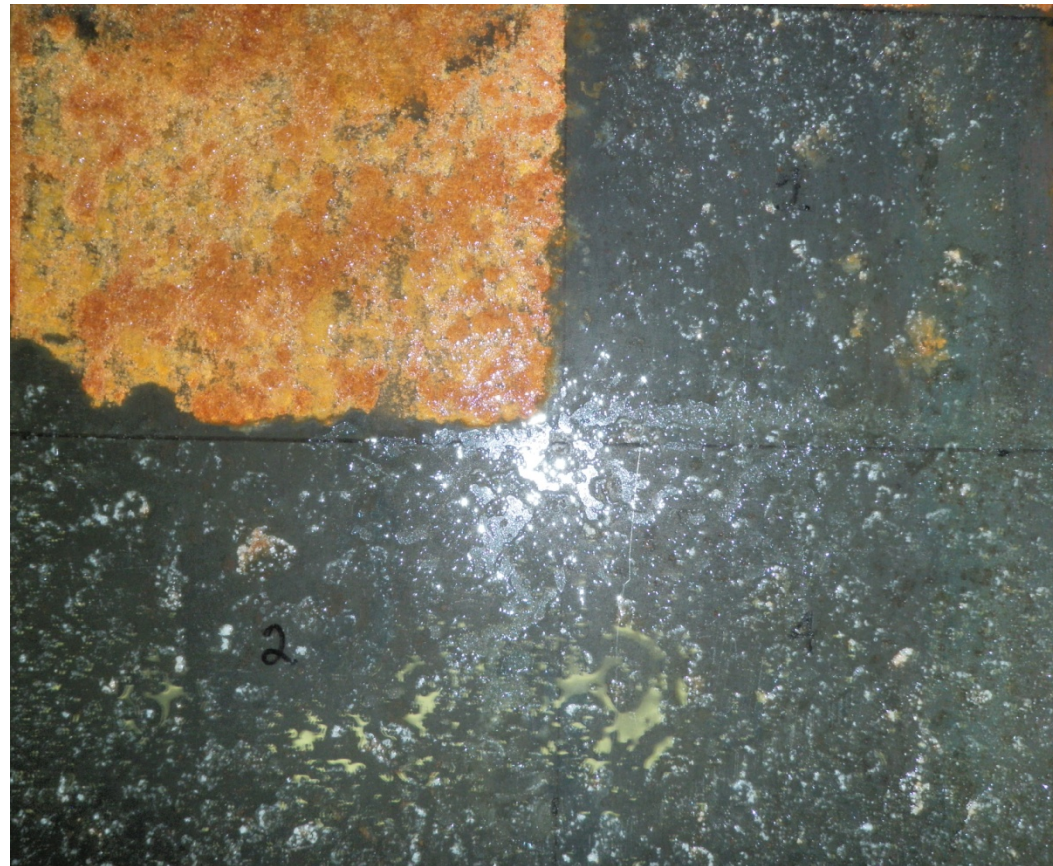
Corrosion Testing of Impregnation Material Applied to Unprepared Steel

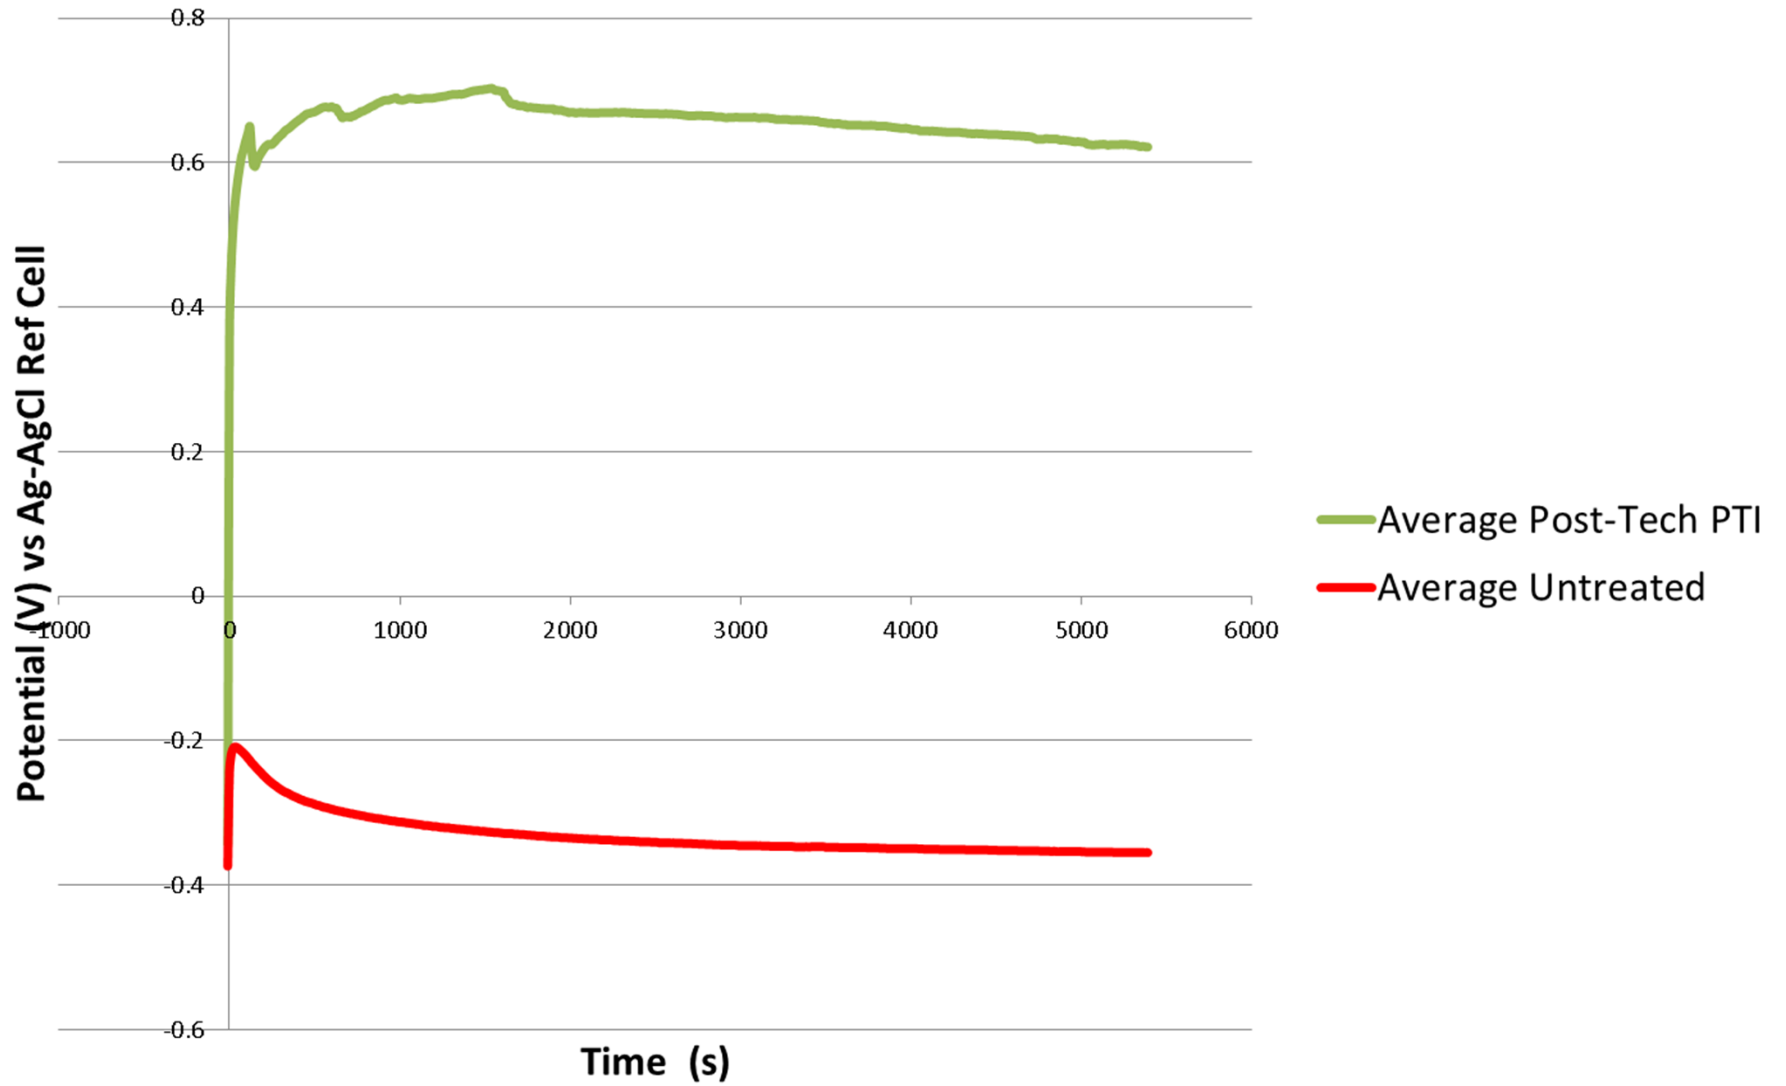
Verification of Corrosion Protection

PT Cable Samples Cast in Chloride Contaminated Grout

Galvanostatic Scans with Applied Current = 2.5 microA/cm²

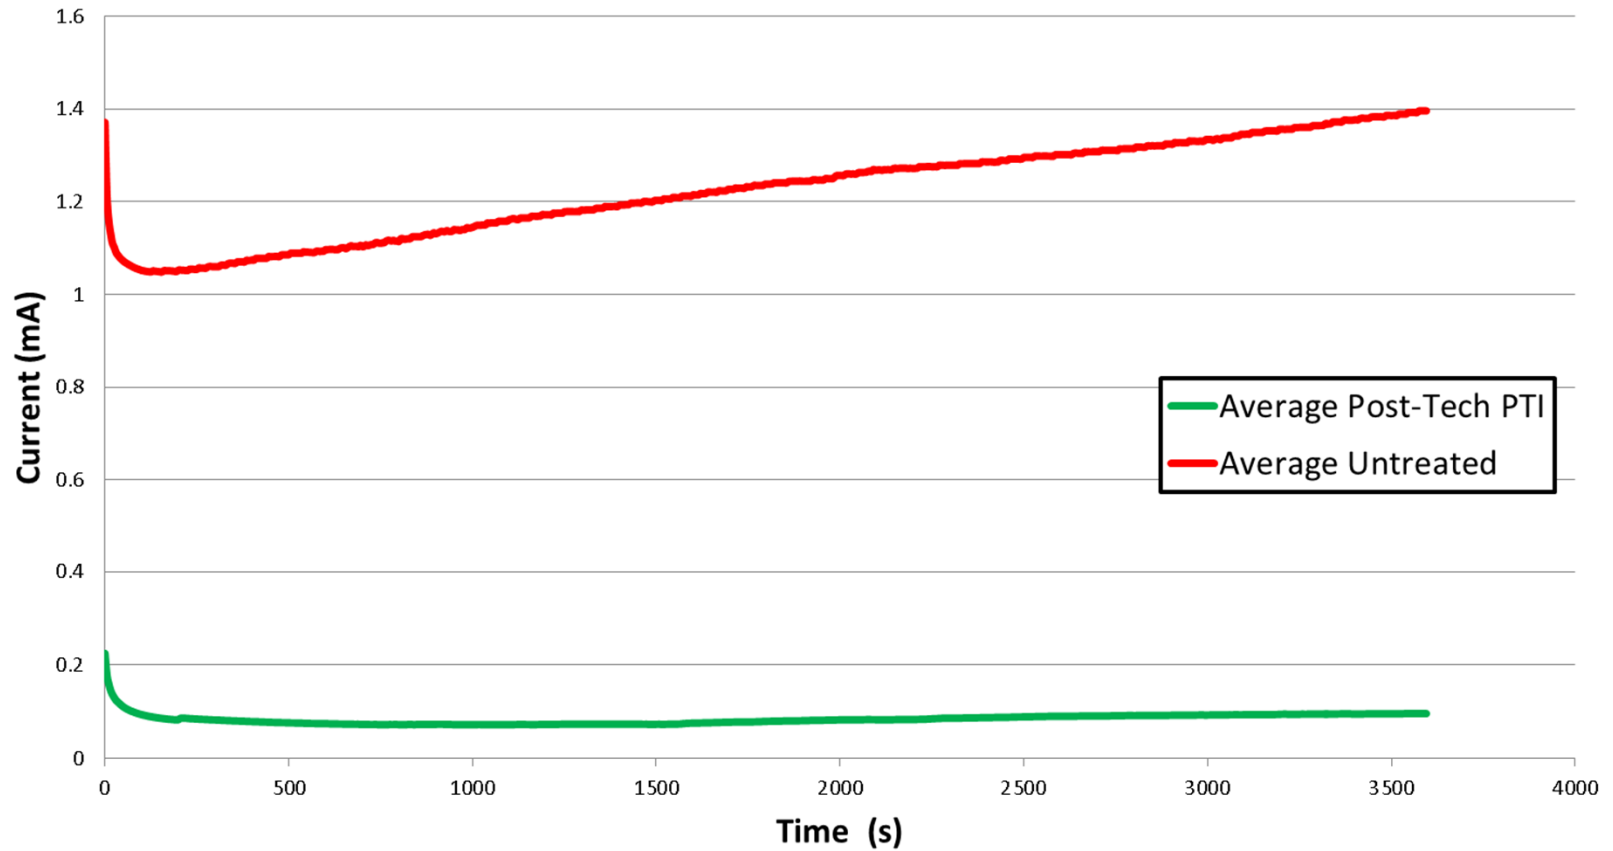
Verification of Corrosion Protection PT Cable Samples in Chloride Contaminated Grout (2% Cl⁻) Potentiostatic Scans with Potential Held at +200mV vs Ag-AgCl Reference Cell
