1 **An Arizona Department of Transportation - United States Geological Survey Pilot Project**
2 **Blending Science and Engineering - Laguna Creek Bridge Bank Protection**

2 Laguna Creek Bridge Scour Remediation, State Project Number H8913 01C,
3 Federal Aid No. 160-B(205)T, is a scour remediation project on the existing Laguna Creek
4 Bridge located in Arizona Department of Transportation's (ADOT) Northeast District. Laguna
5 Creek Bridge is located on United States (US) Route 160, Tuba City-Four Corner Monument
6 Highway, MP 420.1, over Laguna Creek in Apache County, Arizona. The bridge is within the
7 boundaries of the Navajo Nation Reservation. This site is approximately twenty-five (25) miles
8 east of the Town of Kayenta, Arizona. This project was administered by ADOT, who maintains
9 the facility. The project scope consisted of installation of riprap gabion spur-dikes upstream and
10 downstream of the existing structure and along the bridge abutments, in an effort to mitigate
11 scour, provide bank protection, and reduce channel meandering at the bridge.

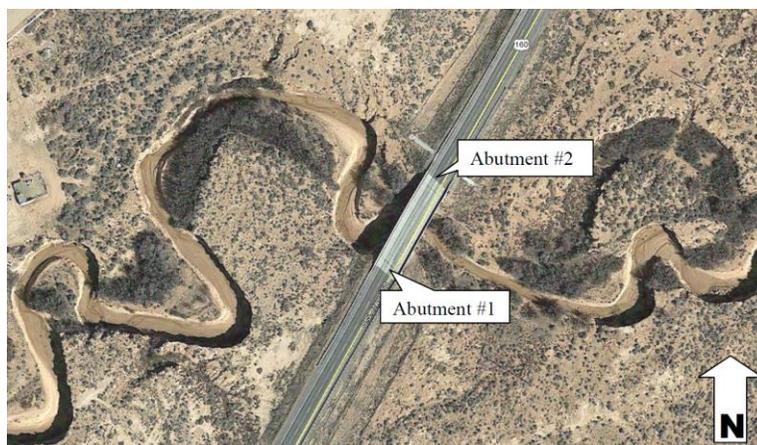
Figure 2. Aerial SR 160 Laguna Creek Bridge

18 Laguna Creek originates at Tsegi Canyon and flows northeast. Soil in the watershed
19 is fine grained and susceptible to sediment transport at relatively low velocities. The US160
20 crossing is characterized by a meandering vertical bank channel (unstable). Laguna Wash has the
21 potential to adversely impact the US 160 structure at the following three locations: 1) Abutment
22 #1, 2) Abutment #2, and 3) the approach roadway west of the structure. The following aerial
23 photograph shows the existing channel and the historic scarring due to previous migrations of the
24 wash (old oxbows).

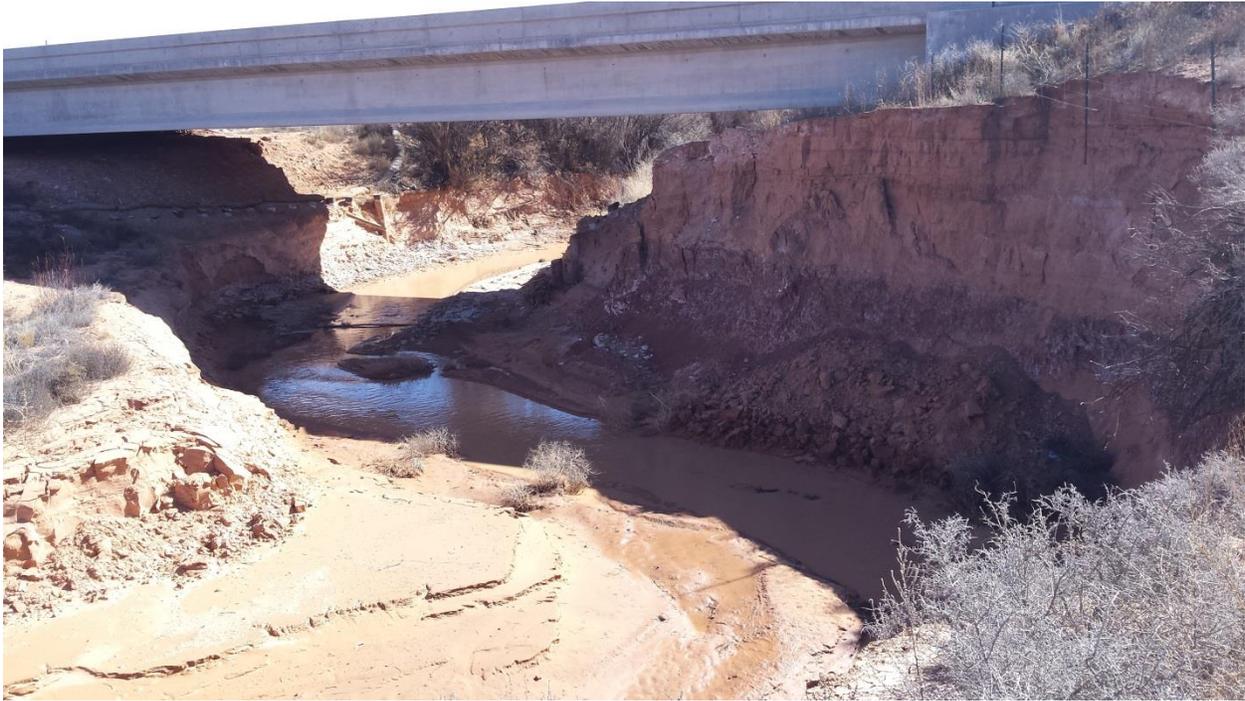
Figure 5. Looking downstream approaching the structure (notice the floating fence – upper right)

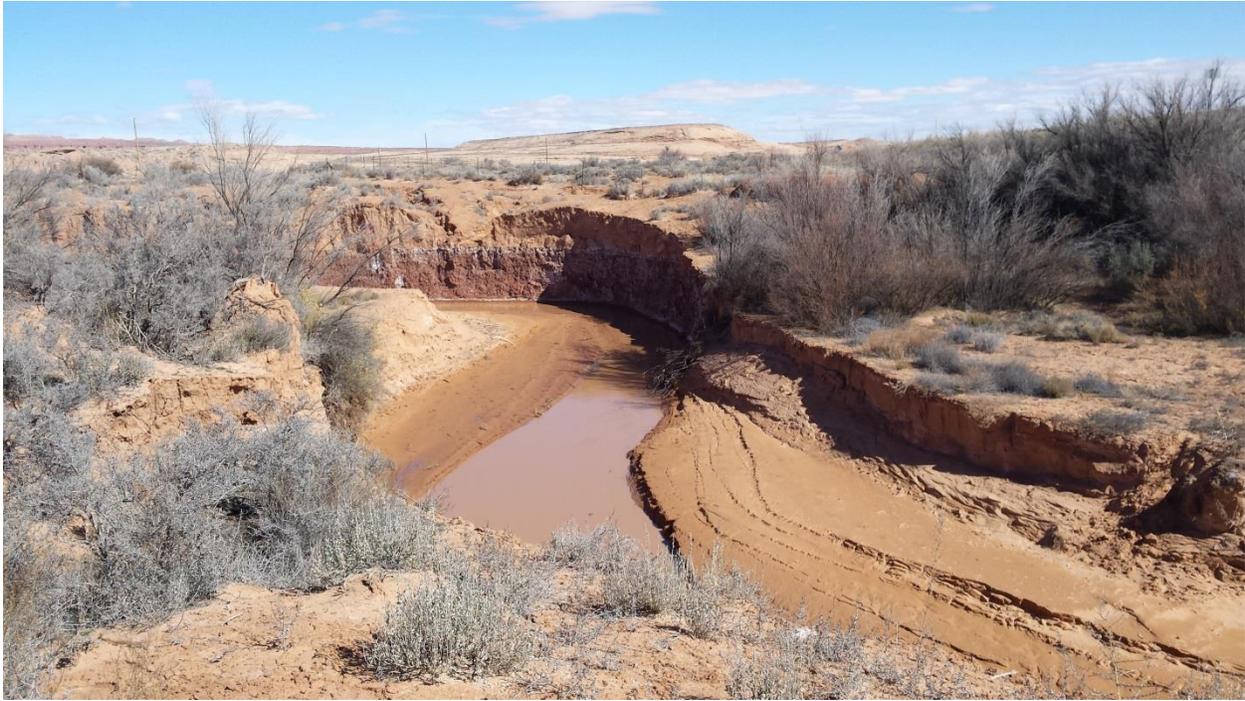
Figure 6. Looking downstream from the structure
