Key Issues and Budget Constraints with Replacing Rural, Low Traffic Volume Bridges. Case Study: Steel I-Beam Bridge Replacements using Glued Laminated Timber

Patrick Bigg, General Manager, Timber Restoration Systems

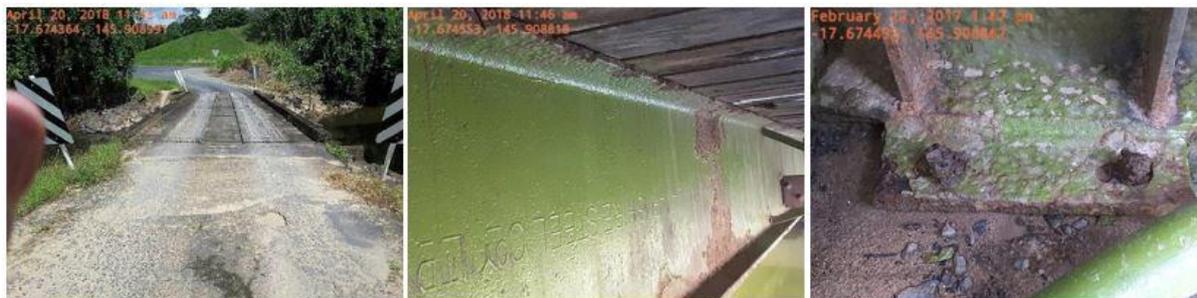
Figure 1 – Seres Road Bridge: The hold down fasteners have rusted away. The protective paint was beginning to flake away and rust had set in eating away at the connection plate.

- 14.3m Single Span
- 4.3m wide hardwood timber deck with timber running planks
- Four 610UB Steel I-Beams

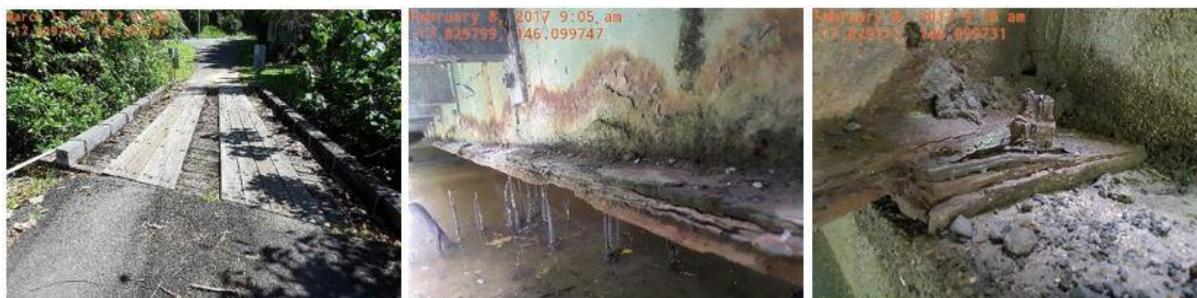
Figure 2 – Koombooloo Creek Bridge: The hold down connection plates and fasteners have rusted away. The bottom flange of these steel I-Beams had delaminated and peel away at the touch.

Koombooloo Creek Bridge had the worst affected set of I-Beams since it is located only metres away from the Pacific Ocean coast line. It was recommended that stainless steel 316 fasteners and brackets be adopted for the Koombooloo Creek Bridge given its location; a worthwhile investment to reduce maintenance and replacement costs later in the asset's life.

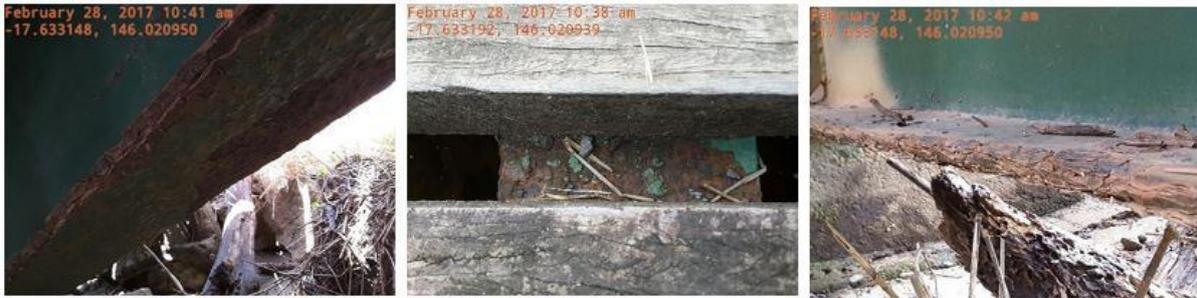
Figure 3 – South Ramleh Road Bridge: The top flange had begun to rust away where the paint had flaked and left the raw steel exposed. The bottom flange, near stagnant water all year round, was in poor condition and beginning to delaminate.

- 12m Single Span
- 4.0m wide hardwood timber deck with timber running planks
- 3 Steel I-Beams

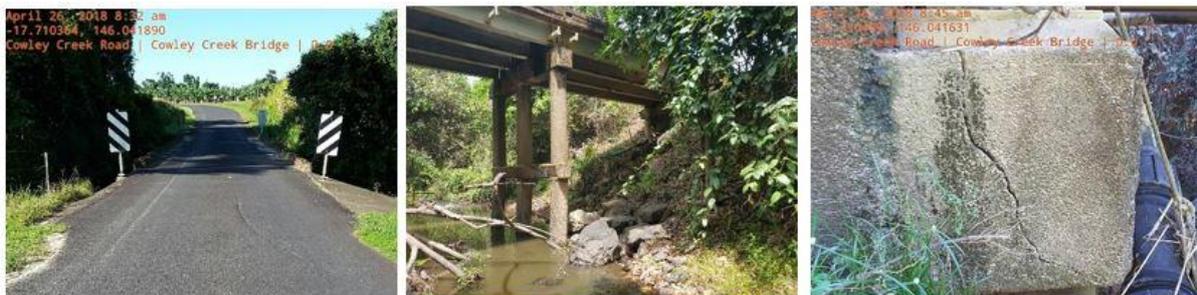
Figure 4 – Cowley Creek Road Bridge: Notice the crack in the existing concrete headstock. This is partially due to significant undermining under the wingwall attached to the headstock.

The Cowley Creek Road Bridge is currently a two-span single lane bridge with a concrete substructure, built back in the 1960's with four steel I-beams and a timber plywood deck and kerb system. CCRC wanted to change the bridge to a dual lane clear span structure. The replacement design utilised the existing abutments by extending them using screw piles for the foundation support. However, while prefabricating the glulam superstructure, deck and crashproof rail system, a dilapidation survey was completed on the substructure which, due to further concrete deterioration, condemned the existing substructure from supporting the new bridge. New abutments have been designed to replace the existing with works about to commence on site.

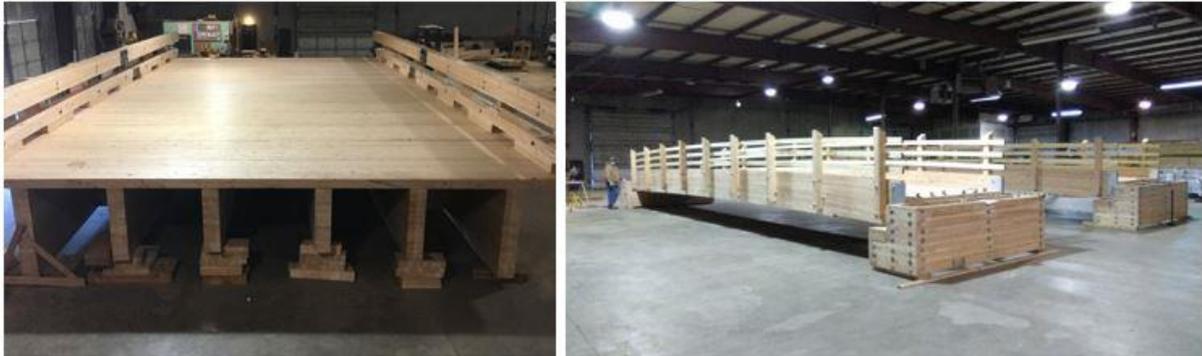
Figure 8 – Prefabrication of the bridges in Jefferson, Oregon.

Each glulam bridge is built from glulam billets that are procured by TRS' facility in Jefferson, Oregon. Shop drawings are supplied to the technicians who transfer all the relevant connection and design details onto the billets ready for fabrication. All these details are cut, drilled and test fitted prior to being sent to the treatment plants. By cutting and drilling prior to treatment, you guarantee the glulam elements will be thoroughly treated and brightwood will be unexposed.

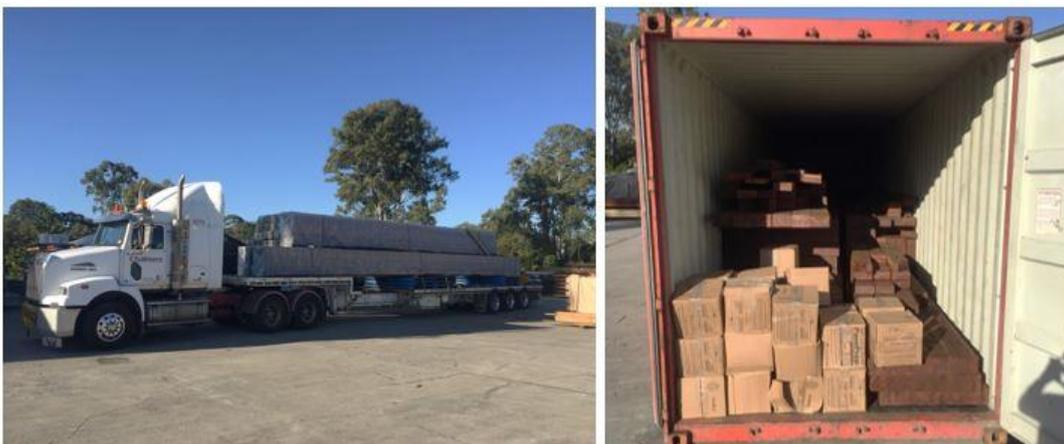
Figure 9 – Delivery of the glulam components to TRS' Caboolture office in Queensland.

Figure 9 shows both the delivery of the breakbulk glulam girder, bundled and wrapped, and a 40ft container ready to be unpacked and stacked.

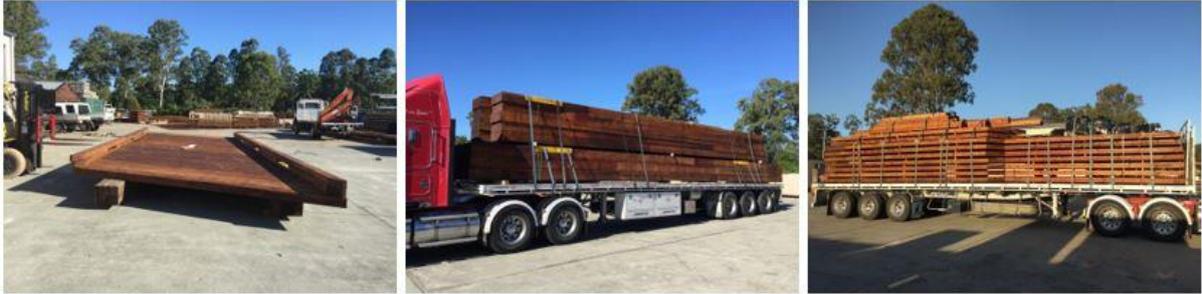
Figure 10 –Trail Layout of the Koombooloo Creek bridge and loading for transportation to site

Each bridge that leaves the Caboolture yard is test fitted and bundled ready for delivery to site. This ensures all components are in hand before mobilization commences. By checking and double-checking, this avoids shortages on site that prove costly, since some of the elements are specially fabricated.

Semi trailers and B-Doubles are commonly used to transport the bridges to site. Each timber component is stacked according to a trailer plan which is calculated to distribute the load evenly across the length of the trailer.

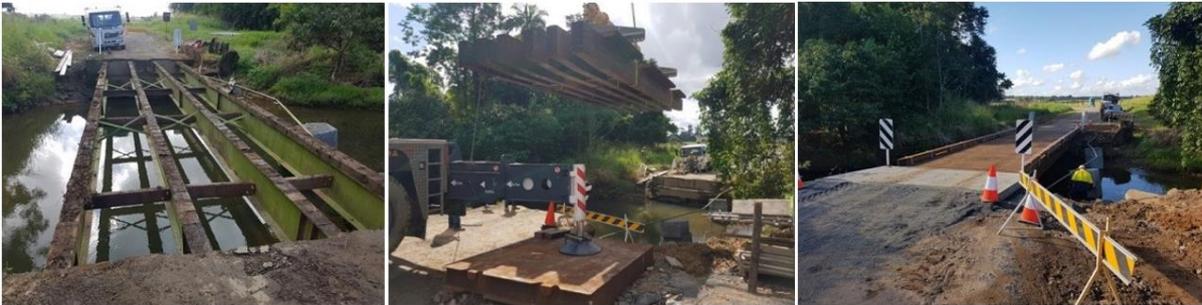
Figure 11 – Demolition and installation of the Seres Road Bridge in CCRC

A timber solution can be prefabricated on site whilst the existing structure is being demolished and be ready in certain cases for an afternoon lift and install. The Seres Road bridge was testimony to this. A 200T crane was on site the morning after the bridge was demolished, ready to lift the old I-beams out and the 14T glulam replacement bridge into position.

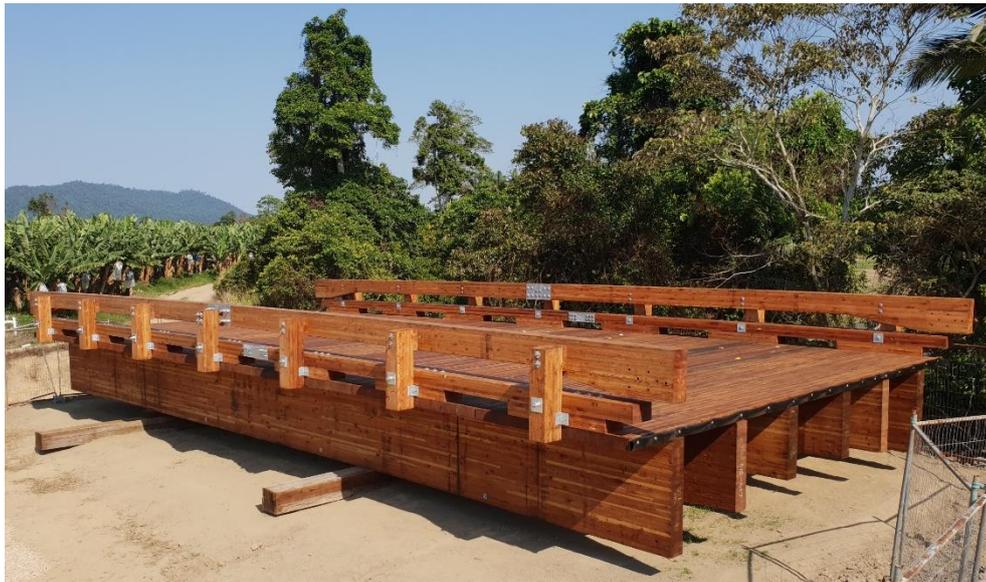
Figure 12 – Fabricated Cowley Creek Road Bridge on site awaiting installation.

Cowley Creek Road Bridge has been prefabricated on an adjacent property where it awaits to be lifted into place using a 250T All Terrain Crane in Far North Queensland. New concrete abutments, which will be formed and poured in-situ once the existing structure has been demolished, are in the design and planning stage at present and will be installed after the wet season.
