Condition assessment of corrugated steel underpasses including three-dimensional terrestrial laser scanning

Nathan Roberts, Associate, Aurecon

Alan Michie, Bridge Engineer, Aurecon

Lindsay Brown, Regional Bridge Engineer, Hunter Region, Roads and Maritime Services NSW

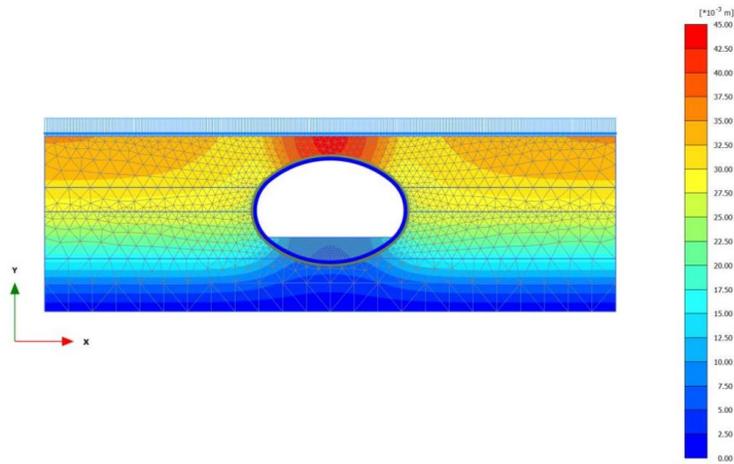
Figure 10 SLS deflection diagram from the PLAXIS model for ‘as new’ condition – Bushells Ridge

(SLS) axial and bending stresses were assessed for each structure and compared with the design capacity. Generally, for horizontal ellipse structures, the peak bending stresses occurred near the thrust beam location and the interface at the internal pavement level. Similarly, for the elliptical arches at Calga and Taree, the peak bending stresses occurred near the upper section of the arch (in similar locations to thrust beams). For the semicircular arch at Cameron Park, the peak bending stresses occurred near the footings. Plate capacities were assessed based on the thickness at the locations under consideration.

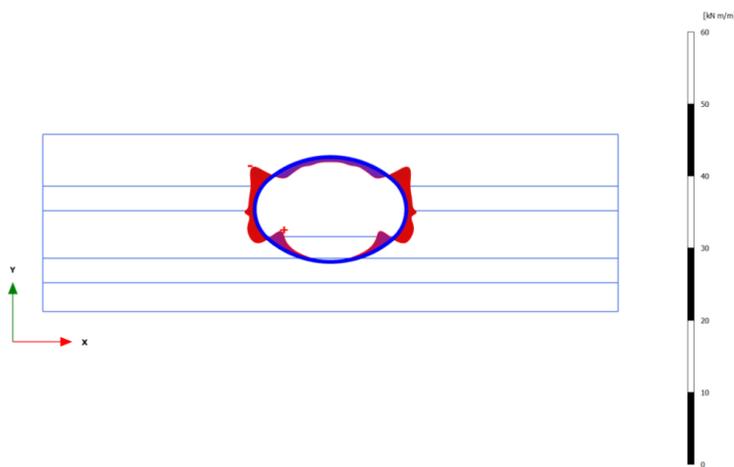
Figure 11 ULS bending diagram from the PLAXIS model for ‘as new’ condition – Bushells Ridge

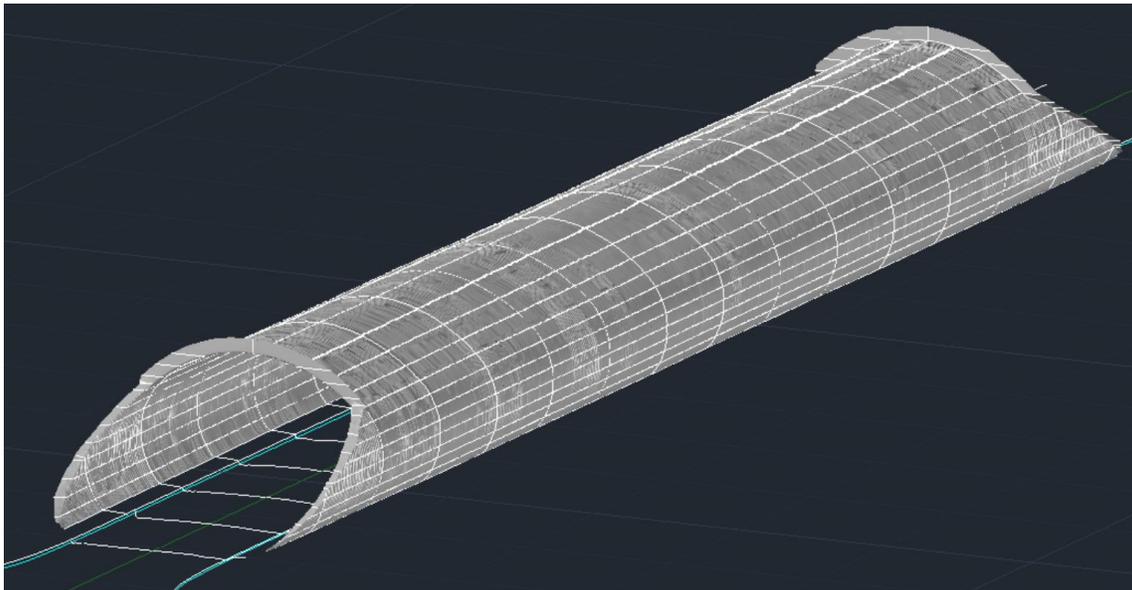
Figure 12 Rendered view with sections for BCMS at Bushells Ridge

Most structures exhibited a reduction in cross-section height from the height shown on the design drawings. However, the structures at Somersby and Calga had a greater height than the design geometry. This could be due to the pavement level being slightly higher (for Somersby), footings being located closer together than the design (for Calga) or variation in compaction during construction. Without further monitoring it is not possible to confirm if the observed deformations between the portals and most heavily loaded sections of the structures are due to structural deterioration or differences between the design and as-built geometry.
