## Demolition of the Angellala Creek Bridges

Shane Crawford, Principal Engineer, RoadTek, Department of Transport and Main Roads

On Friday 5 September 2014 a truck carrying ammonium nitrate rolled and exploded, destroying the road bridge carrying the Mitchell Highway over Angellala Creek, approximately 30 kilometres south of Charleville. The adjacent railway bridge also sustained significant damage in the blast.

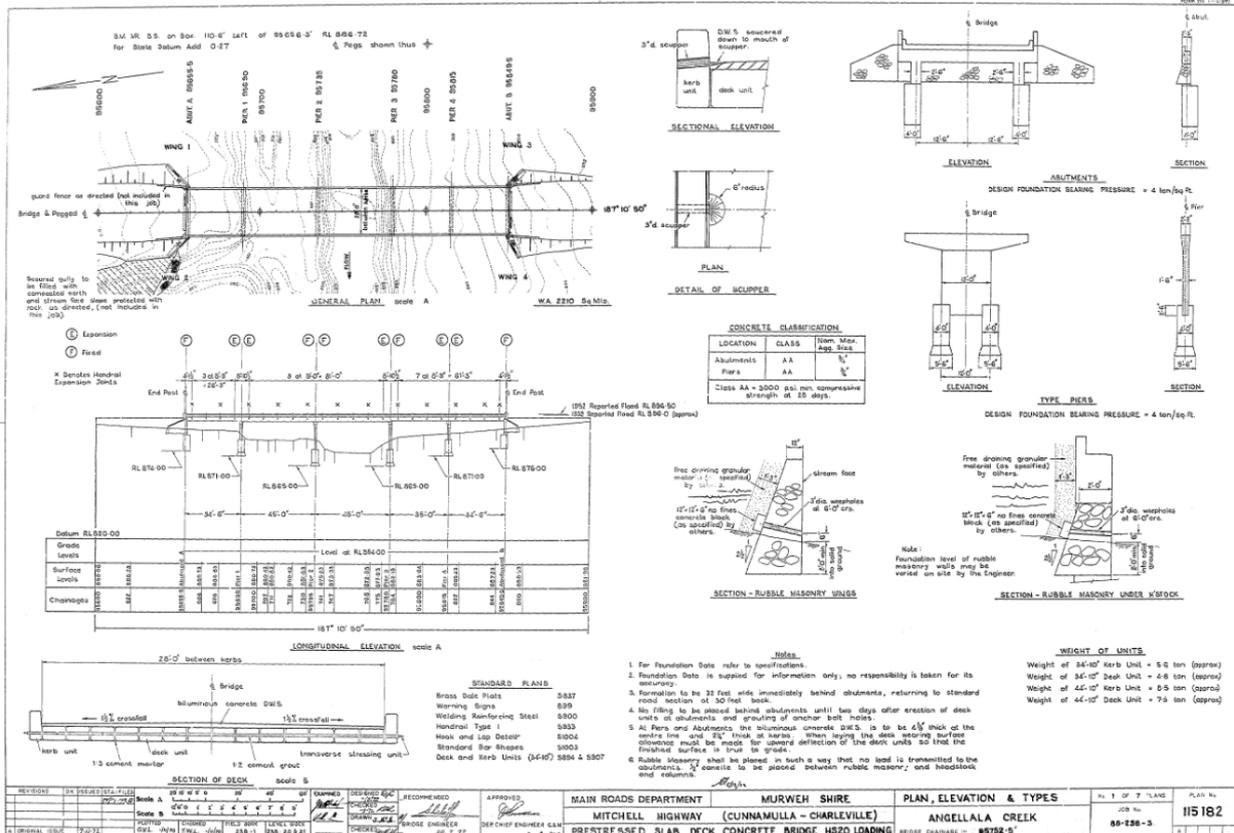
Figure 7 – Engineering drawing of the Angellala Creek Road Bridge

The original road structure had five spans, with the deck consisting of prestressed concrete deck (and kerb) units, transversely stressed and surfaced with a layer of asphalt. The deck was supported by four reinforced concrete piers which were comprised of a large hammerhead-style headstock seated on a blade column and two cast in situ bored piles, and two reinforced concrete abutments also seated on cast in situ piles (refer to Figure 7 for the general arrangement details of the structure).

accessible, an attempt would be made to release each nut with a breaker bar. If this proved unsuccessful, the outer kerb unit would be broken up by a 30 tonne excavator with a hammer attachment, working from one end of the unit to the other, gradually releasing the residual prestress in the tendons and simultaneously releasing the transverse stressing bars.

- The decks of spans 2 and 5 would be the first segments to be attended to. Once the transverse stress within these spans were released, the individual units would be separated as much as possible using an excavator, with discrete sections of the deck units broken up to enable observation of the ground beneath the units by the Explosives Inspectorate officers. The deck units would be broken up directly over the internal voids, to reduce the effort required. As the northern end of Span 5 was still suspended from the abutment, efforts were concentrated at the opposite end of the span.

- Once the site had been declared clear of residual ammonium nitrate, the exclusion zone would be relaxed and the remainder of the suspended concrete components would be brought to the ground in a similar fashion to the processes described above. The damaged pier supporting Span 1 had the headstock pulled over by two excavators (Figures 9 and 10), and the concrete blade column broken back with the excavator-mounted hammer until the northern end of Span 1 had been lowered to ground level.

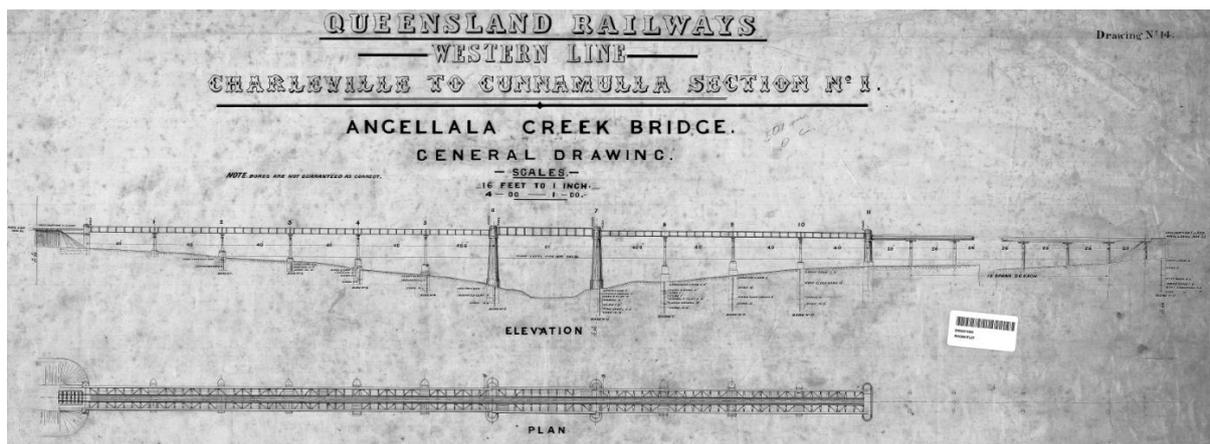
**Figure 11 – Engineering drawing of the Angellala Creek Rail Bridge**

- The southern portion of the bridge comprised of 12 timber girder spans, supported by timber piers and founded on timber sill logs on top of a concrete plinth. This portion of the structure was largely unaffected by the incident, and as such was not to be demolished.

- The northern portion of the bridge comprised of 11 steel ‘half-through’ girder spans, with the main span seated on large concrete pier walls. The remaining spans were supported by cast iron columns seated on concrete plinths. The main span of the bridge had been completely pushed off the concrete piers, and was hanging suspended from the western side of the bridge. The adjacent steel spans and cast iron columns either side of the main span had been pushed sideways to varying degrees based on their proximity to the main span. The spans immediately adjacent to the main span appeared to have moved sideways approximately 2-3 metres, while the spans most distant from the main span showed little or no signs of transverse movement (Figures 12 and 13). The deck spans and cast iron columns were to be brought down to ground level and relocated out of the waterway so as not to obstruct the flow of the creek.
