## SMALL BRIDGES CONFERENCE 2015

### TOPIC TITLE: Repair/Strengthening of a Six Span Timber Rail Bridge

Anstice, D.J., GHD, 145 Ann Street, Brisbane, QLD 4000, e: [daniel.anstice@ghd.com](mailto:daniel.anstice@ghd.com)

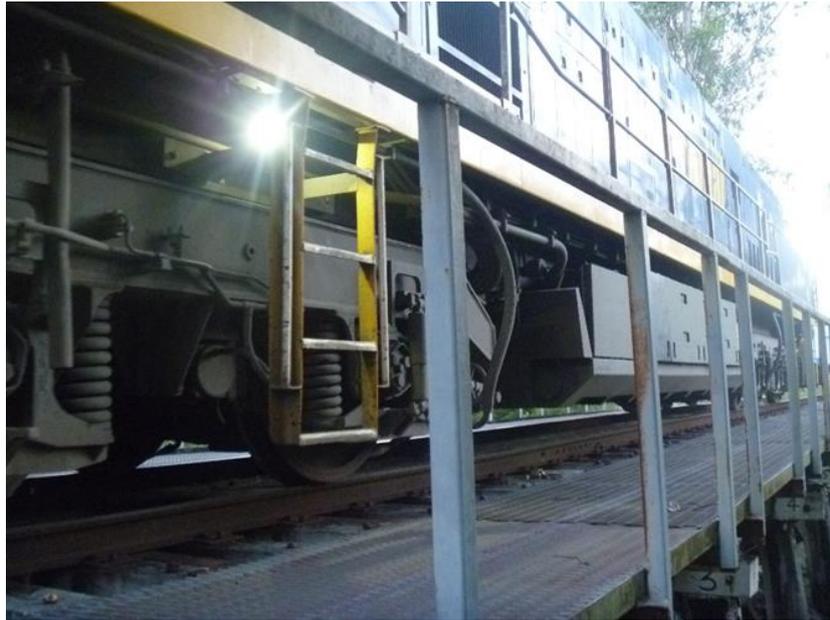
**Figure 9 – Train Passing Over Bridge**

In addition, the bridge was assessed visually and audibly for indications of distress (Figure 9) while loaded with a typical train delivering steel (multiple wagons plus one locomotive). No significant deflection or sounds of distress were observed.
