# Design, installation and management of remote pedestrian structures in Tasmania

Tim Chappell, Senior Engineer Tasmania Parks & Wildlife Service

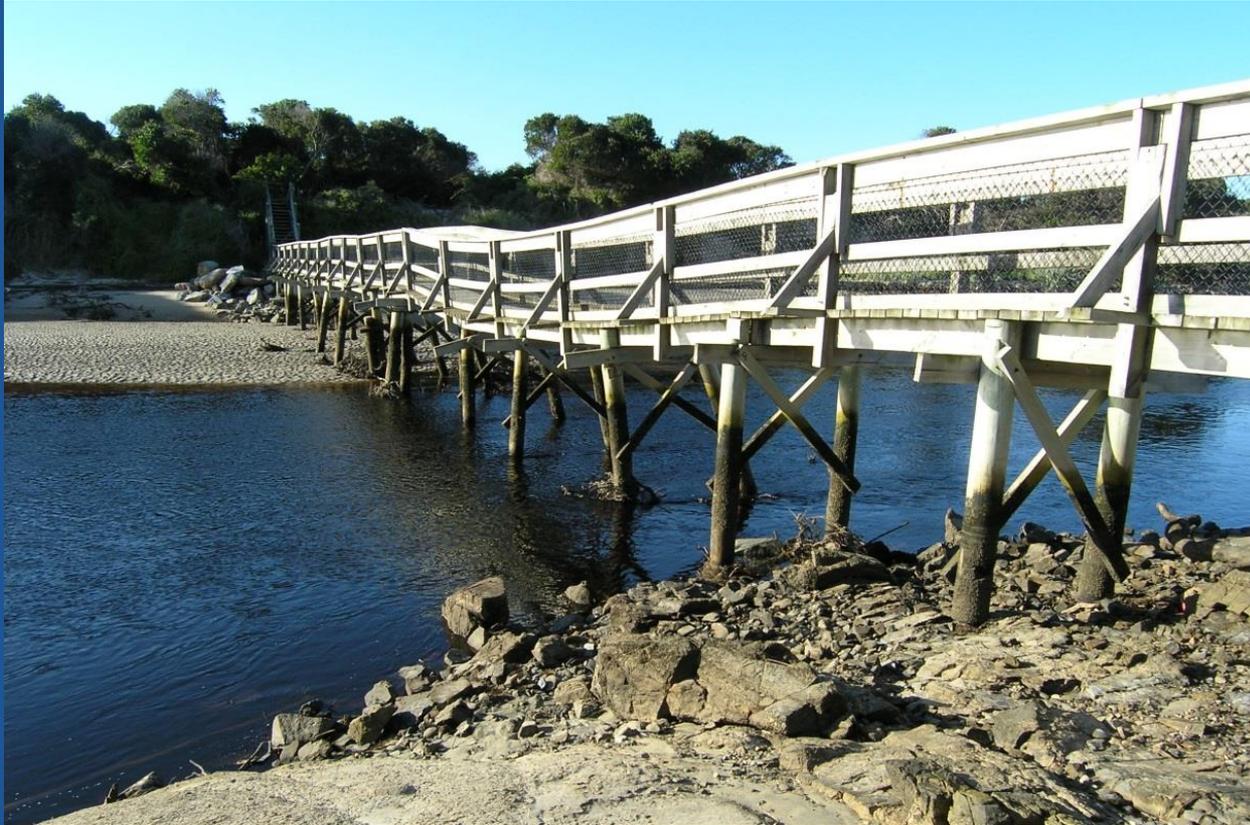
Typically low standard infrastructure dating from the 1980's,  
predominantly treated pine

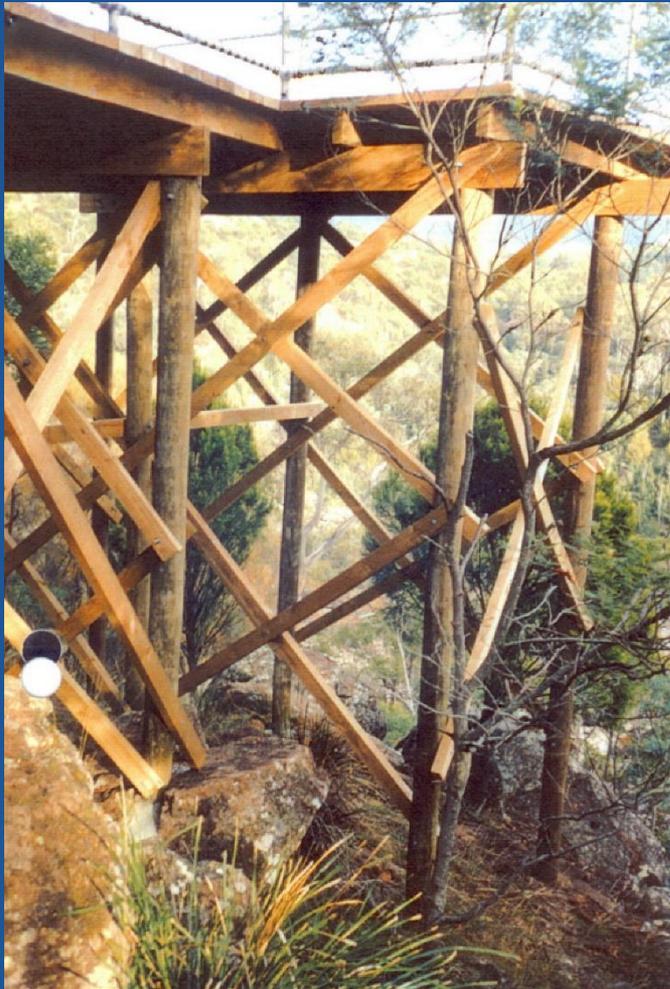
Example of a structure that was closed during the first round of engineer inspections, post 1995

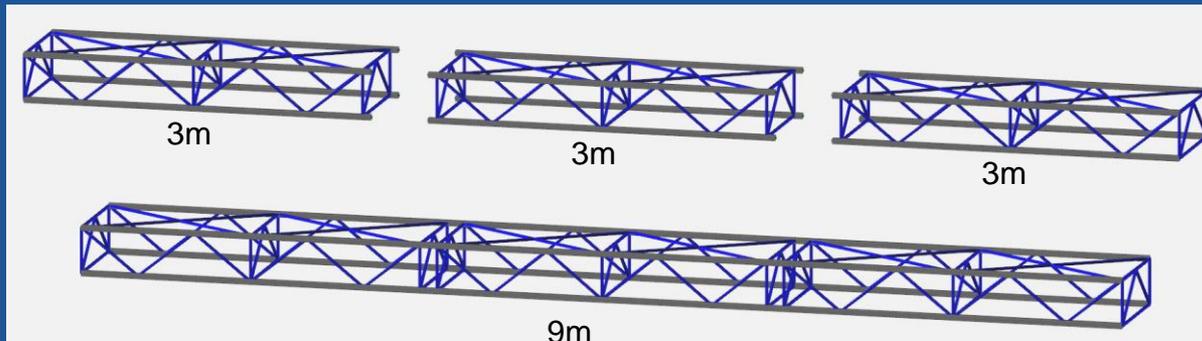
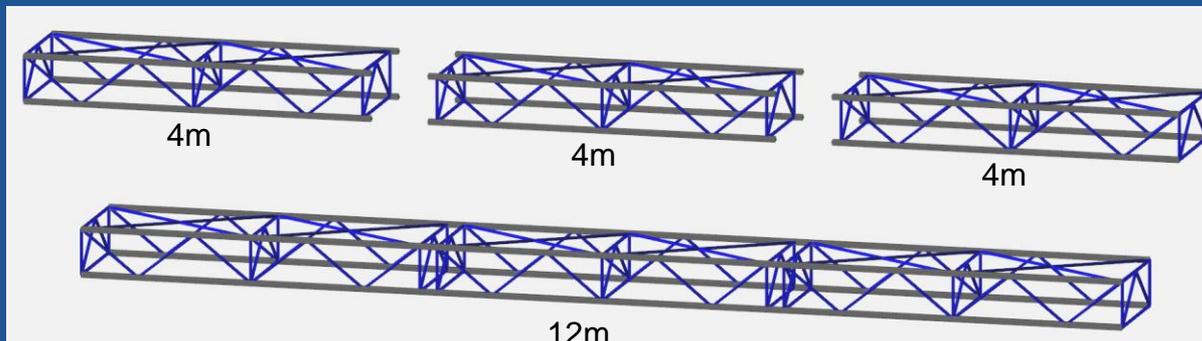
# Example: modular bridge (under-truss type)

- Fully vented SHS truss for safe hot-dip galvanizing
- Modules can be transported on a small truck/ute or even a power barrow and can be lifted manually
- Single module mass 100kg (9m) or 185kg (12m)
- Heli lift mass (truss with deck): 525kg (9m) or 850kg (12m), suitable for B2/B3 “Squirrel” helicopter
- Modules bolt together, either prior to heli lift, or on site
- Safety barriers (if required) are fitted after installation

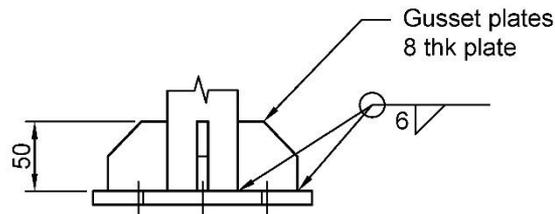
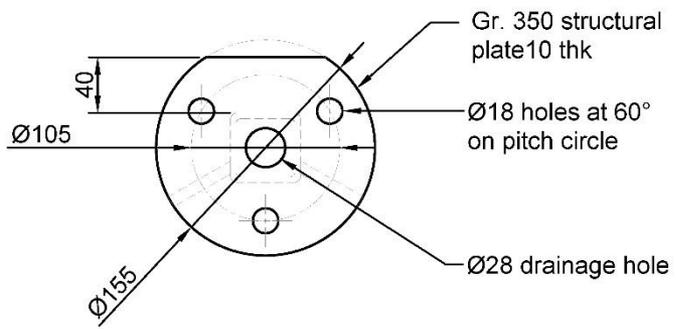
CONNECTION PLATE DETAIL

Material:  
 A..... 50x4 SHS Grade C350LO to AS 1163  
 B..... 35x3 SHS Grade C350LO to AS 1163  
 Bolts: M16-50 Grade 8.8/S galv. to AS/NZS 1252.  
 Total no. 24.

Finish:  
 Hot-dip galvanize to AS 4680, 390 g/sq.m

VENTING

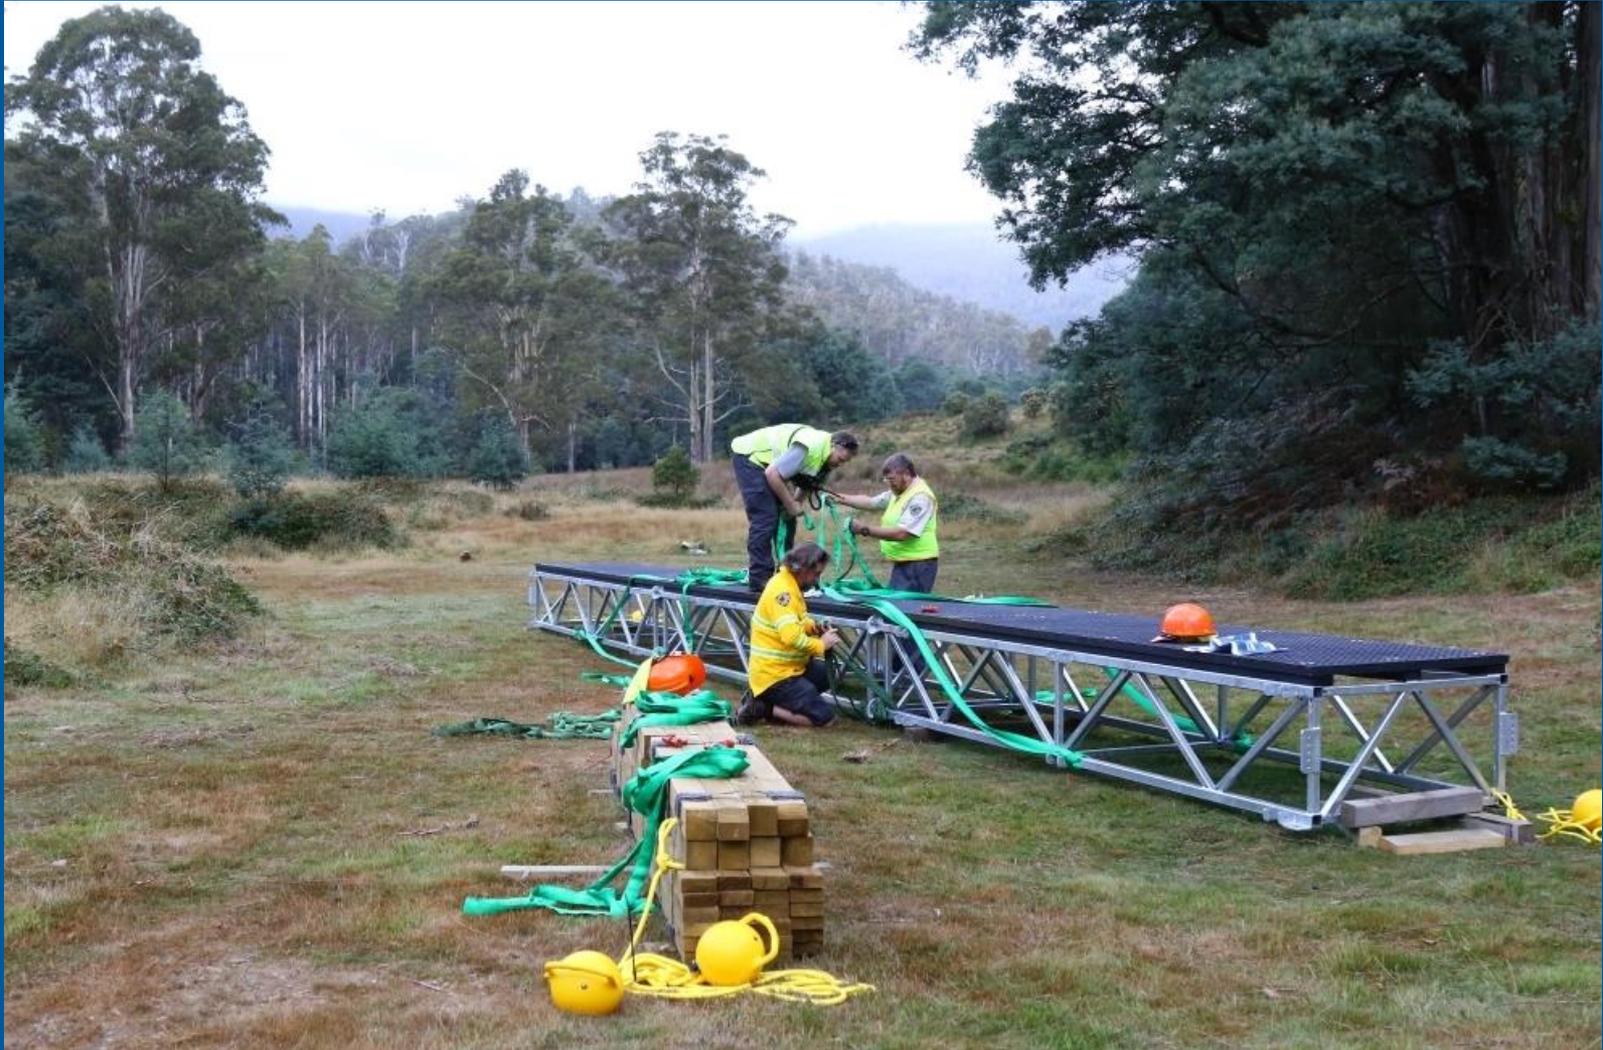
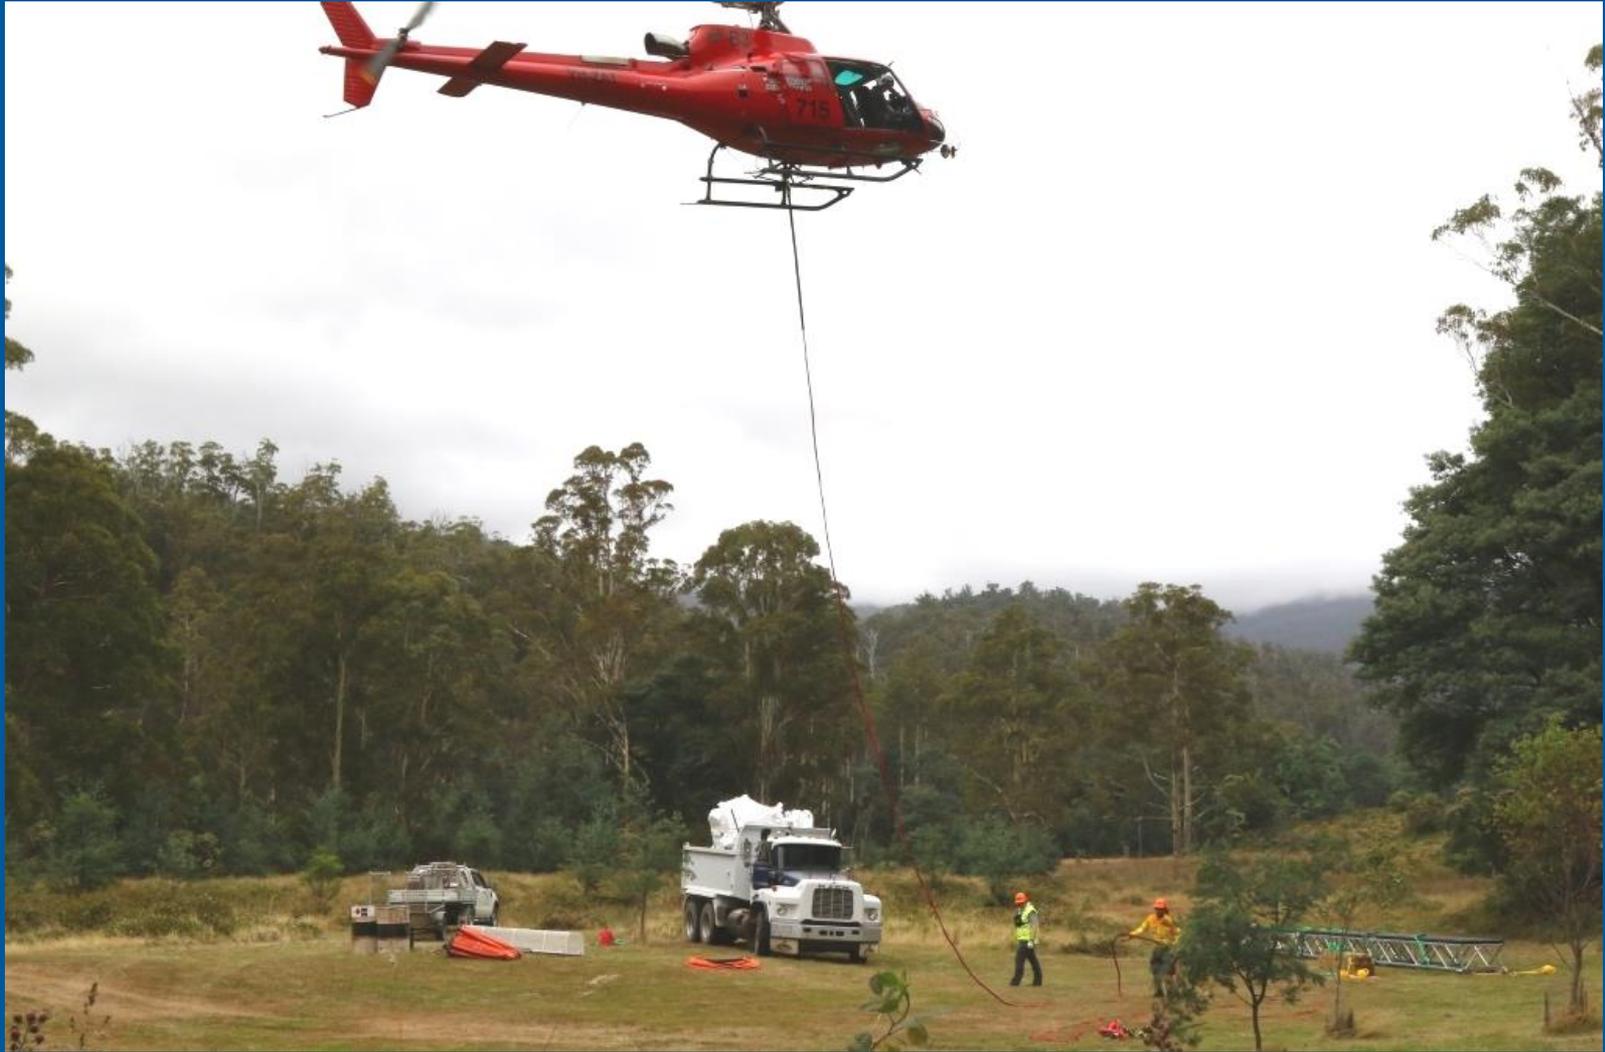
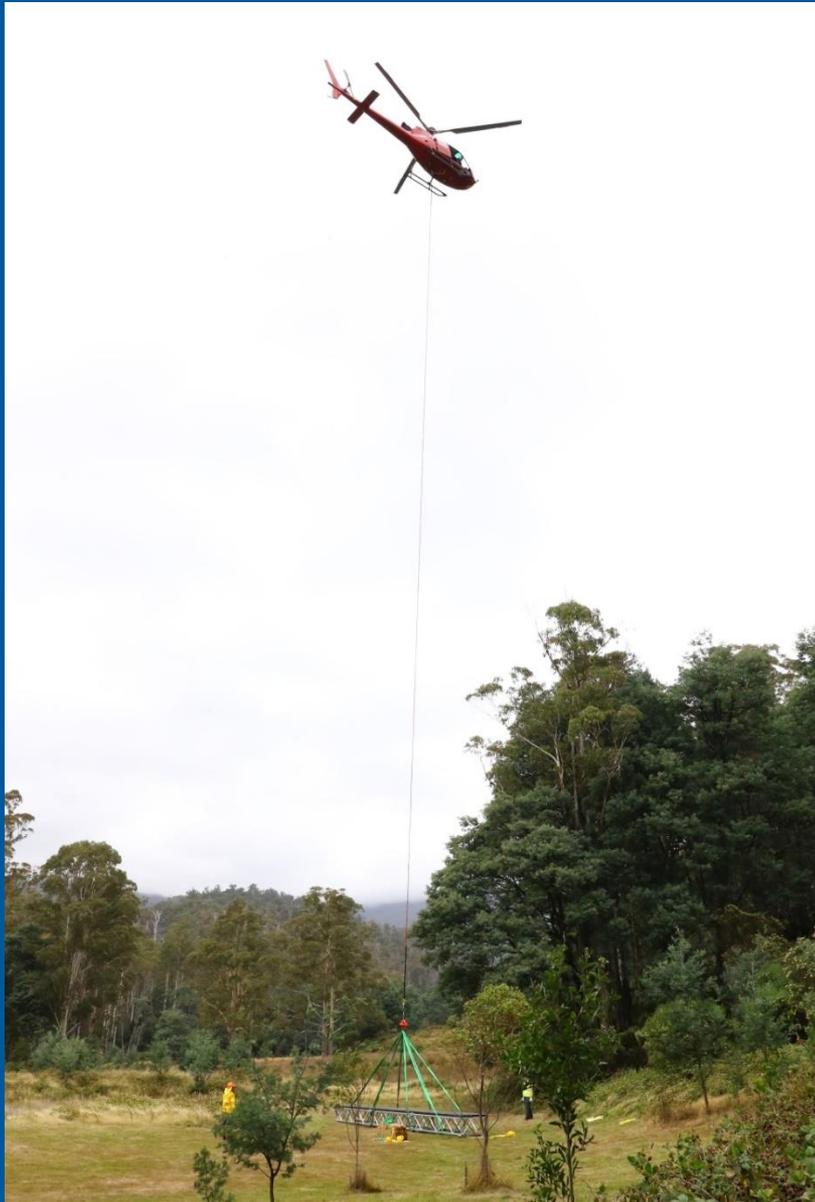
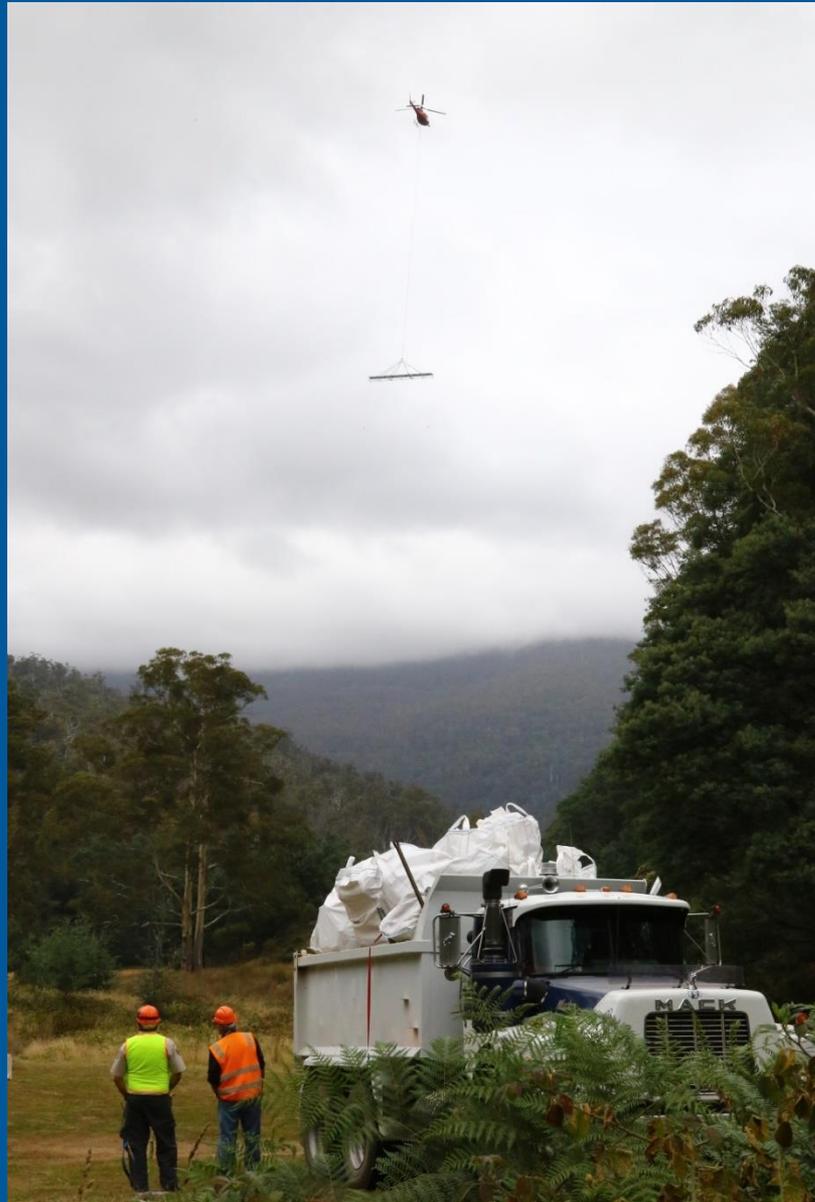
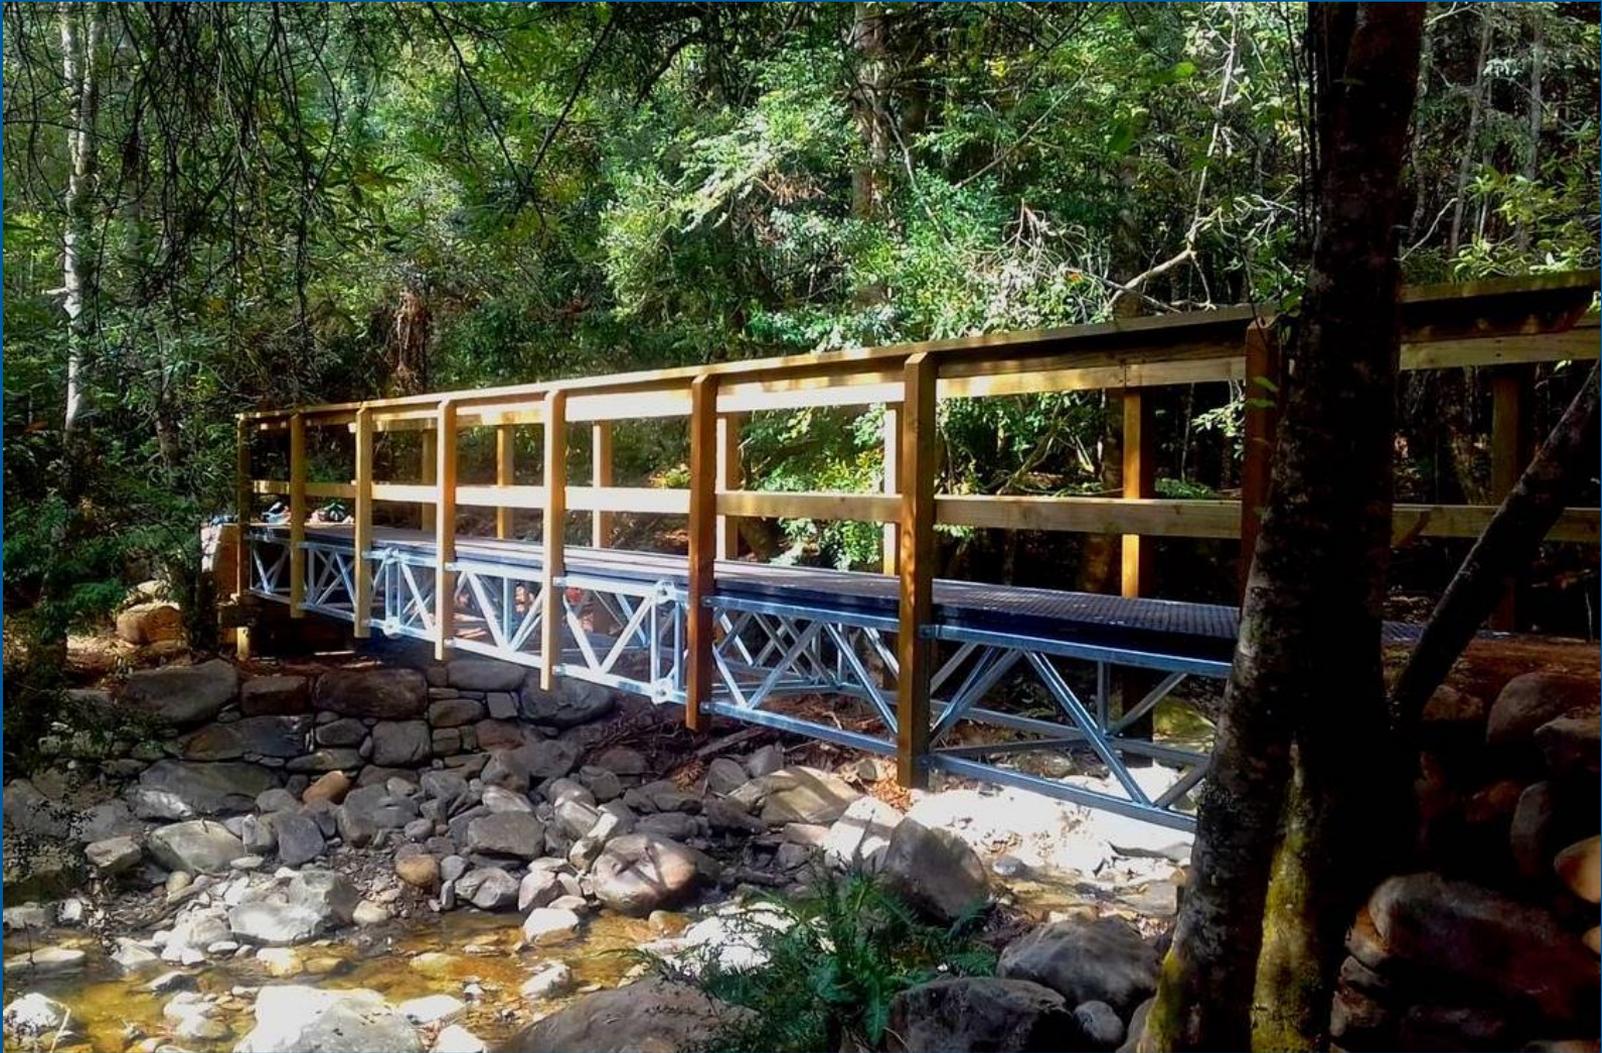
# Photographic record – Quinns Creek Bridge 12m modular truss

Quinns Creek Bridge: modular truss, span 12m.  
Total installation cost (including helicopter) approximately \$25,000.

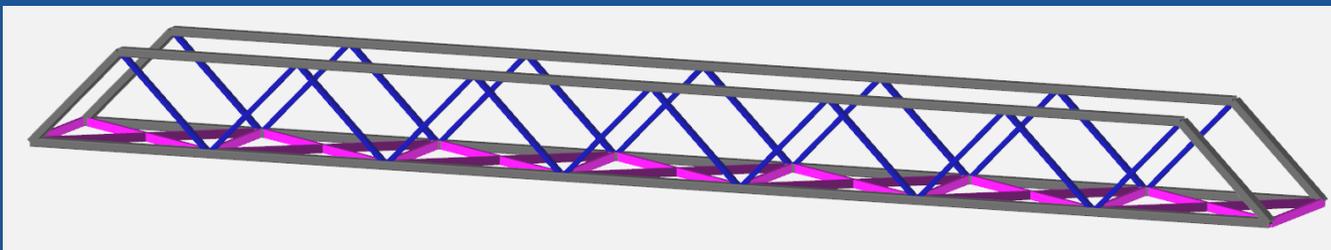
## Walk-through truss bridge

- Efficient for longer spans, up to 24m length practical.
- Truss depth 1.0 – 1.4m desirable so the truss becomes part of the safety barrier system (but does not obstruct views).
- Welded marine-grade aluminium (6061-T6, 6063-T6 etc.) is light weight and suited to coastal and remote locations. It also performs well at low temperatures.

- Design to AS 1664.1 (limit state), analysis with Space Gass
- The top chord buckling mode and FoS determined using S.G.
- Tension in lower chords, particularly at butt welds, checked using welded alloy properties – often critical
- The structures are relatively stiff (Span/600)
- Resonant frequencies checked using S.G.
- AS 5100.2-2017, frequencies >5 Hz do not need to be investigated further (was 3.5Hz in the 2004 code)
- Thermal expansion/contraction is significantly higher for aluminium compared to steel

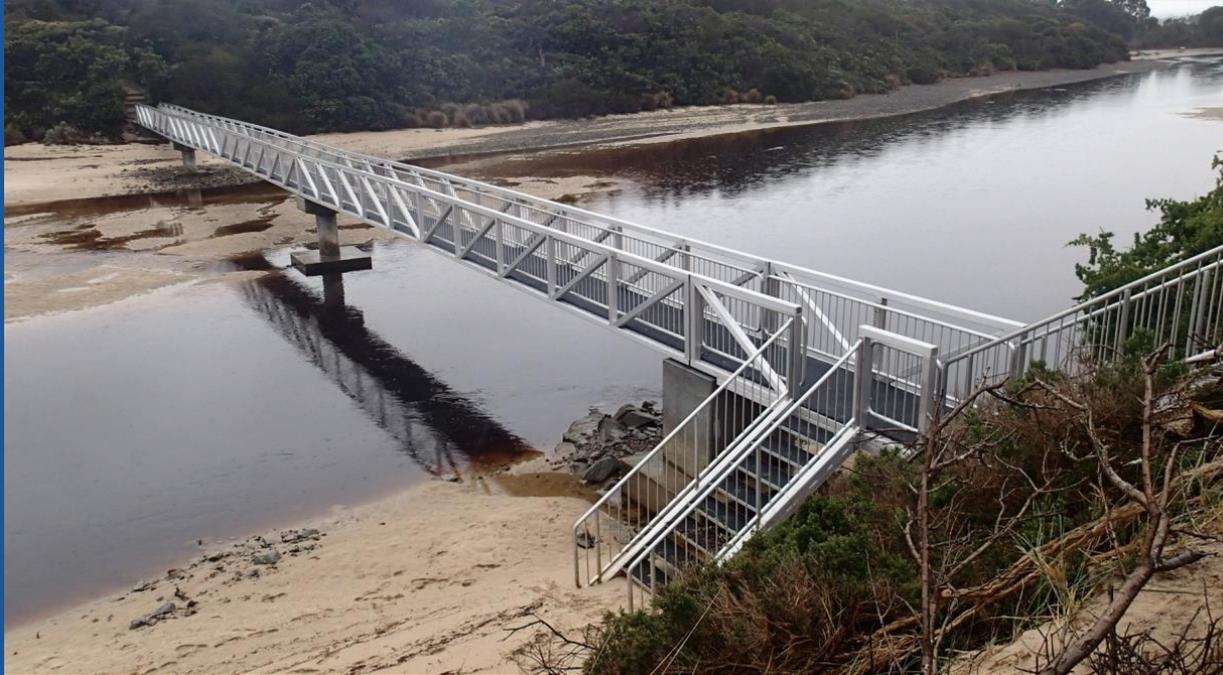
- Several 24m spans have been installed by crane at coastal sites accessible by vehicles
- To date, longest span installed by helicopter is 19m (very remote location on the South Coast Track)

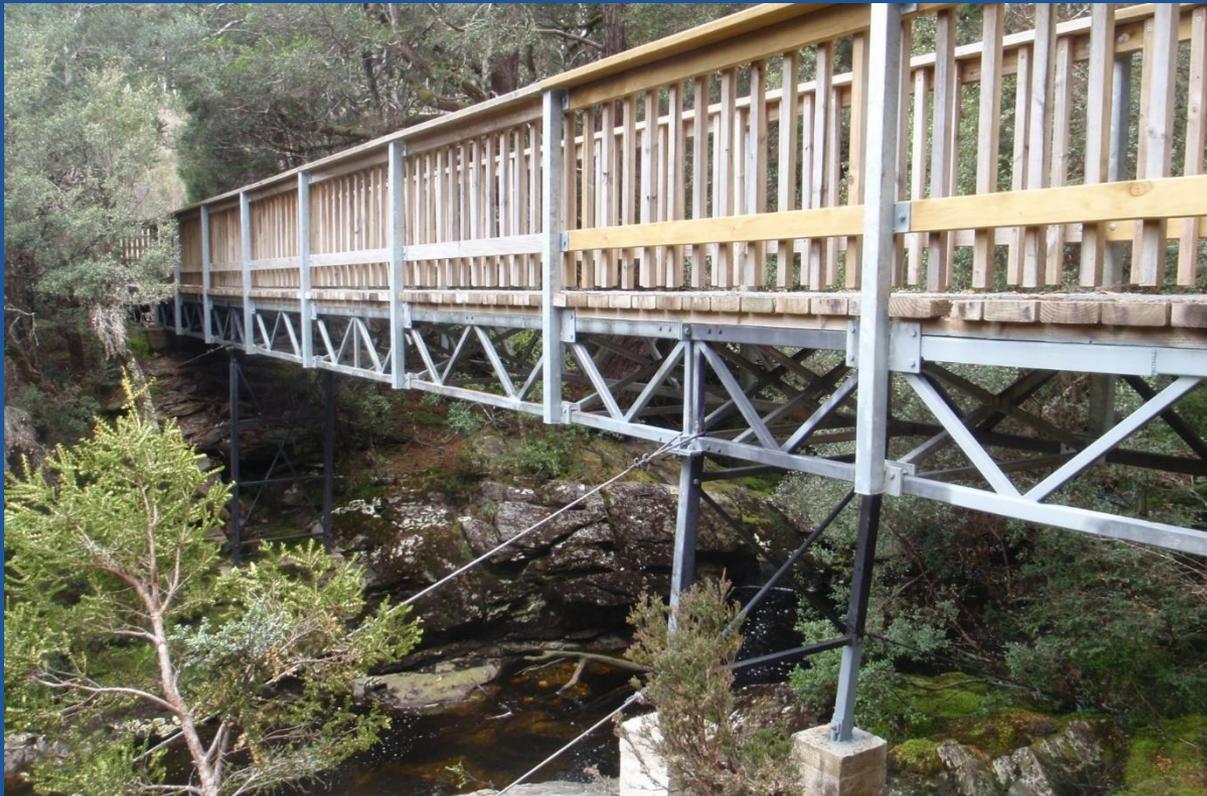
Previous structure (18m length with 2 intermediate piers)

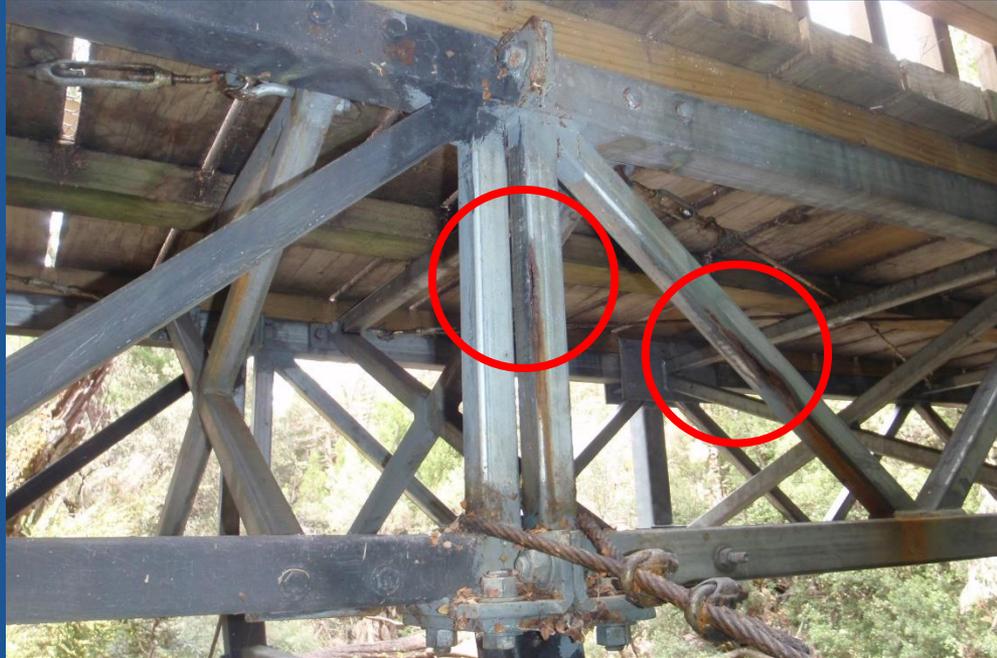
Extensive freeze/thaw splitting, combined with other deficiencies, resulted in a recommendation to replace the structure after only 20 years in service.

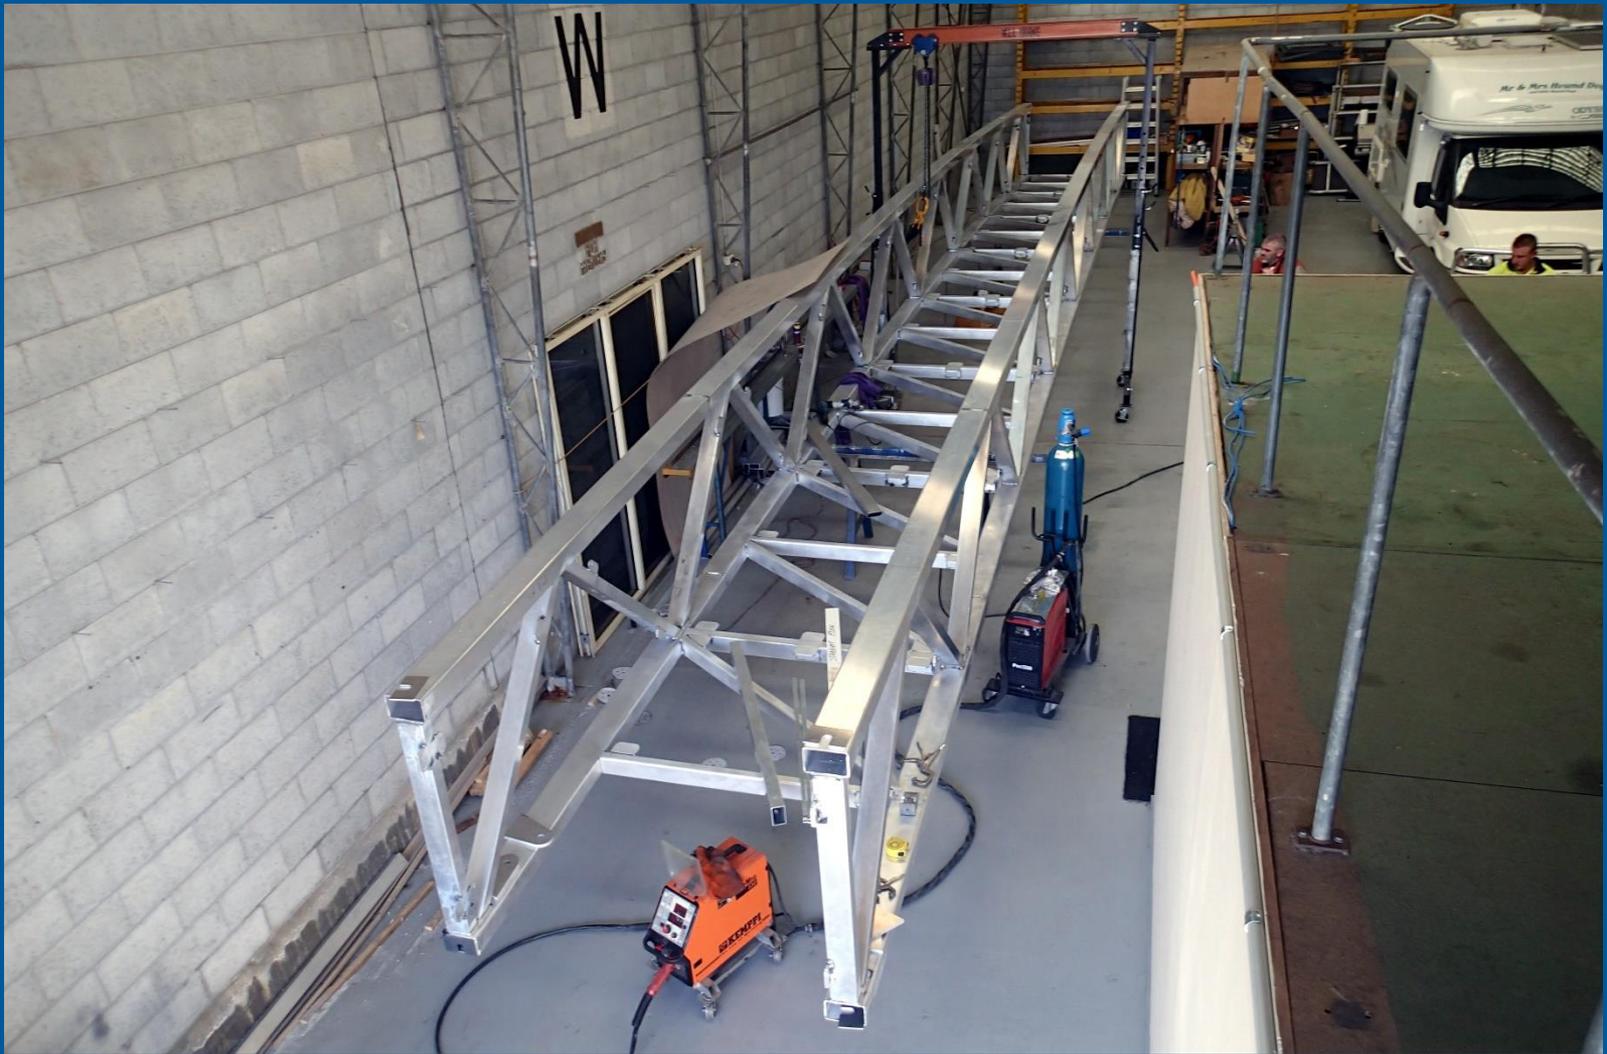
Aluminium walk-through truss under fabrication, length 18m, mass 850kg

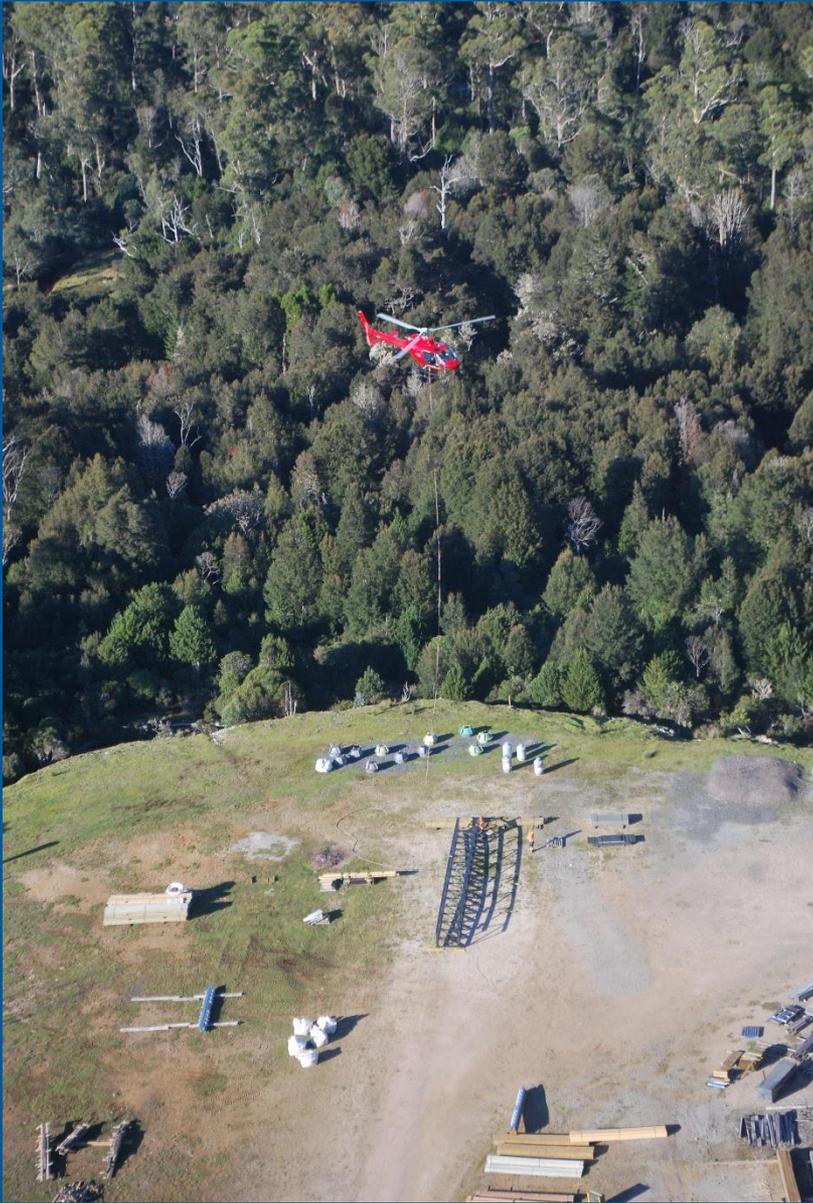
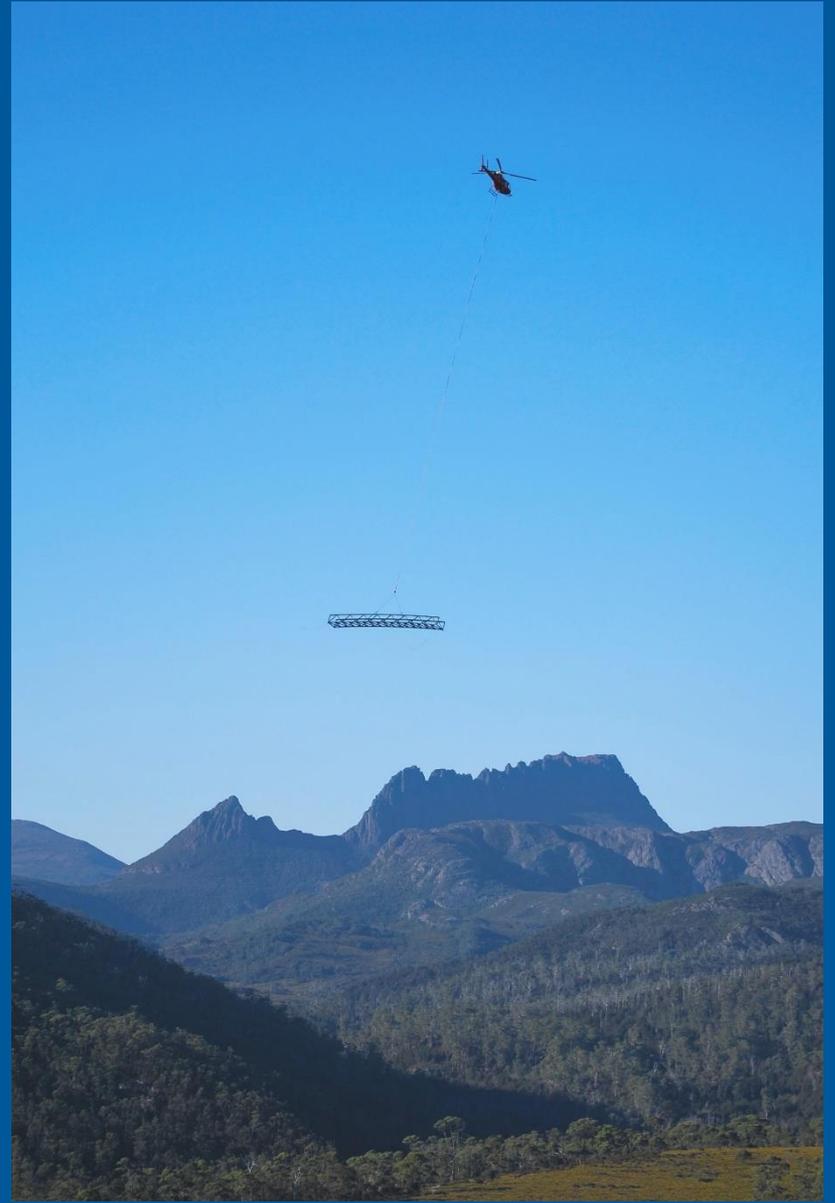
Heli lift from local base (AS350 B3 “Squirrel” helicopter)

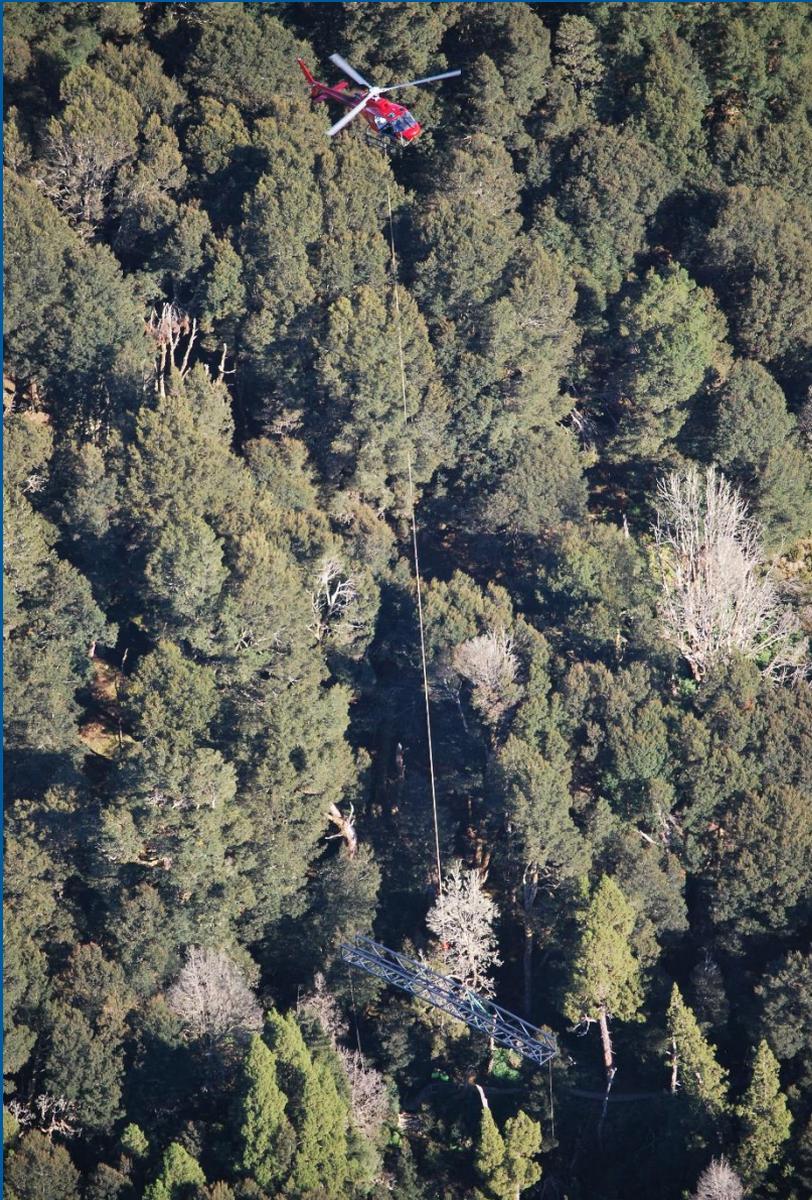
The truss is lowered to tree top level, where ground crew can reach guide ropes.

Ground crew (both sides of river) use guide ropes to help manoeuvre structure through tree canopy. Radio communications are maintained with pilot throughout.

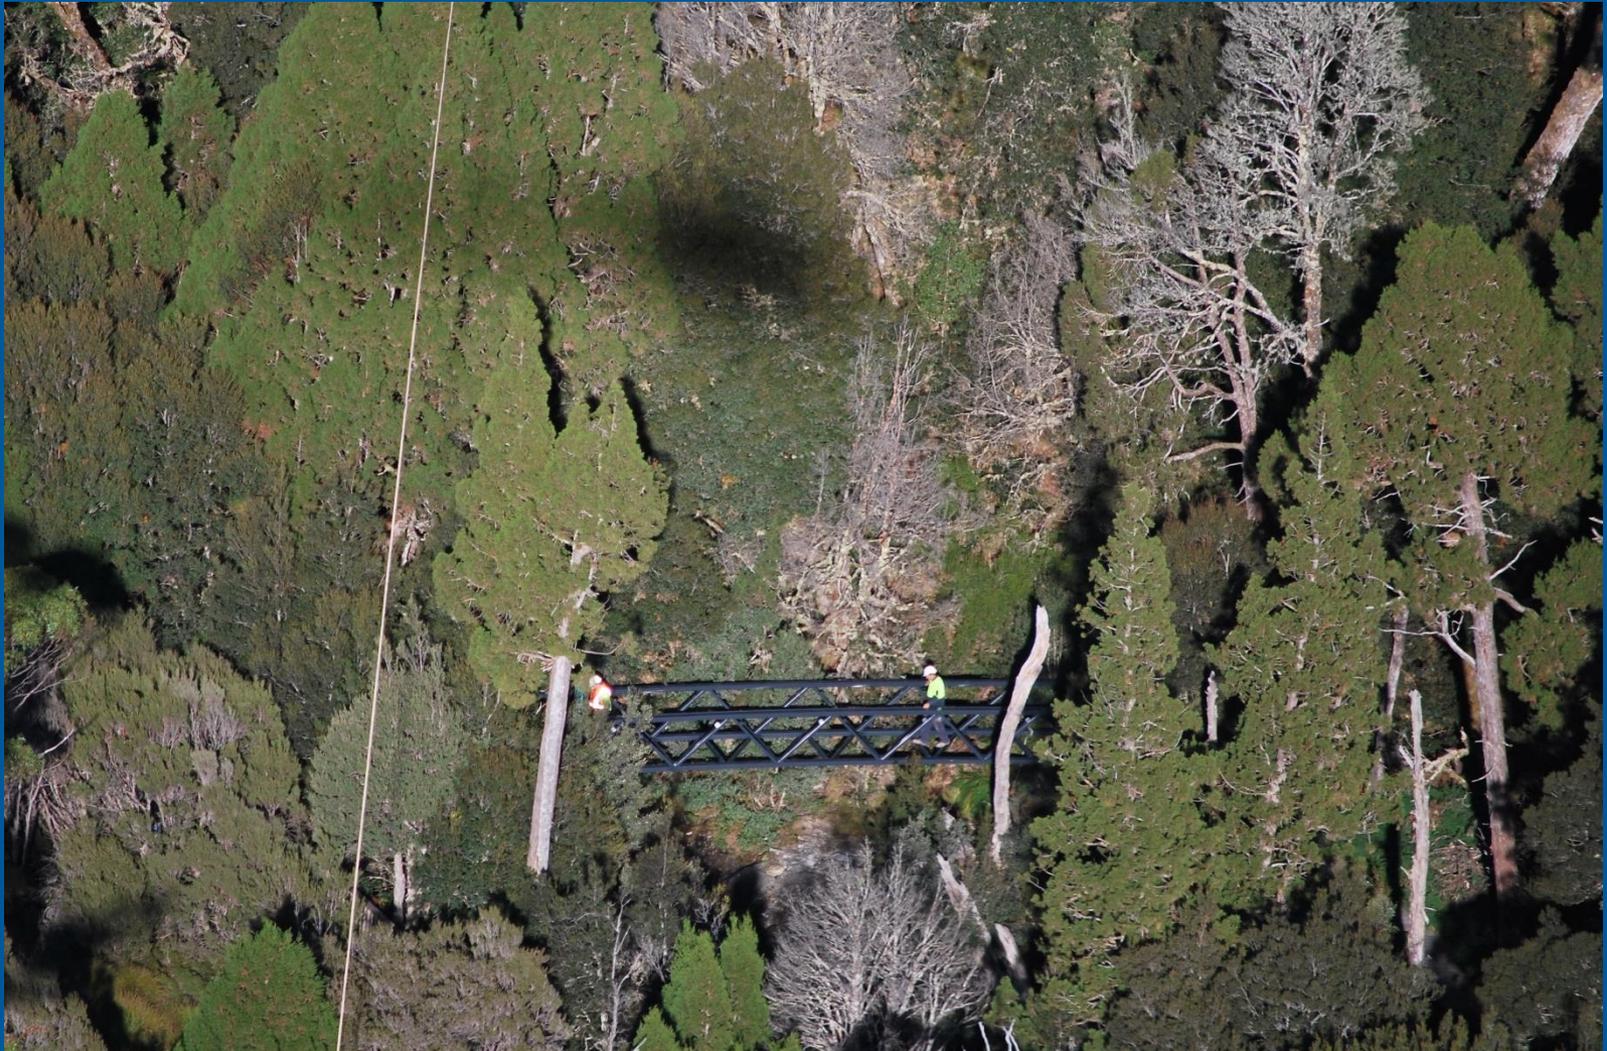
The structure is positioned on the existing abutments (with adapter brackets)

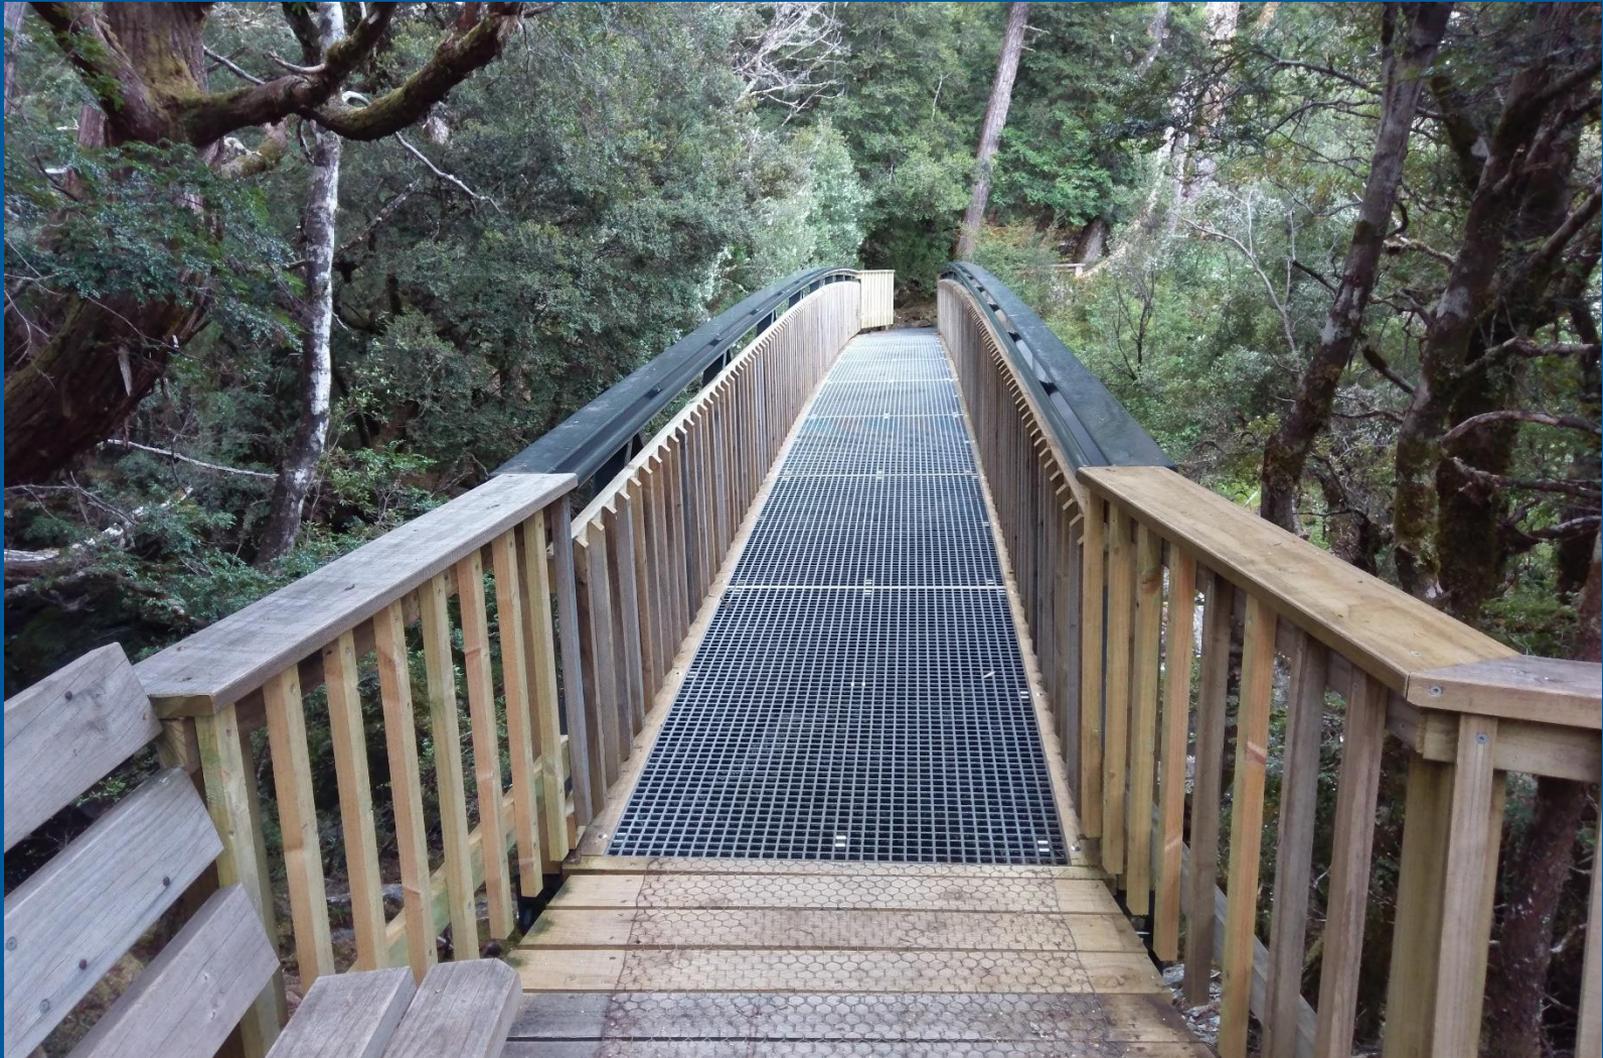
Decking and barriers are installed (timber recycled from the previous structure)
