## low impact development technical workshop series

### Water Quality Treatment and Permeable Pavement

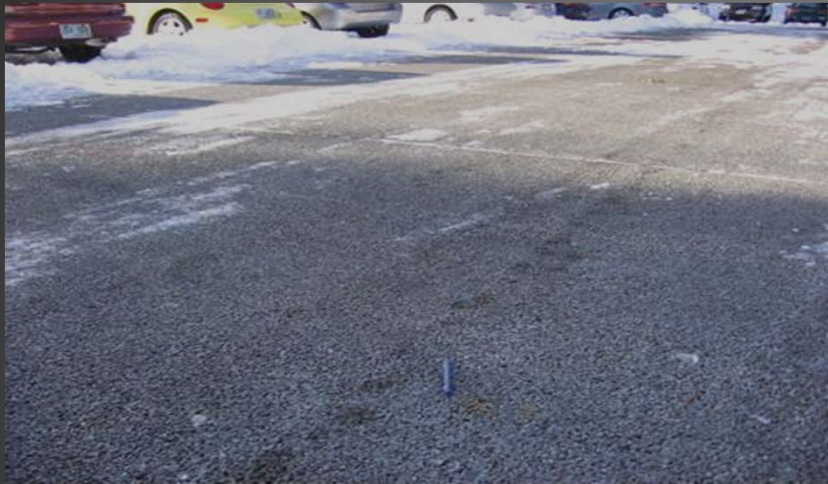
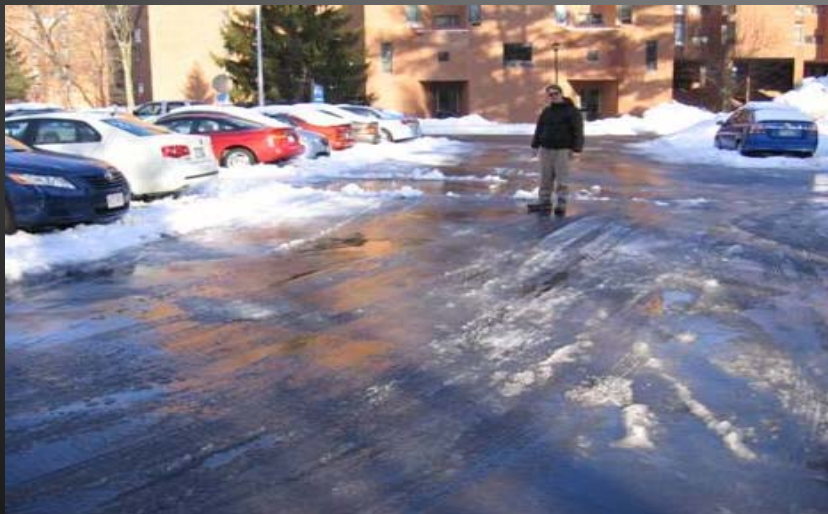
# UNH Stormwater Center finding significant reduction of deicing salts for permeable paving compared to conventional paving

May reduce salt use by 70% by allowing snowmelt and rain to infiltrate.

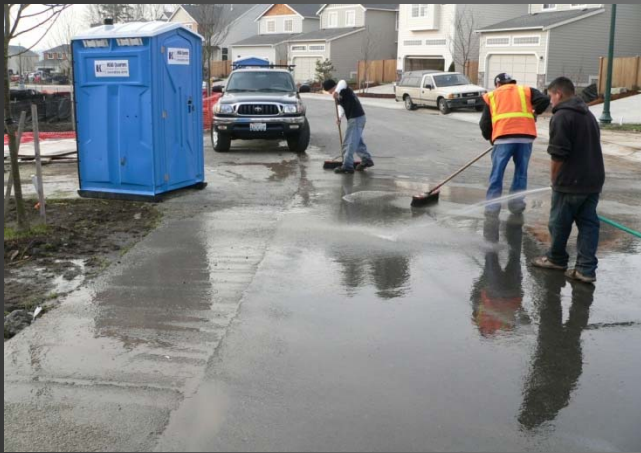
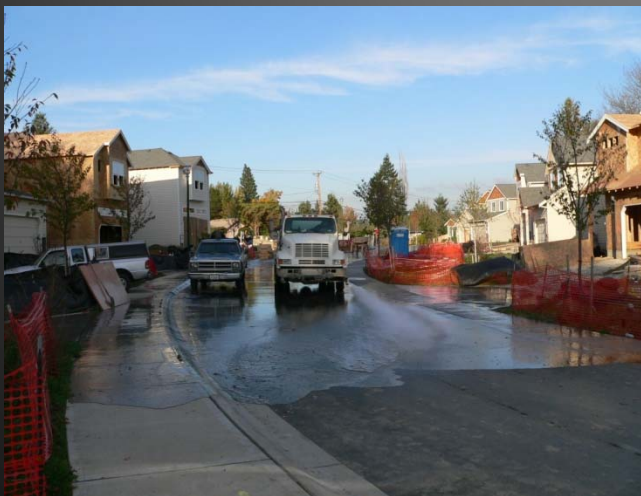
# High initial infiltration rates in permeable paving will diminish over time...important to consider context and maintenance

## Infiltration Rates Over Time

- Most conservative: 10.0 in/hr for 20 yr life span (ICPI).
- 50% of initial infiltration rate typical recommendation.
- Permeable asphalt hwy: 1986 100 in/hr, 1990 28 in/hr.
- Florida permeable concrete field evaluation: 6.5 yrs old: 240 in/hr, 8 yrs old: 42 in/hr.
- Borgwardt: reports a long-term infiltration rate for permeable pavers of 4.25 in/hr.
- Worst case: 1096 cm/hr reduced to 3.32 cm/hr observed...105 cm/hr after cleaning (Hinman, 2009).
